MARINE OCCURRENCE REPORT

02-203

Harbour tug *Purau*, loss of control and grounding, Lyttelton

1 March 2002

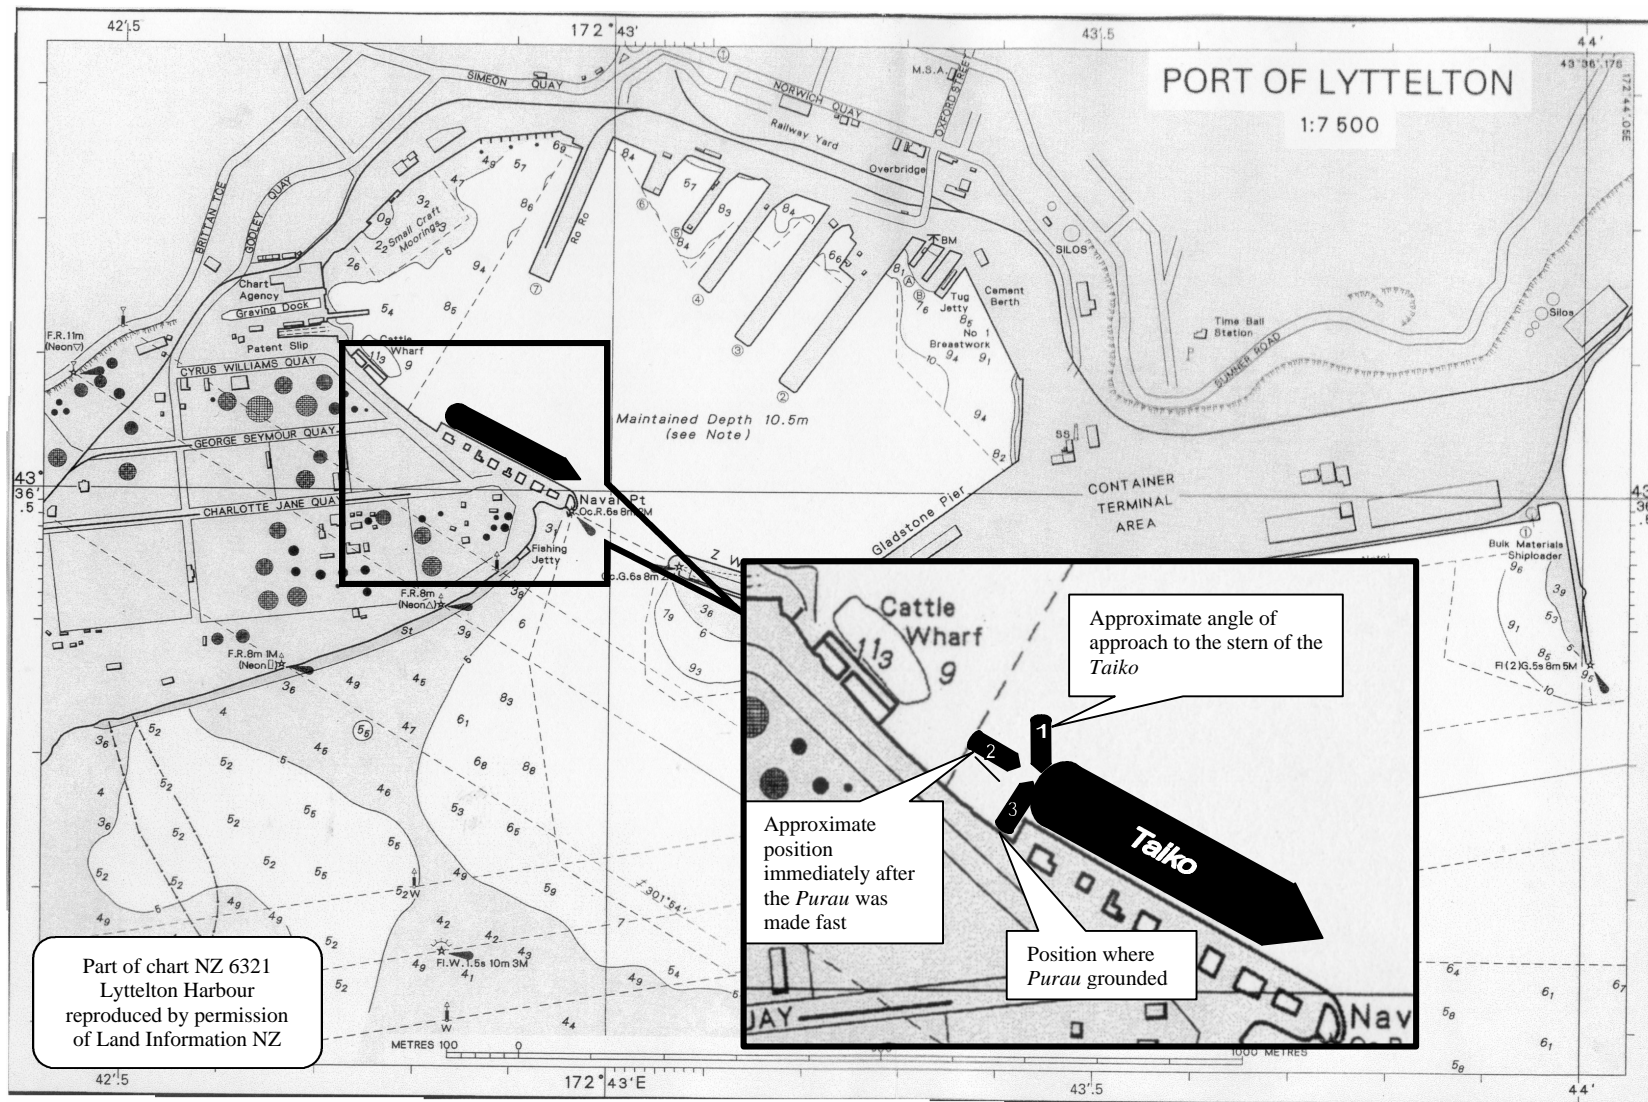
Figure 1
Partial chart of Lyttelton harbour

- 1.1.1 On 1 March 2002, the harbour tug *Purau* was assigned to assist the tanker *Taiko* depart from the Lyttelton oil wharf at about 1140 (see Figures 1 and 2). The tug had been ordered for 1130 and the crew had arrived in sufficient time to prepare the tug.
