## MARINE OCCURRENCE REPORT

03-201

passenger ferry *Harbour Cat*, engine room fire, Auckland Harbour

16 January 2003

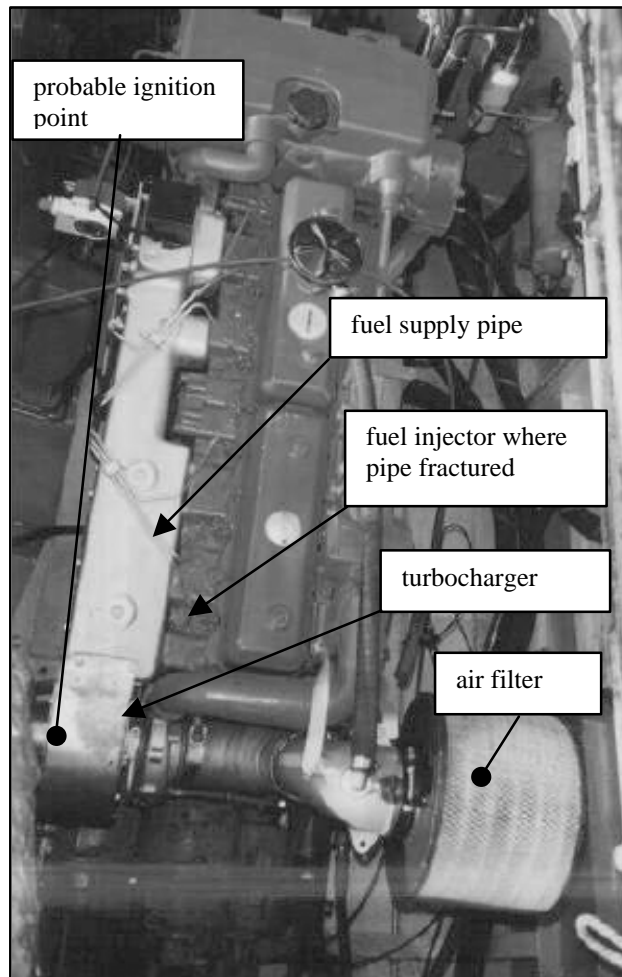
**Figure 2**  
A Scania DSI-11-74 engine similar to those installed on the *Harbour Cat*

- 1.2.1 A relief crew was put on board to monitor the situation overnight and to start general cleaning. After confirming that the fire was fully extinguished the crew then started a general cleanup operation.
- 1.2.2 A maintenance team started investigations on the morning of 17 January 2003. It discovered that the fuel pipe leading to the fuel injector for the aftermost cylinder had fractured where the pipe entered the compression nipple on the fuel injector. This part of the fuel line was unsheathed and so did not re-cycle the fuel oil or sound the alarm.

- 1.2.3 The New Zealand representative for Scania marine diesel engines stated that fuel pipes breaking in the vicinity of the compression nipple was an unusual occurrence that he had not previously witnessed.
- 1.2.4 The operator tested the fuel injector and the fuel pump to ensure that they were operating correctly. Neither item was found to be producing pulsing or hammering in the fuel lines, which may have contributed to the fuel line failure.
- 1.2.5 The fuel pipe that fractured contained diesel fuel at an operating pressure of 300 bar [30 MPa]. When the pipe fractured fuel was able to spray out into the surrounding area. Located in the vicinity of this fuel pipe were the turbocharger, exhaust manifold and air filter.
