## M A R I N E   O C C U R R E N C E   R E P O R T

Report 03-204, restricted limit passenger vessel *Tiger III*,  
passenger injury, Cape Brett

TRANSPORT ACCIDENT INVESTIGATION COMMISSION  
NEW ZEALAND

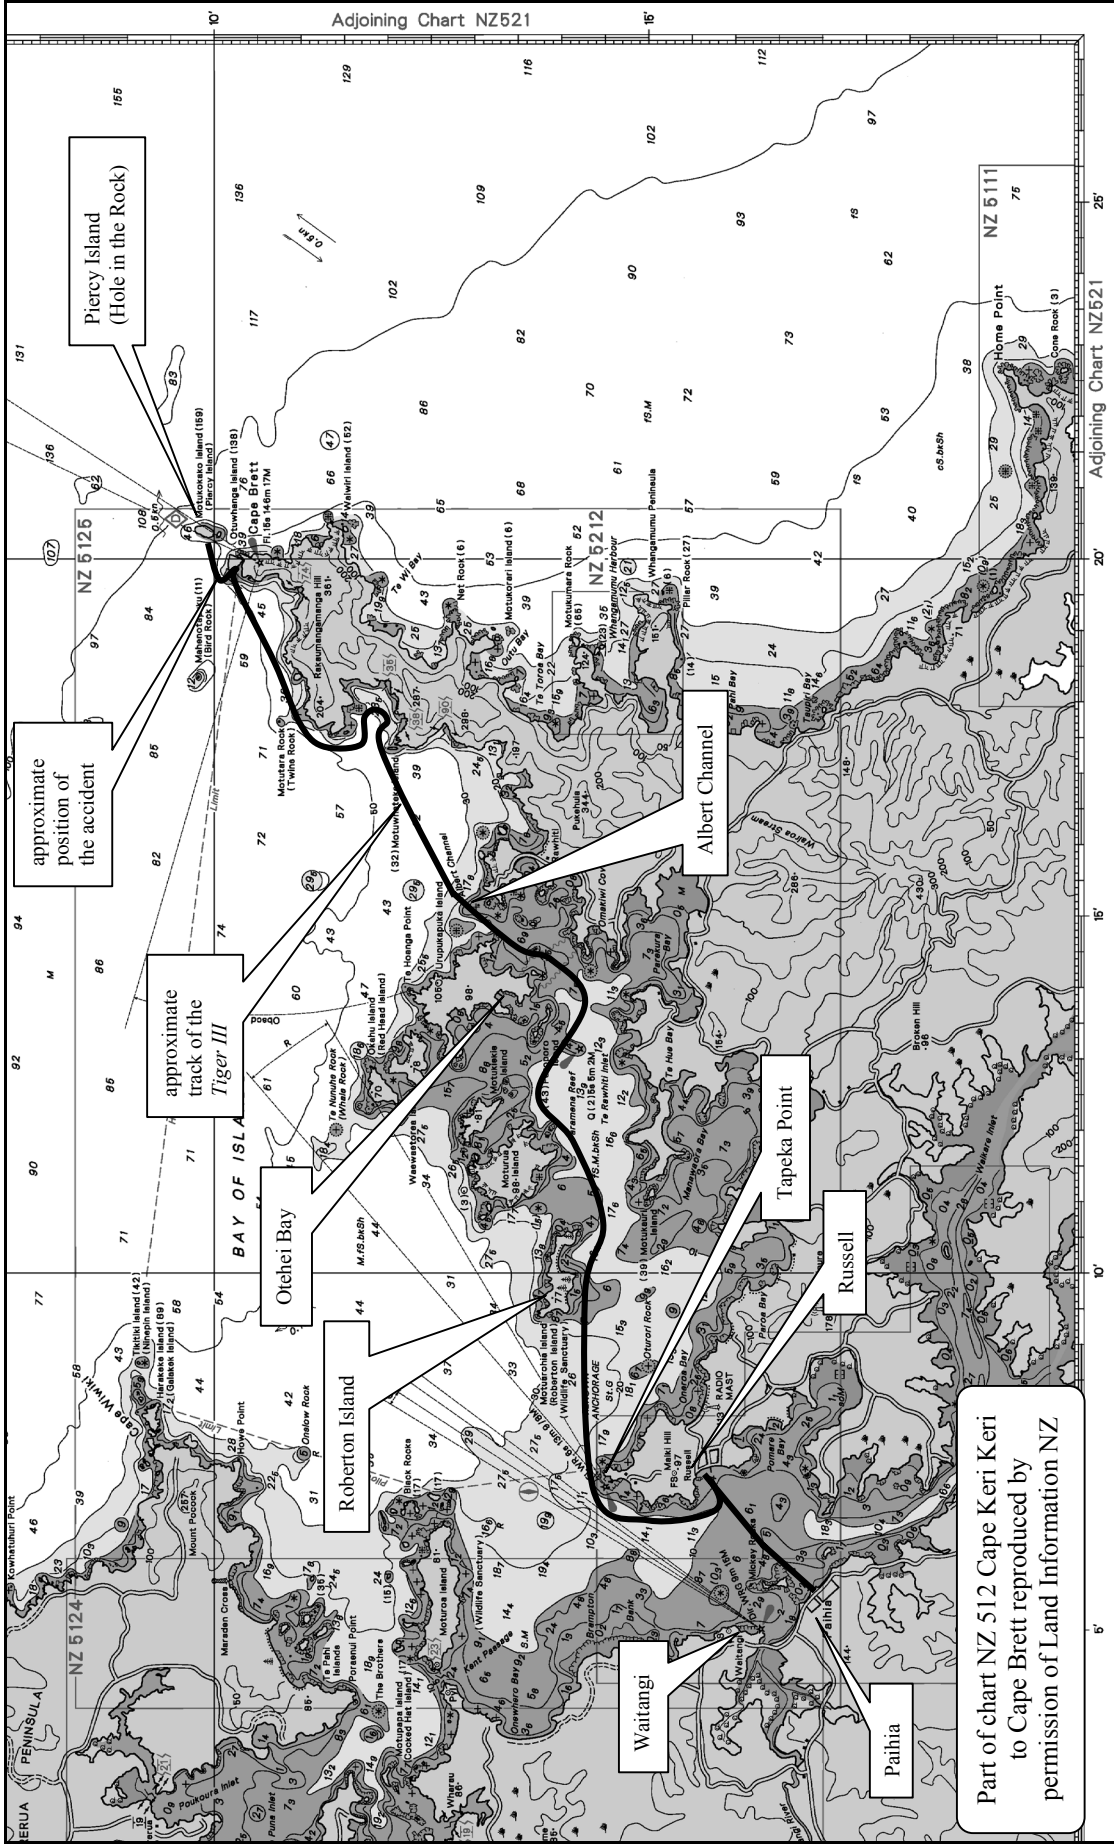
Figure 1  
 Extract of Chart NZ 5125 showing the approximate track of the *Tiger III* on its voyage to the Hole in the Rock

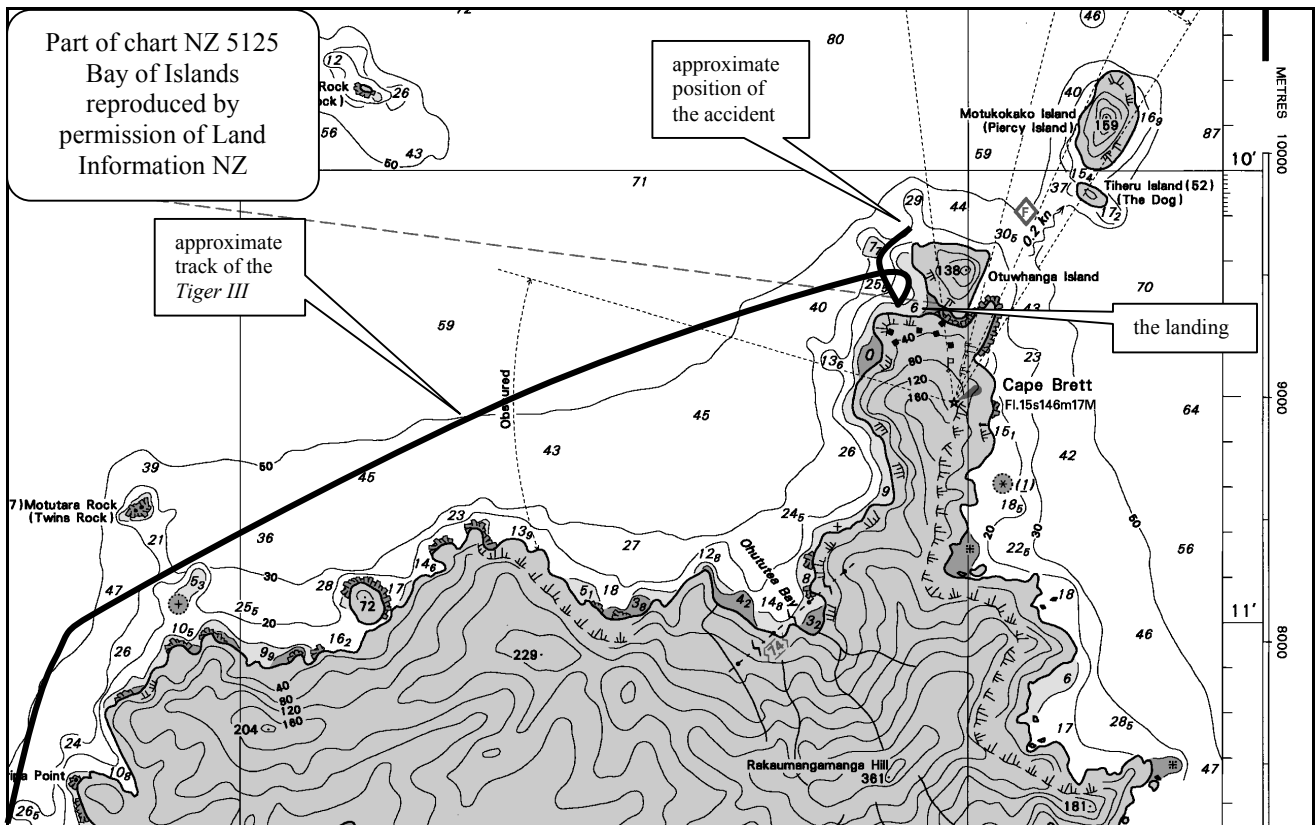
**Figure 2**  
**Extract of chart NZ 5125 showing the approximate track of the *Tiger III* to the Hole in the Rock**
