MARINE OCCURRENCE REPORT

03-206

tanker *Capella Voyager*, grounding, Whangarei

16 April 2003

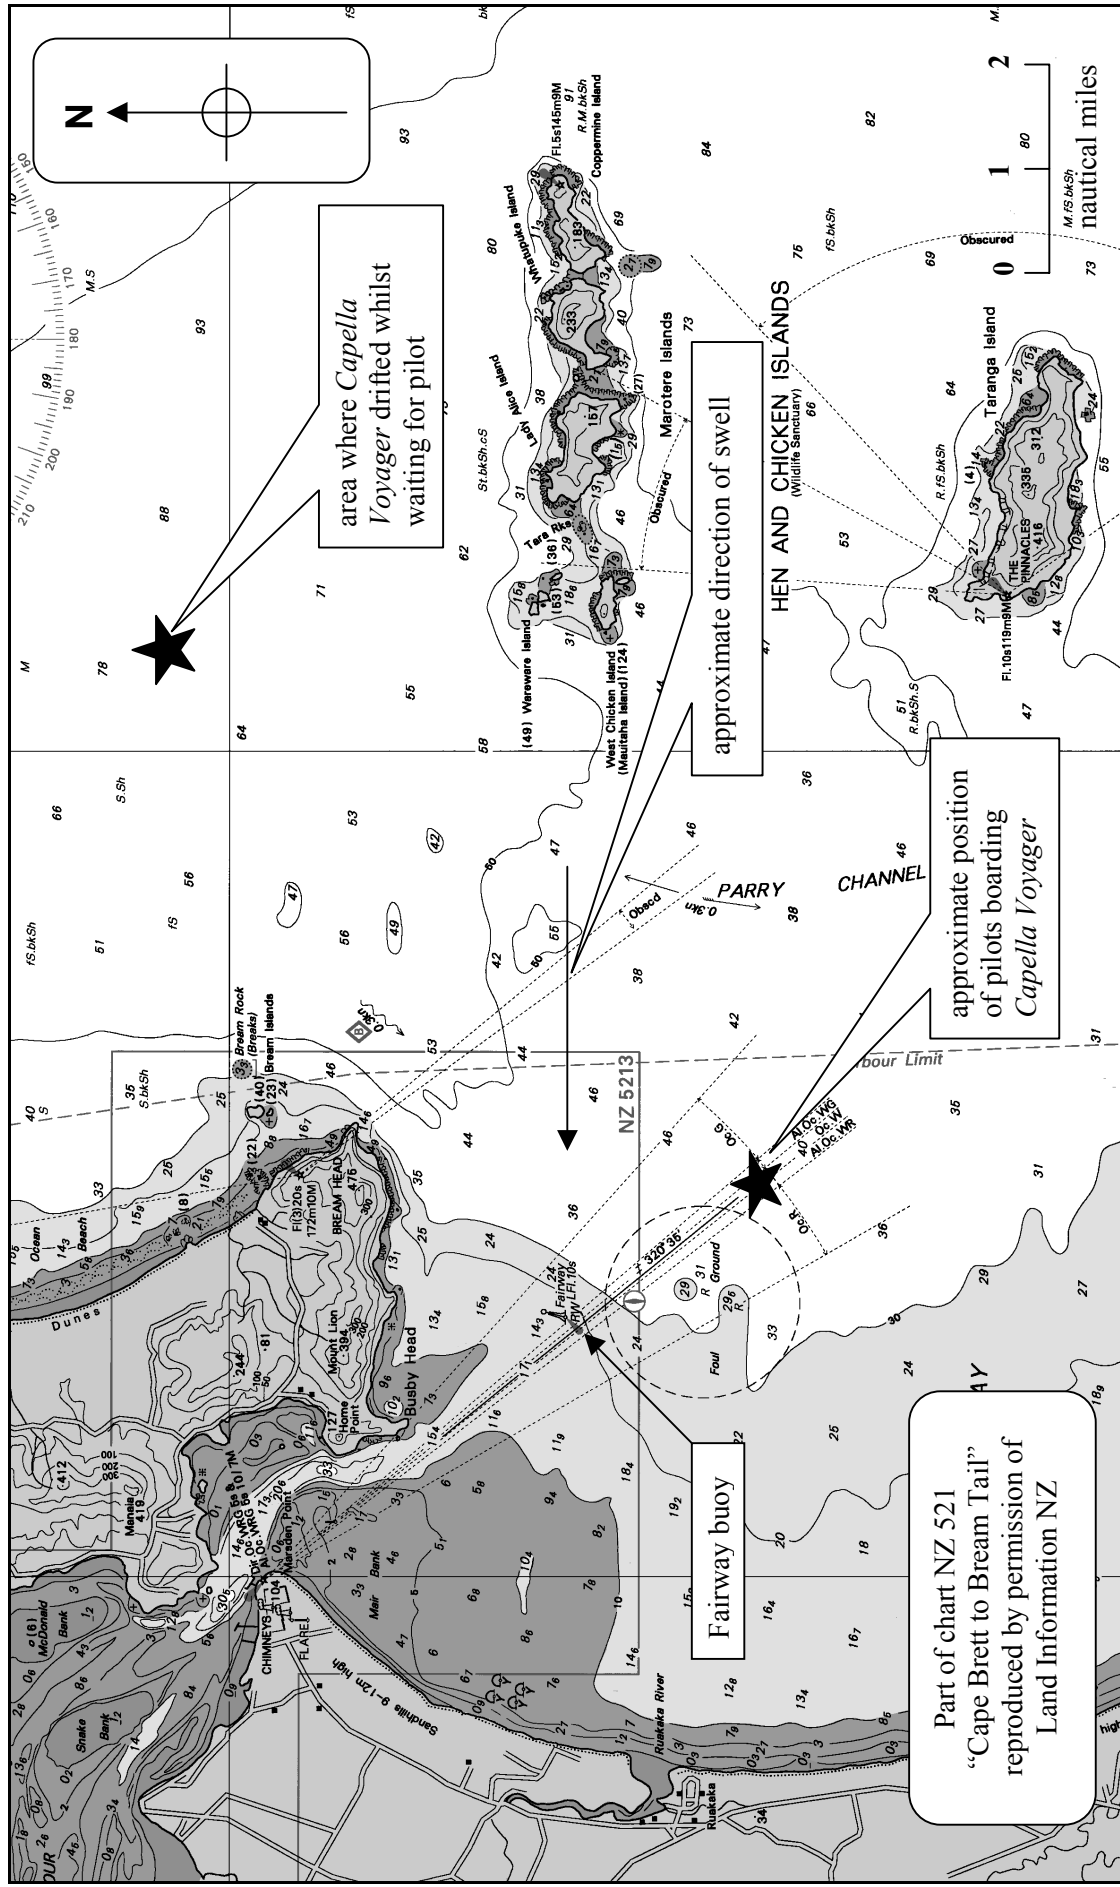
Figure 1
General area of the accident

- 1.1.4 The master of the *Capella Voyager* conned the ship into clear water to drift and await the next pilot boarding time (see Figure 1).
- 1.1.5 The master of the *Capella Voyager* was in contact by satellite communications with the ship's agent and the general manager of North Tugz, the harbour operators, during the day. North Tugz requested that at the next pilot boarding time a pilot join the ship to assess the situation, irrespective of whether or not the ship entered harbour. The master agreed to this request.

- 1.1.7 At approximately 1730, 2 pilots boarded the ship about 2 nm from the Fairway buoy (see Figure 1). After discussion with the master agreement was reached that a "dry run" would be made towards the Fairway buoy to assess the ship's movement on the approach. The ship was steadied on the leading line course of 320° and the approach made. At about 1 nm from the Fairway buoy, a slow turn of 360° to starboard was made.

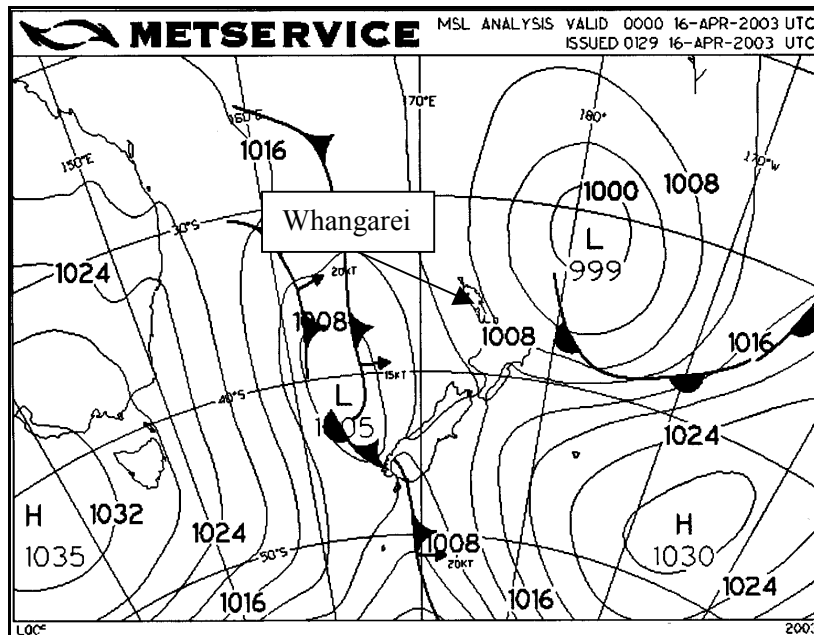
Figure 4
Mean sea level analysis synoptic chart for 1200 16 April.

- 1.5.1 During the 48 hours prior to the grounding, the wind at Whangarei harbour had been from a generally easterly to south-easterly direction due to a high-pressure weather system over central New Zealand. A low-pressure weather system formed to the north of the North Island and moved south-south-easterly towards the Chatham Islands increasing the easterly wind flow before it changed to a south-westerly flow (see Figure 4).
