## MARINE OCCURRENCE REPORT

03-209

container vessel *Bunga Teratai 4* and fishing vessel *Mako*,  
collision, Tasman Bay

4 July 2003

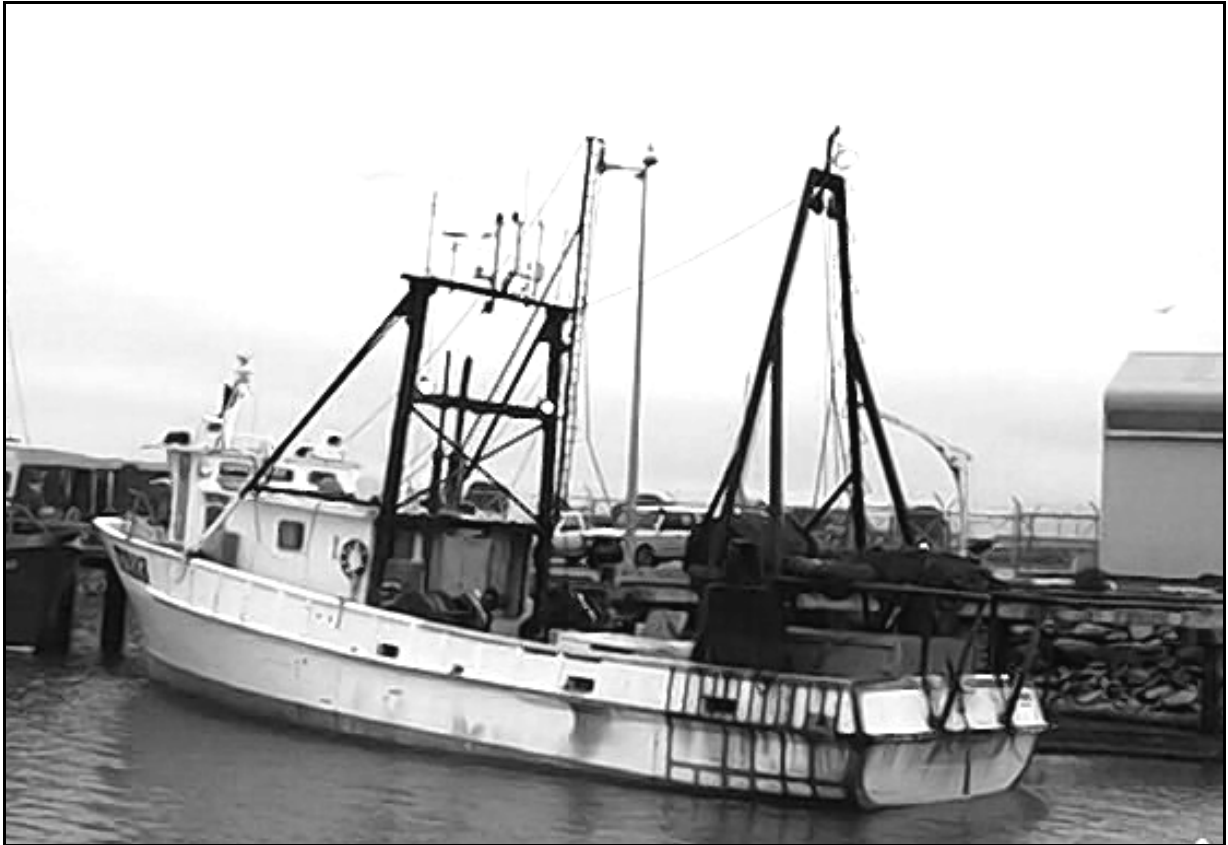
*The Mako*

**Damage:** paintwork scratched anchor fairlead displaced and bow set in. Paravane arm severely bent and damage to superstructure in way of the wheelhouse
