MARINE OCCURRENCE REPORT

03-210

passenger freight ferry *Aratere*, collision with moored fishing vessel *San Domenico*, Wellington Harbour

5 July 2003

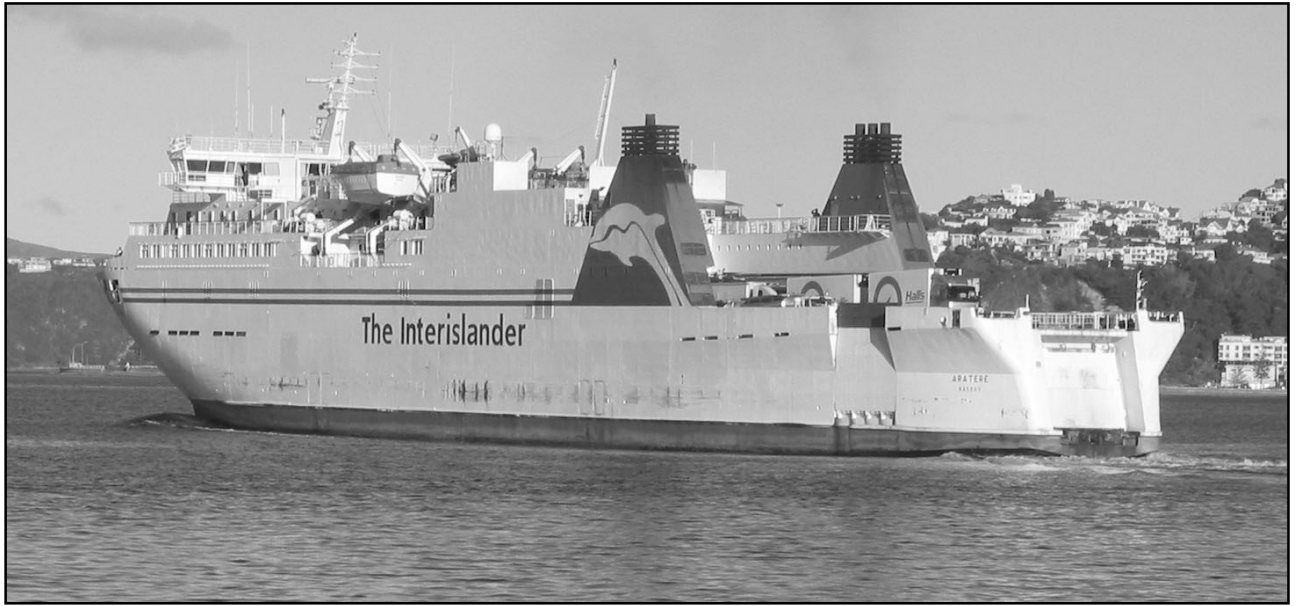
The *Aratere* in Wellington Harbour (note bulbous bow)

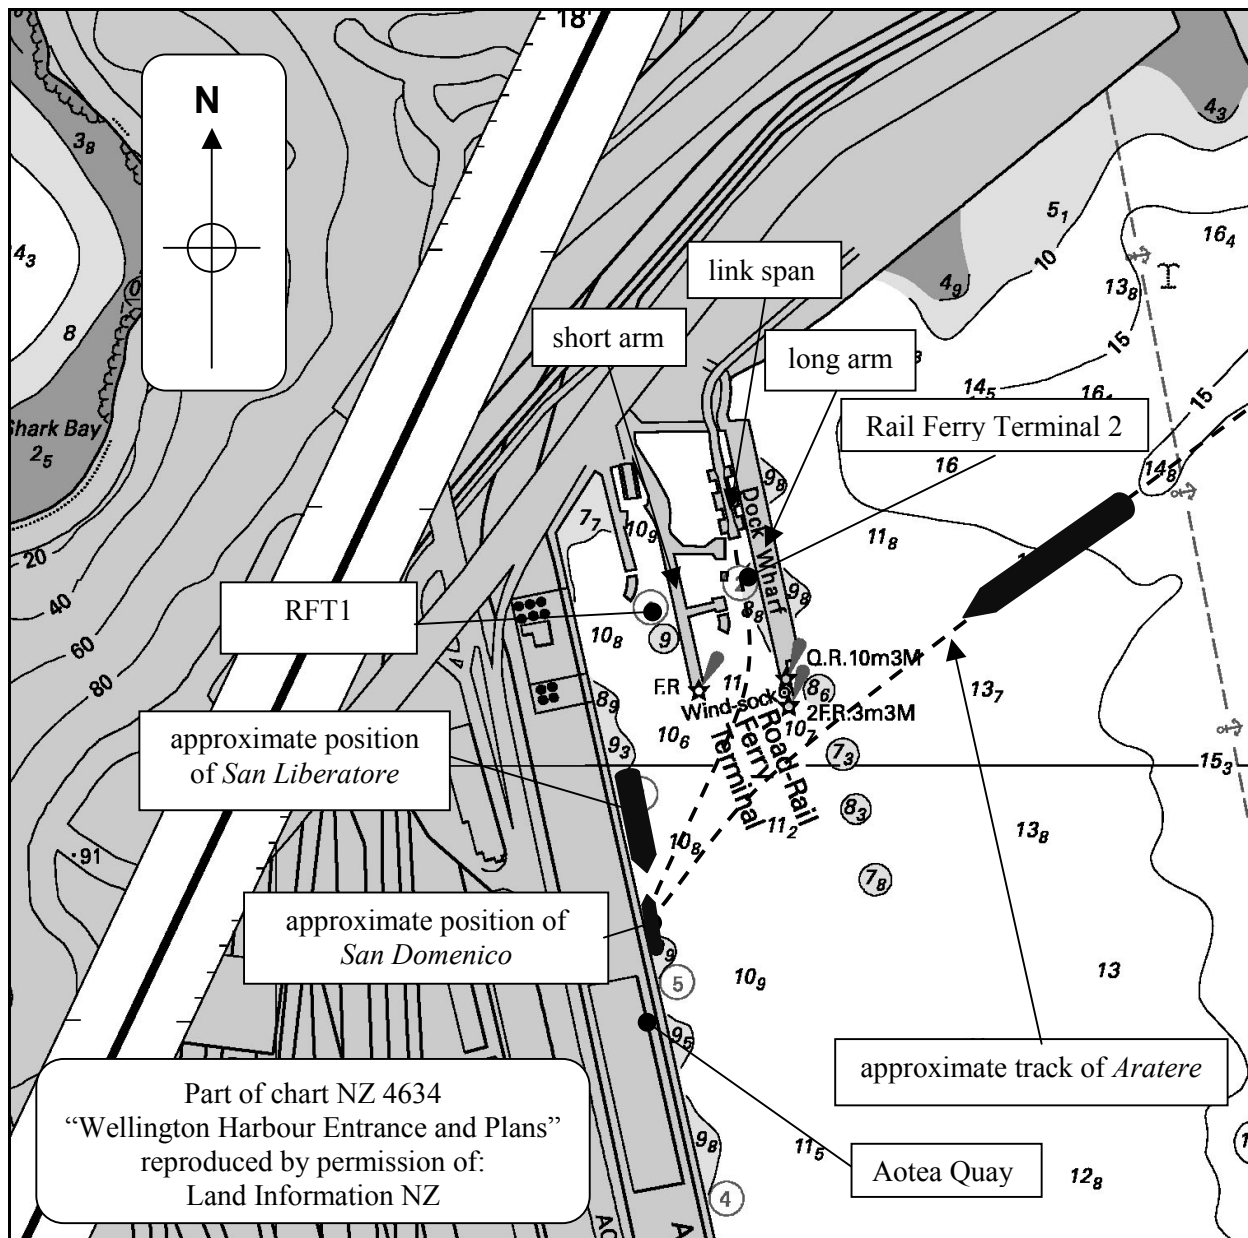
Figure 2
Plan of rail Ferry Terminal and Aotea Quay

- 1.2.1 RFT2 was a purpose built ro-ro berth with a link span fitted at the inner end. Dock Wharf referred to as the 'Long Arm', was approximately 212 m long, with a link span protruding 68 m from near the root of the wharf. There was a clear water width of approximately 133 m between Dock Wharf and Aotea Quay (see Figure 2).

- 1.2.2 Between the Long Arm and Aotea Quay a smaller wharf, referred to as the 'Short Arm', extended into the harbour a distance of about 180 m. This wharf had 2 smaller jetties extending from it towards Dock Wharf, which provided the other side of the berthing facility for the rail ferries. A second berth, rail ferry terminal 1 (RFT1) was located between the Short Arm and Aotea Quay (see Figure 2).

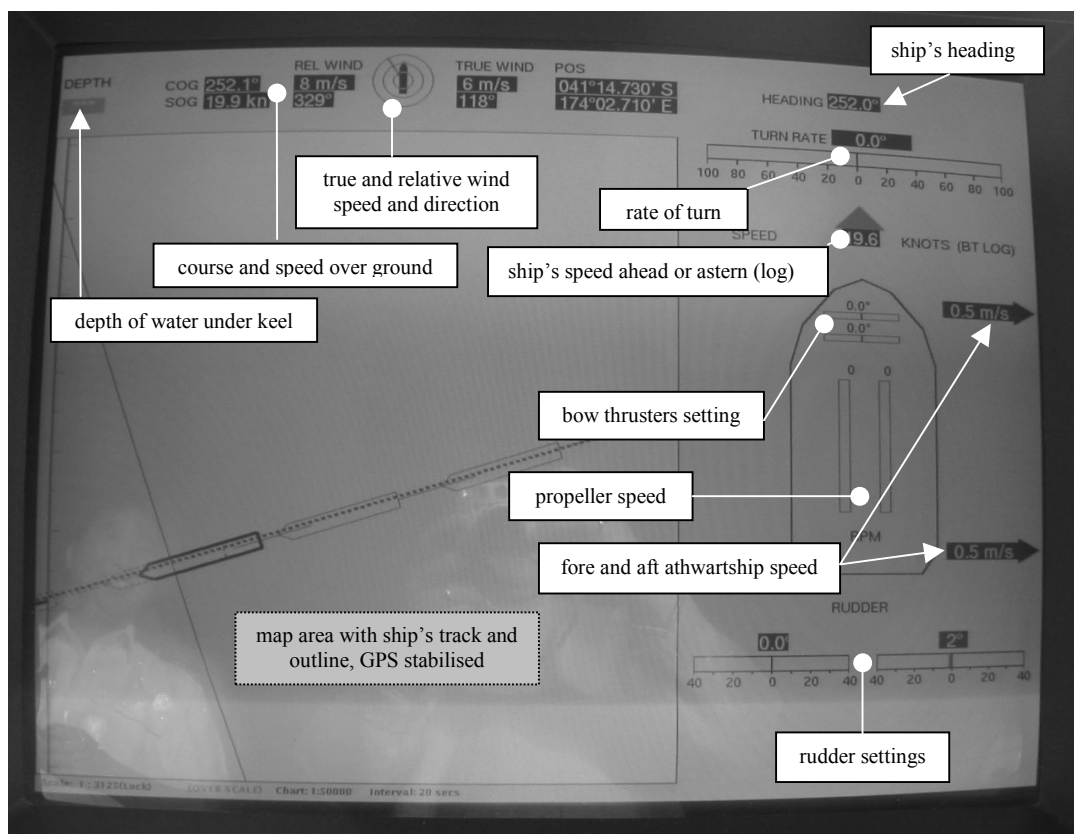
Figure 3
ECDIS display in docking mode, showing information available

- 1.3.6 When in “docking mode”, the ECDIS system graphically displayed a position of the ship overlaid on a large scale chart, the revolutions for the engines and bow thrusters, rudder indicators and readouts for the ship's position, wind velocity and direction (true and relative), direction and speed of the ship and sideways movement (see Figure 3).
