MARINE OCCURRENCE REPORT

04-202

Restricted limit passenger vessel *Queenstown Princess*,
grounding, Lake Wakatipu

13 February 2004

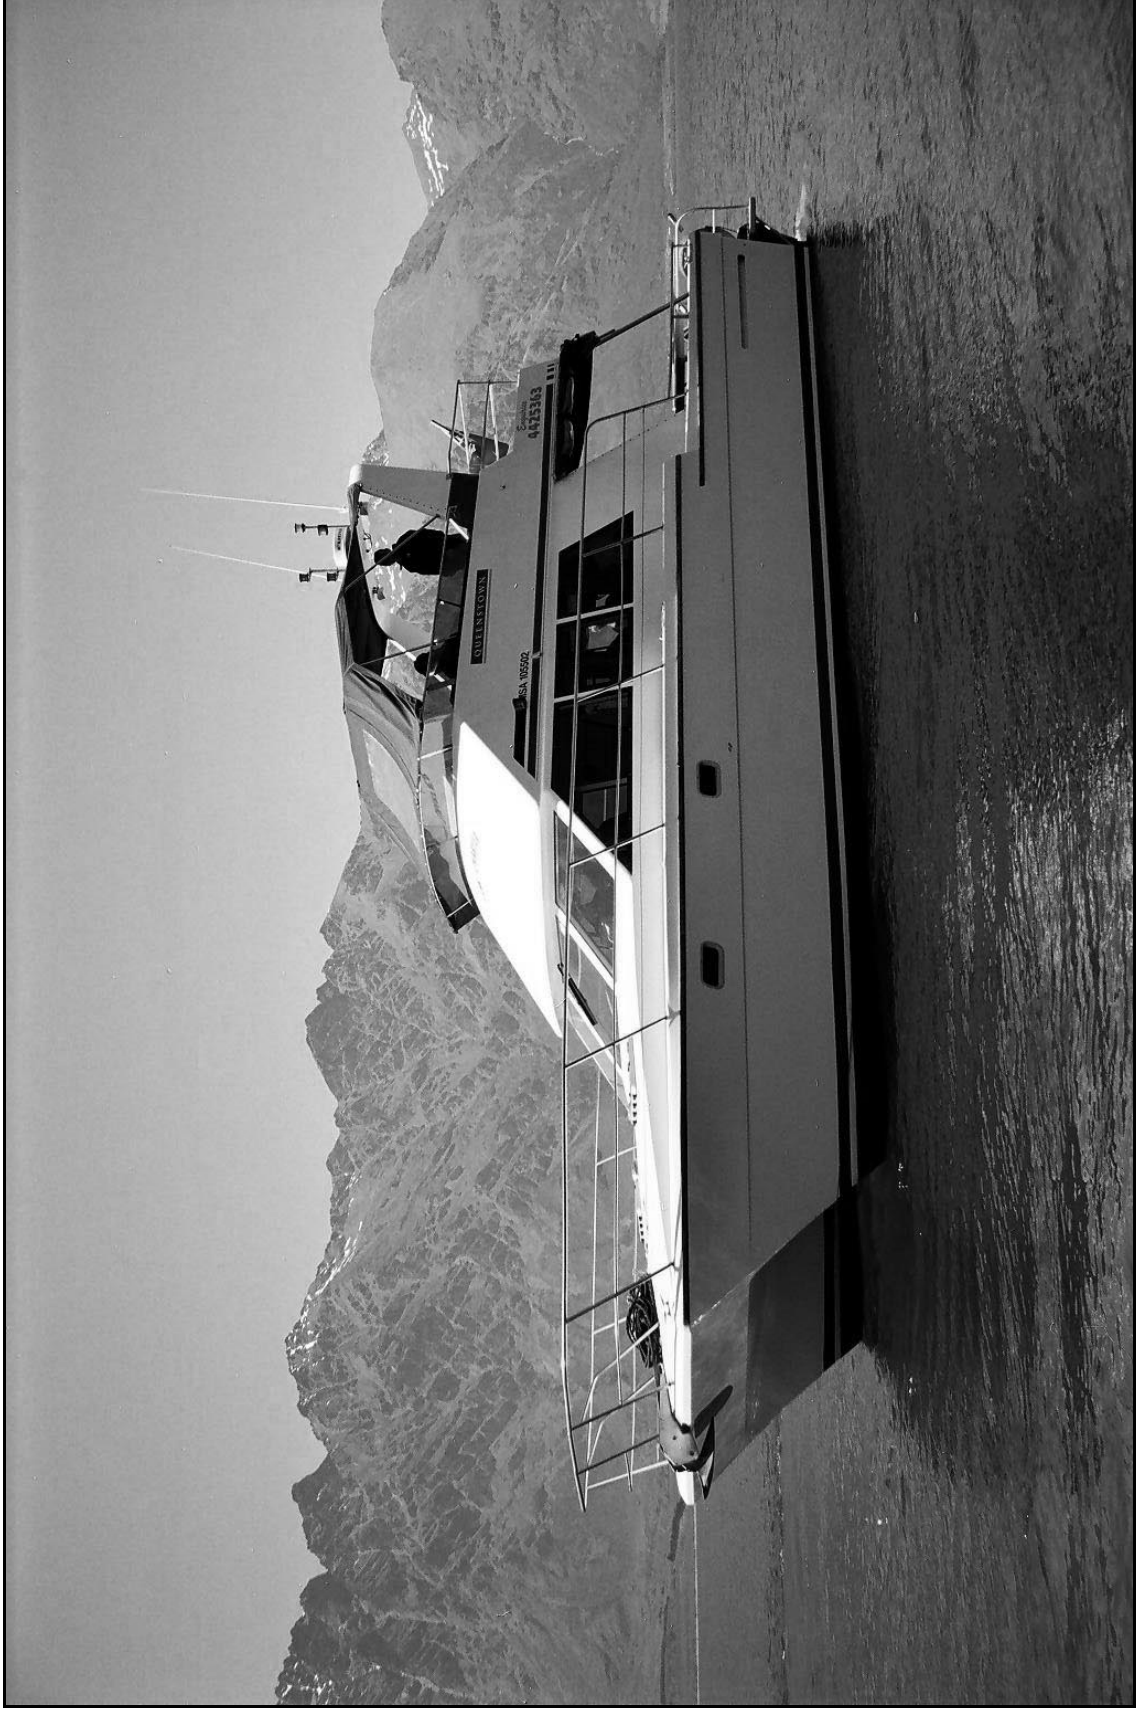
The Queenstown Princess

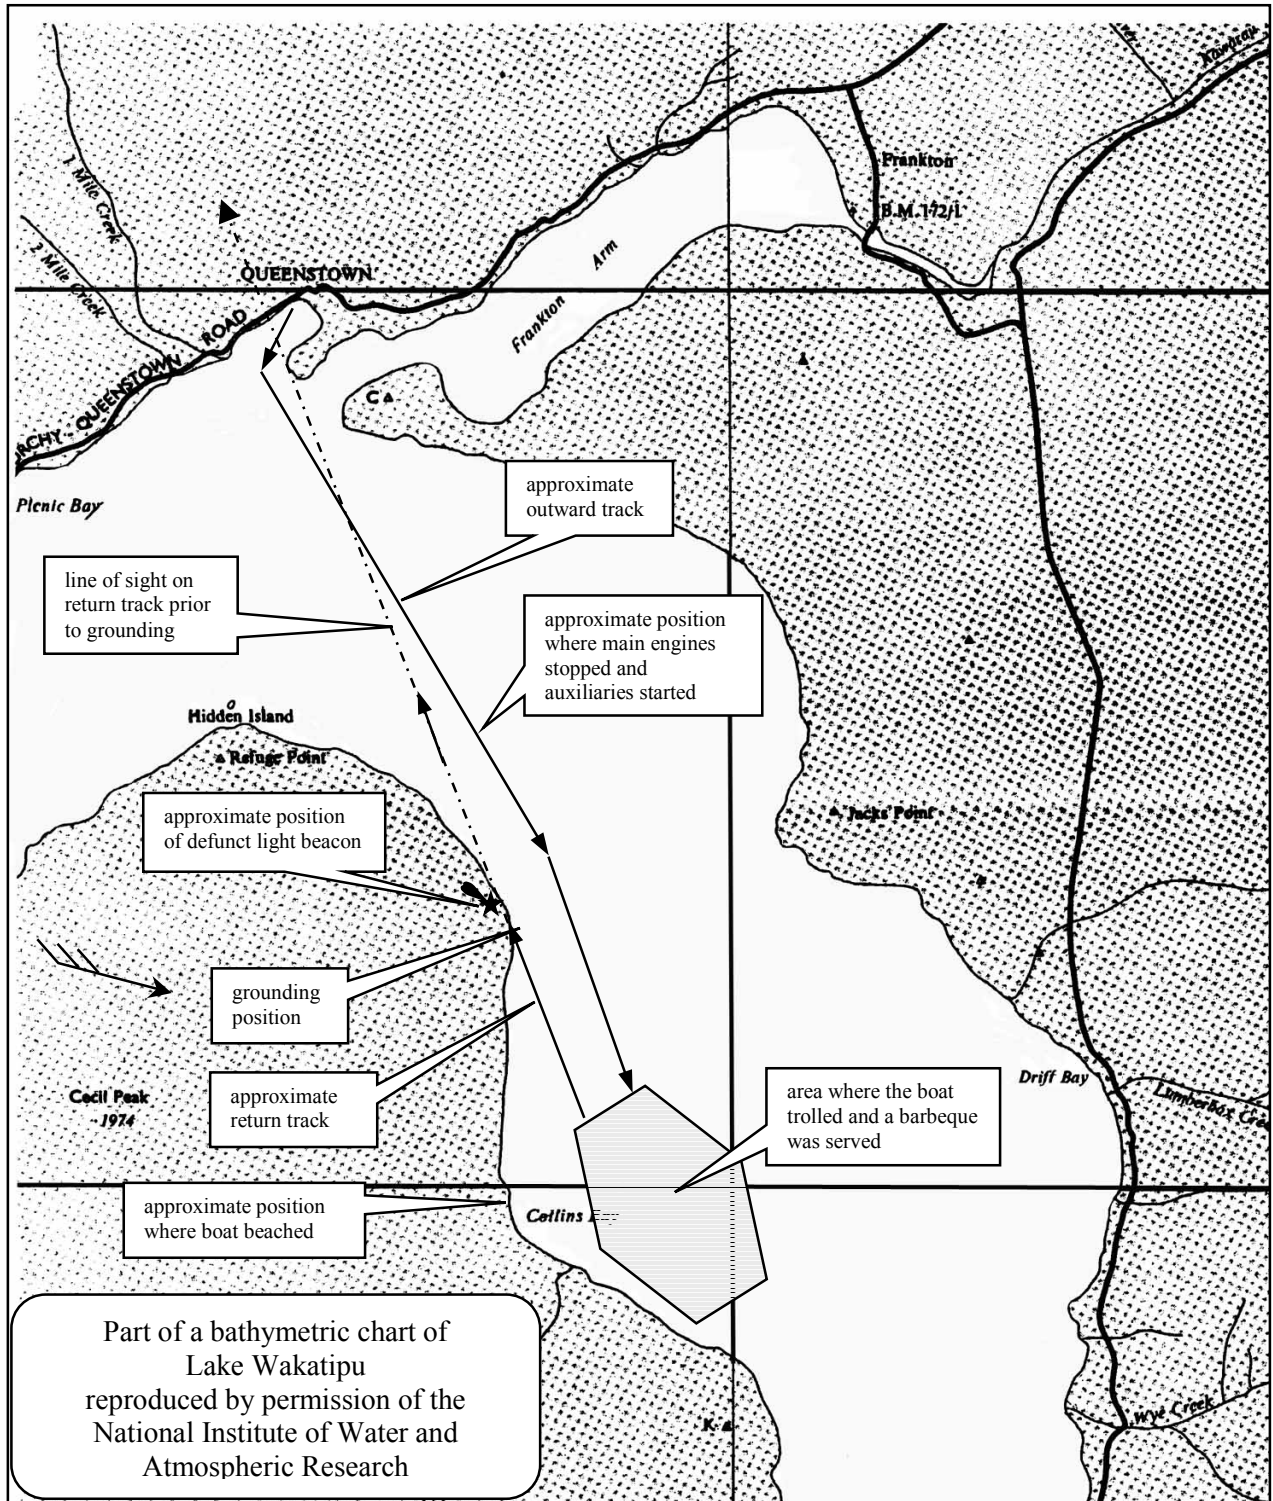
Figure 1
Chart of Lake Wakatipu

1.6.1 There were no navigational lights around the shores of Lake Wakatipu. The lake was generally deep and the shore steep-to. There were few isolated dangers offshore, the only one close to the area of operation of the *Queenstown Princess* on the evening of 13 February was Hidden Island off the northern coast of Cecil Peak (see Figure 1). There were no submerged dangers except in the shallows, very close to the shore.
