## M A R I N E   O C C U R R E N C E   R E P O R T

04-203

Coastal passenger and freight ferry *Arahura*, heavy weather incident, Cook Strait

15 February 2004

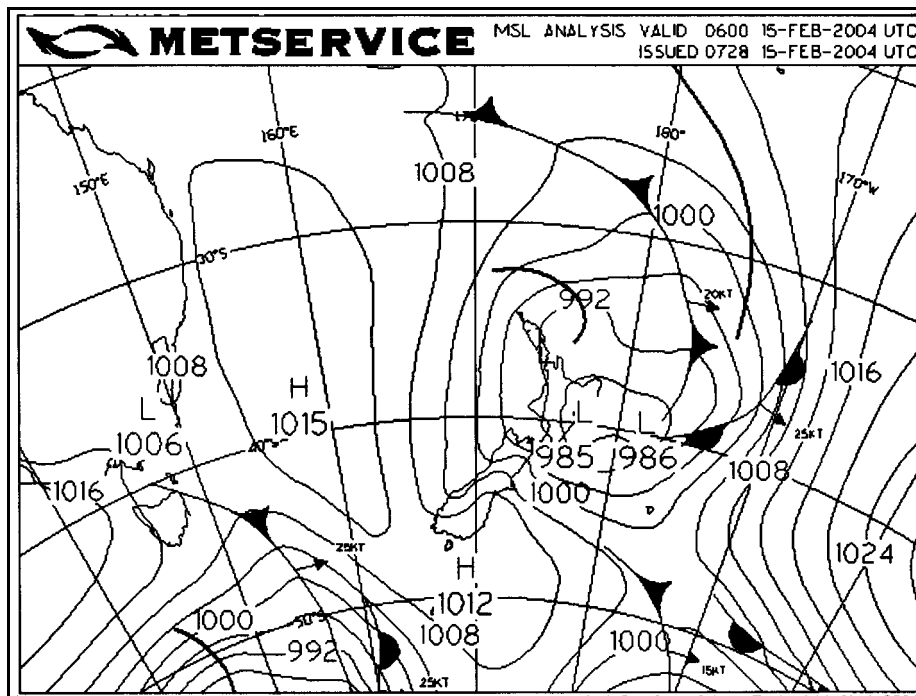
**Figure 5**  
**Mean sea level analysis synoptic chart for 1800 15 February 2004**

- **Situation.** At 6pm on 15 February 2004, a large depression was centred just east of North Island, and was intensifying. A very strong south to southeast airflow covers central New Zealand.
- **Weather conditions:** Cook Strait and the sea area south of Wellington between 3pm and 6pm  
**Wind:** Southerly, 30 to 35 knots, increasing to 35 to 40 knots  
Momentary gusts were in the range of 45 to 55 knots.  
**Sea state:** Very rough (waves 4 metres, occasionally 5.5 metres) becoming high (waves 5.5 metres, occasionally 7.5)  
**Swell:** Southerly, about 3 metres, rising  
**Combined Waves:** waves 5 metres, occasionally 7 metres, increasing to 6 metres occasionally 8 metres.

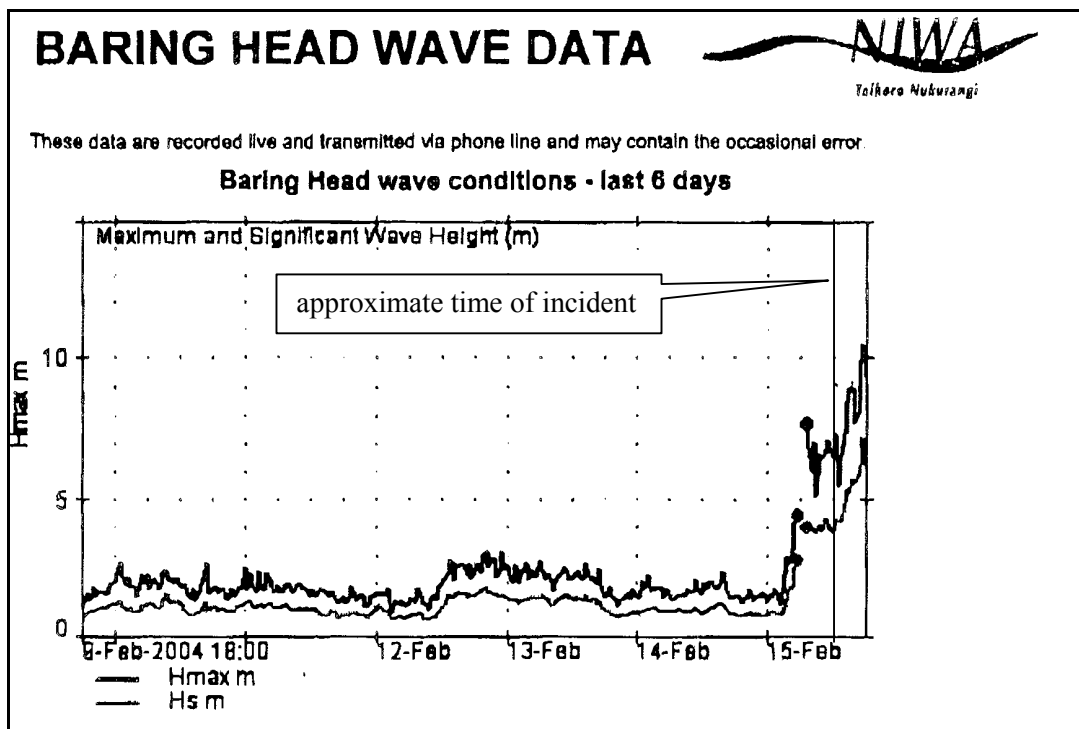
Figure 6  
Graphical representation of data obtained from Baring Head wave rider buoy

- 1.6.10 The National Institute of Water and Atmospheric research (NIWA) maintained a wave rider buoy situated off Baring Head in position 41° 21.14' S 174° 50.85'E (see Figure 1). Data from the buoy was available to the master of the *Arahura* either from The Interisland Line, Beacon Hill signal station or from the Metservice duty forecaster. Readings on the 15 February 2004 were:
