MARINE OCCURRENCE REPORT

04-211 coastal cargo vessel *Southern Tiare*, loss of rudder, off
Mahia Peninsula

4 July 2004

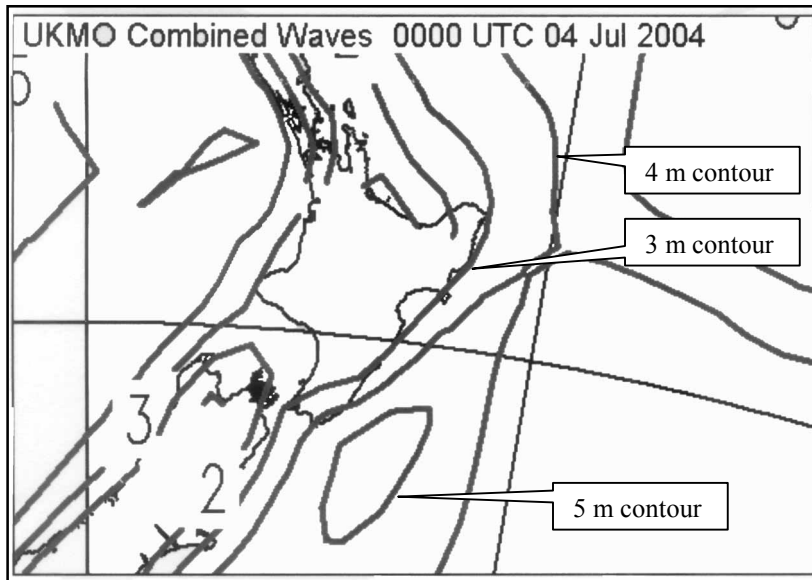
Figure 4
Combined wave height analysis valid for 1200 4 July 2004

Sea state: Beaufort state 5, Moderate, significant wave height about 2 metres and probable maximum waves 2.5 metres.
Swell: From the south, significant wave height between 1.5 to 2 metres and probable maximum 2.5 metres.
Combined waves: significant wave height 2.5 to 3 metres and probable maximum waves 3.5 metres.
Visibility: 30 kilometres.
Weather: None, partly cloudy.

1.4.5 Metservice also provided a wave height analysis for the sea, the swell and the combined sea and swell (see Figure 4).
