## MARINE OCCURRENCE REPORT

04-212 Fishing vessel *Iron Maiden*, foundering, off Pandora Bank, 16 August 2004  
Northland

### **Abstract**

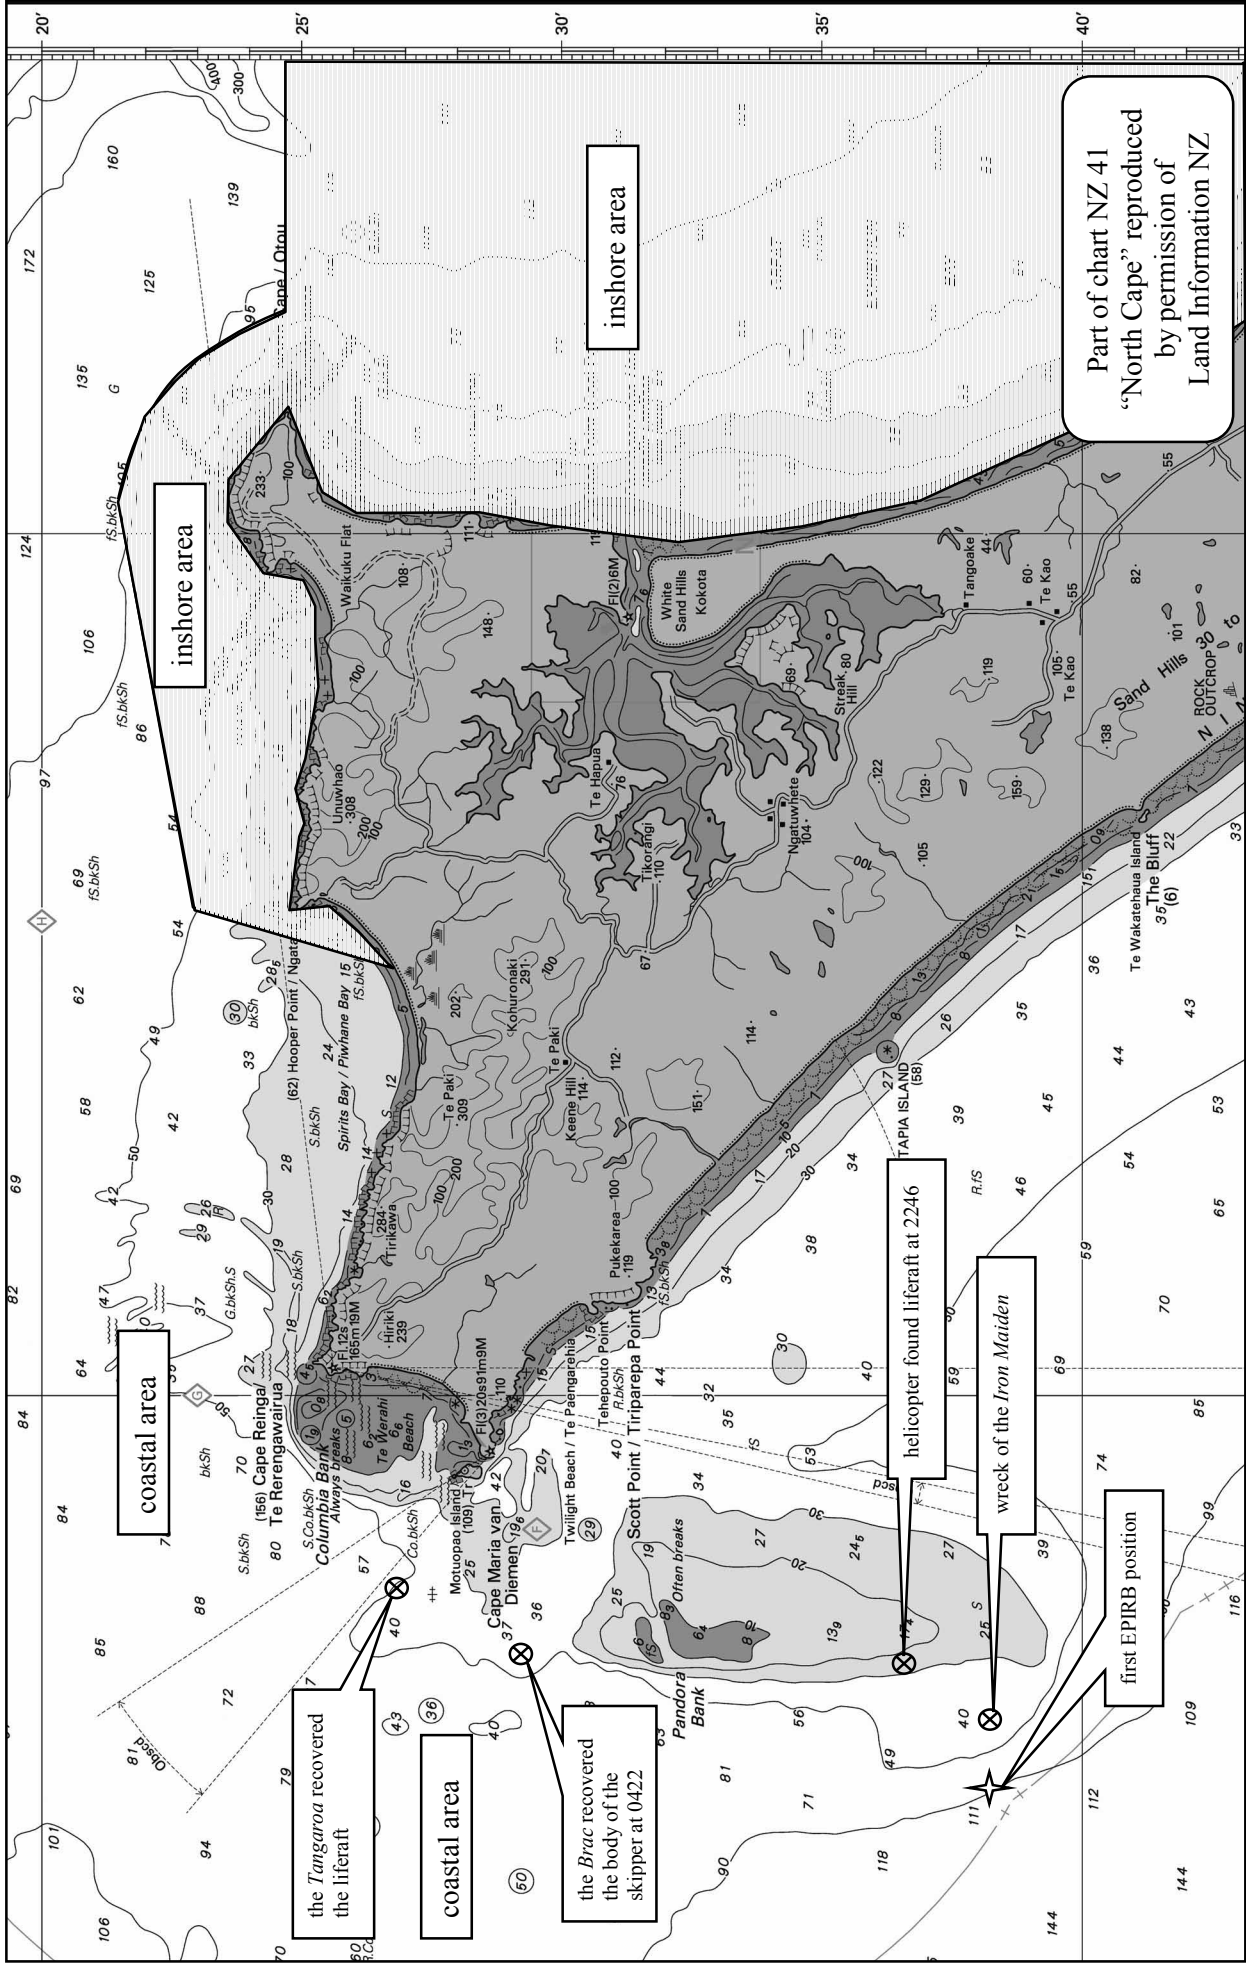
Figure 1  
 Part of chart NZ 41 North Cape

- 1.5.1 The standard of certification required for a restricted limit fishing vessel depended upon the area in which the boat was intended to operate. The intended route of the *Iron Maiden* from Mangonui to Raglan would have started in the inshore area and then crossed into the coastal area when it was abeam of Hooper Point, midway between North Cape and Cape Reinga (see Figure 1). From that position, the rest of the journey would have been in the coastal area.

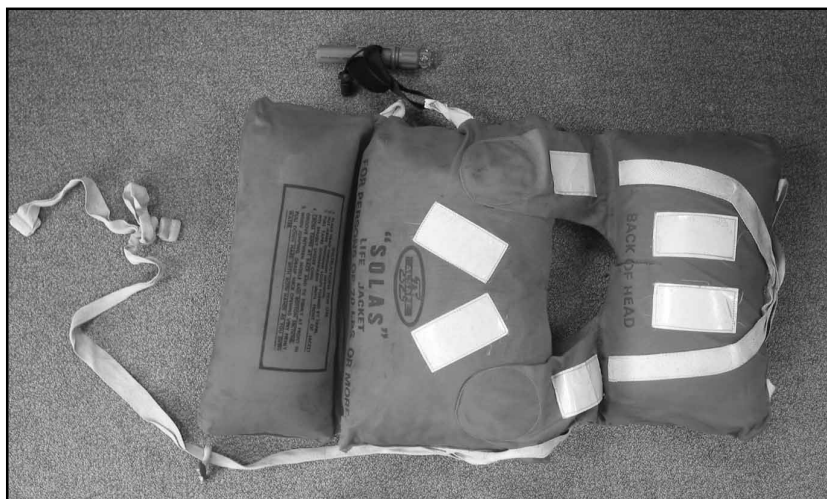
**Figure 2**  
**The lifejacket the skipper was wearing**

- 1.1.17 The Orion dropped smoke floats to guide the fishing vessel *Brac* to the position of the EPIRB. At 0422 the *Brac* located the body of the skipper of the *Iron Maiden*. He was wearing a lifejacket and had the EPIRB tied to his wrist.

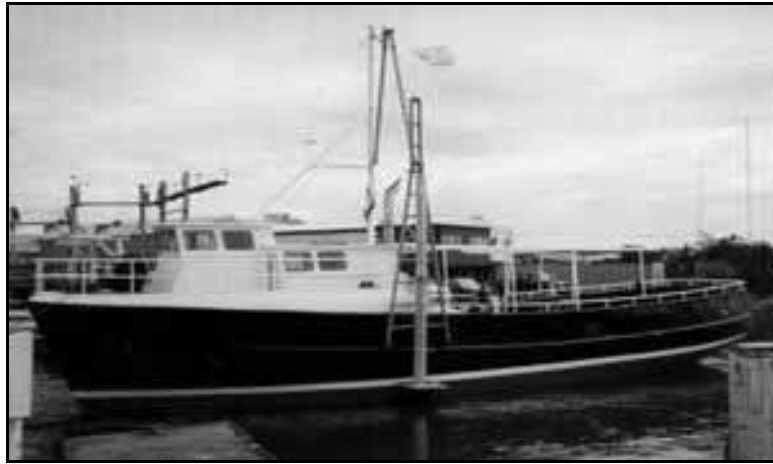
**Figure 4**

- 1.3.7 In May 2004, the owner fitted a stabiliser arm to the port side of the boat. The arm consisted of a horizontal plate, or foot, at the lower end of a solid arm, which was attached to a gantry that was horizontal when the stabiliser was deployed and vertical when stowed. When deployed, the arm and the gantry were locked in position so that the resistance on the foot produced when the boat rolled was transferred to the boat and so reduced the rate and therefore the extent of the roll.

**A stabiliser arm, in the stowed position, similar to that fitted to the *Iron Maiden***

- 1.3.8 The gantry was stowed by unlocking the arm and the gantry, and hoisting them up vertically so that the arm rested against the gantry (see Figure 4). The immediate past skipper of the *Iron Maiden* said that once stowed, he lifted the foot onto the upper deck where it was secured. This allowed the boat to berth port side to a wharf.
