MARINE OCCURRENCE REPORT

04-213

Restricted limits passenger ferry *Superflyte*, engine room fire,
Motuihe Channel, Hauraki Gulf

22 August 2004

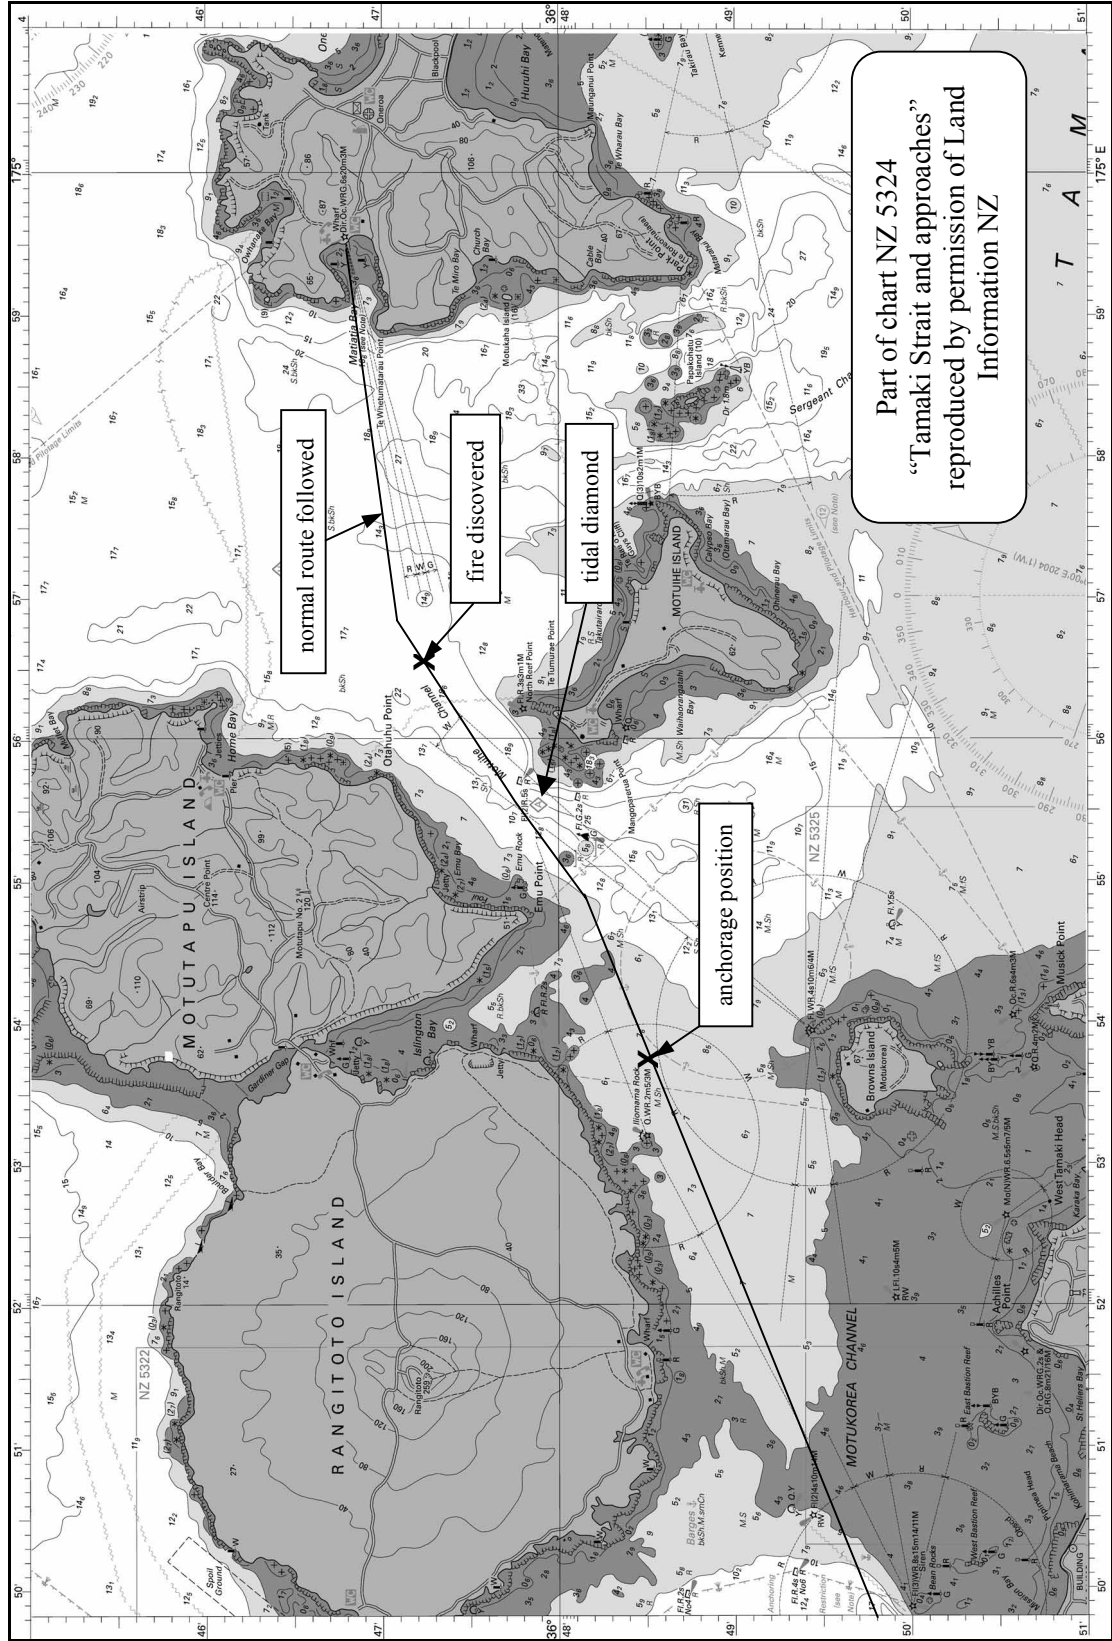
Figure 1
General area of the accident

- 1.1.12 At about 1730, when the *Superflyte* was clear of the Motuihe Channel (see Figure 1), the master lost control of the starboard engine and heard the clutch disengage as the power from the engine decreased. The master decided to anchor the vessel about 0.4 nm off Iliomama Rock beacon.

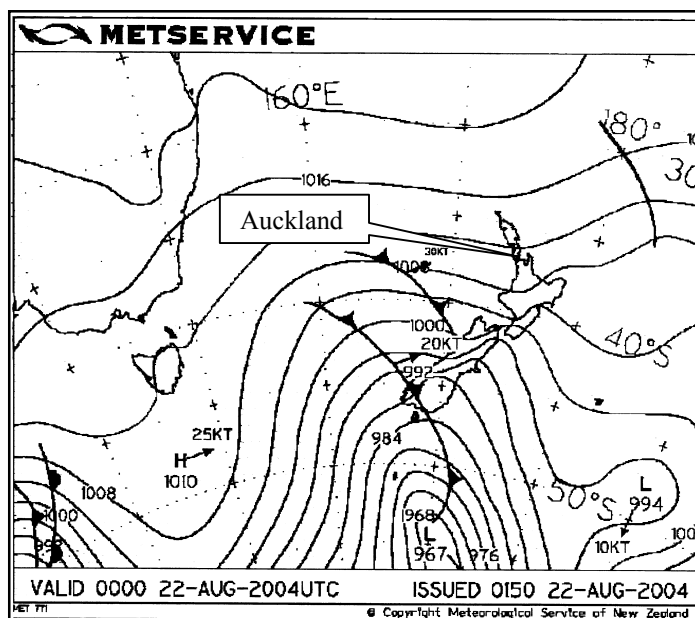
Figure 4
Mean sea level analysis synoptic chart for 1200 22 August 2004

- 1.4.1 At the time of the accident, a low was situated to the south-south-east of South Island New Zealand with a cold front leading to the north-north-west. A further cold front was ahead of this front situated from the west coast of the South Island in a north-north-westerly direction into the Tasman Sea (see Figure 4).
