## MARINE OCCURRENCE REPORT

04-214

passenger freight ferry *Aratere*, loss of mode awareness  
leading to near grounding, Tory Channel

29 September 2004

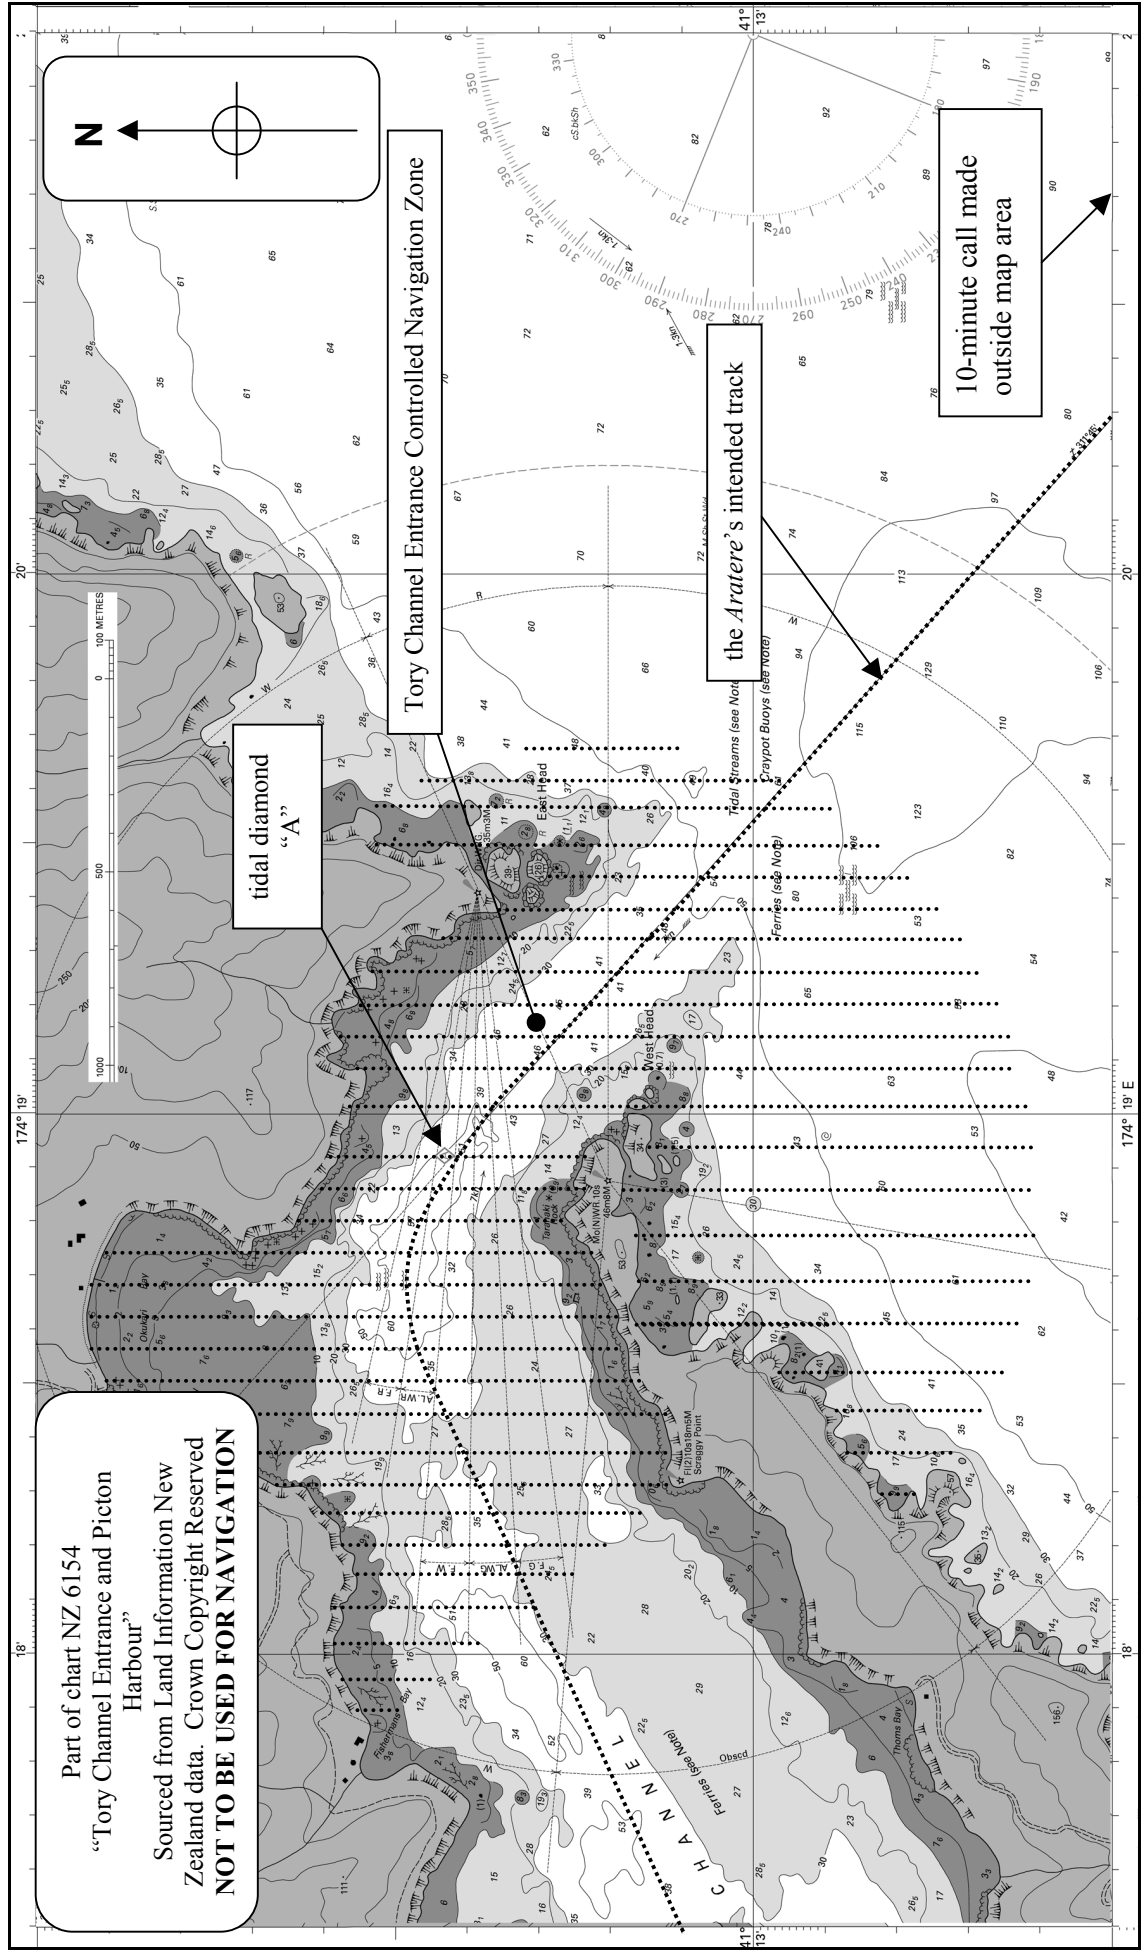
**Figure 1**  
 General area of occurrence

- 1.1.3 At about 1707, when the ship was about 10 minutes from passing East Head light, the mate made an “all ships” call on the very high frequency (VHF) radio, channels 16 and 19, advising that the *Aratere* would be transiting Tory Channel Entrance Controlled Navigation Zone (see Figure 1). After making the call, the mate called the master to the bridge.

1.4.2 Opposite the entrance to Tory Channel from Cook Strait, Okukari and Whekenui Bays lie directly ahead of ships entering. In the bays the bottom is relatively flat and gently shelving towards the land with no obstructions shown on the chart (see Figure 1).

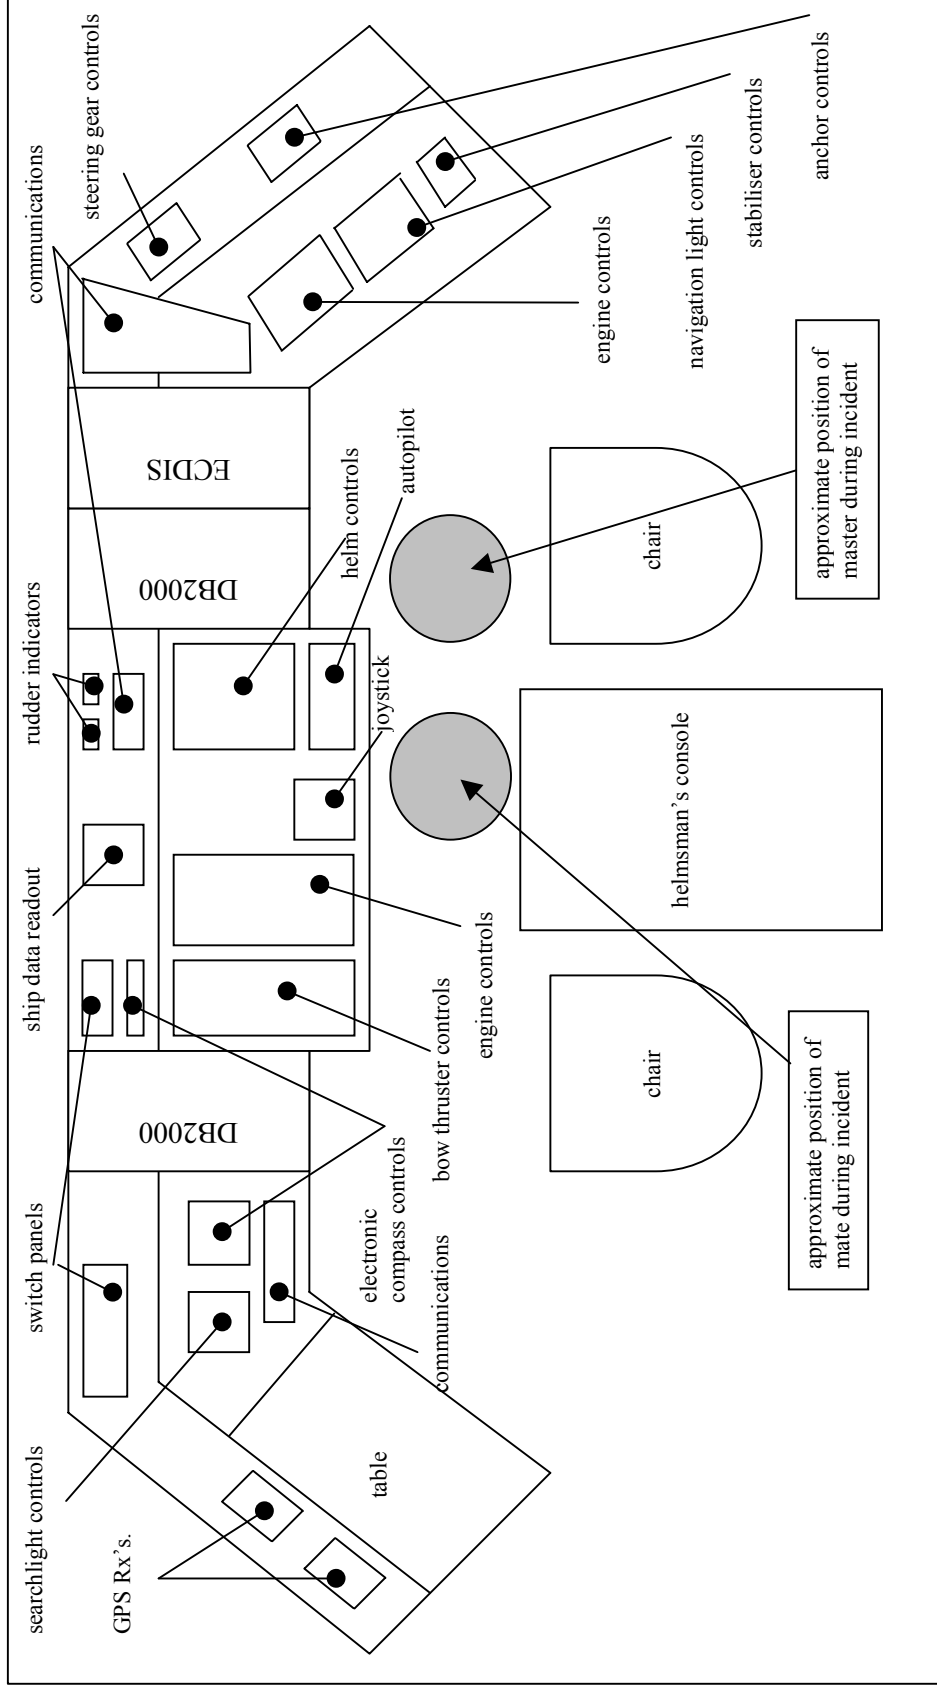
**Figure 3**  
**Diagram of the layout of the central console on board the Aratere**

- 1.1.5 Shortly after the mate had changed to enclosed waters mode, the master arrived on the bridge and positioned himself at the bridge console between the electronic chart display and information system (ECDIS) and the starboard radar (see Figure 3). The master did not take the con because, as he stated later, he was satisfied that the mate, who held a pilotage exemption for Picton, could continue to Picton.

- 1.2.5 The main console (see Figure 3) was also fitted with:
- 2 DB2000 automatic radar plotting aid (ARPA) radars that could be linked into the ECDIS
  - 2 differential global positioning system (DGPS) receivers
  - gyro compass controls
  - medium-frequency radio communication equipment
  - high-frequency radio communication equipment
  - digital selective calling
  - one AP2000 autopilot
  - steering motor controls
  - stabiliser fin controls
  - navigation light controls
  - anchoring controls.

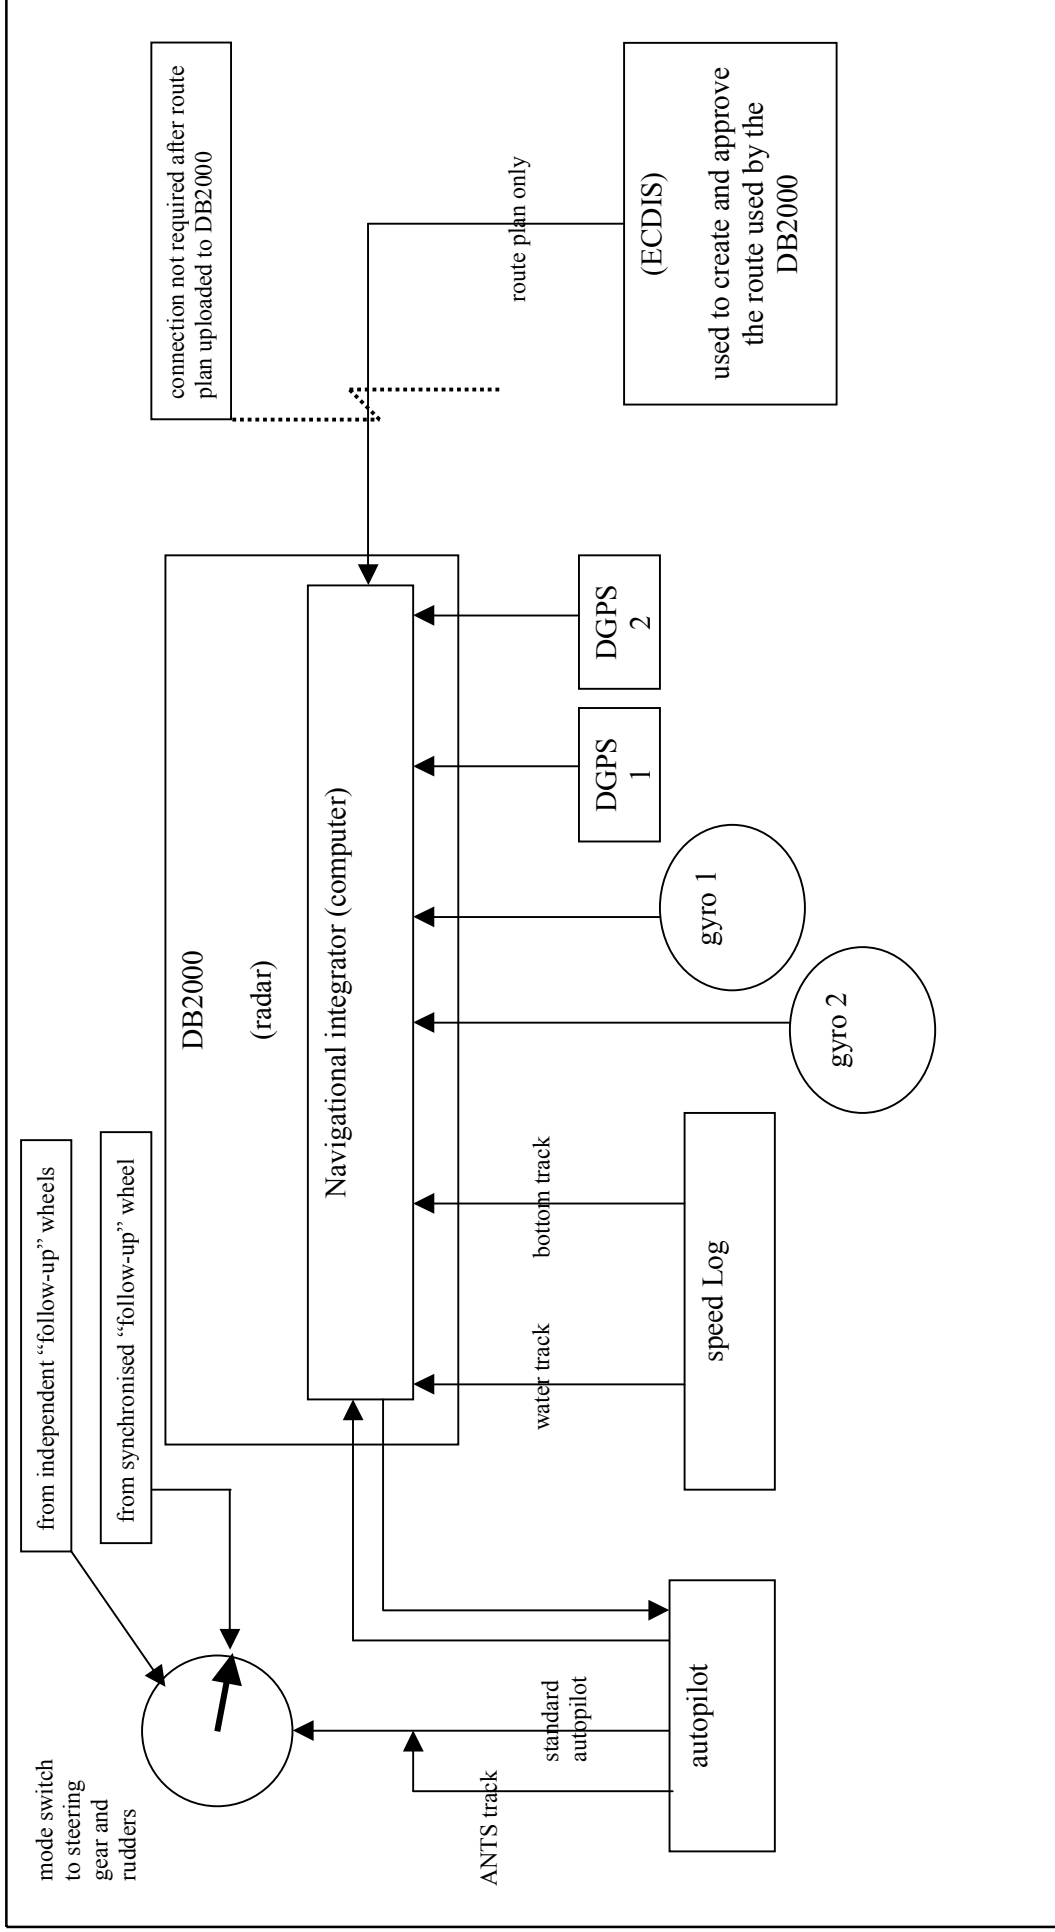
**Figure 4**  
**Schematic diagram of the DB2000 and autopilot interfaces**

- 1.3.10 The AP2000 was an adaptive autopilot with track keeping functions connected to the main DB2000 computer, a magnetic compass and a distribution unit. The distribution unit provided connections for feedback from the rudders, connections to the steering gear and to external alarms.
- 1.3.11 The DB2000 was an ARPA radar system that also provided the computing power for the integration of the external sensors such as differential global positioning system (DGPS), Doppler log, Loran C, radar, gyro compass, and transmitting magnetic compass with the uploaded track information.

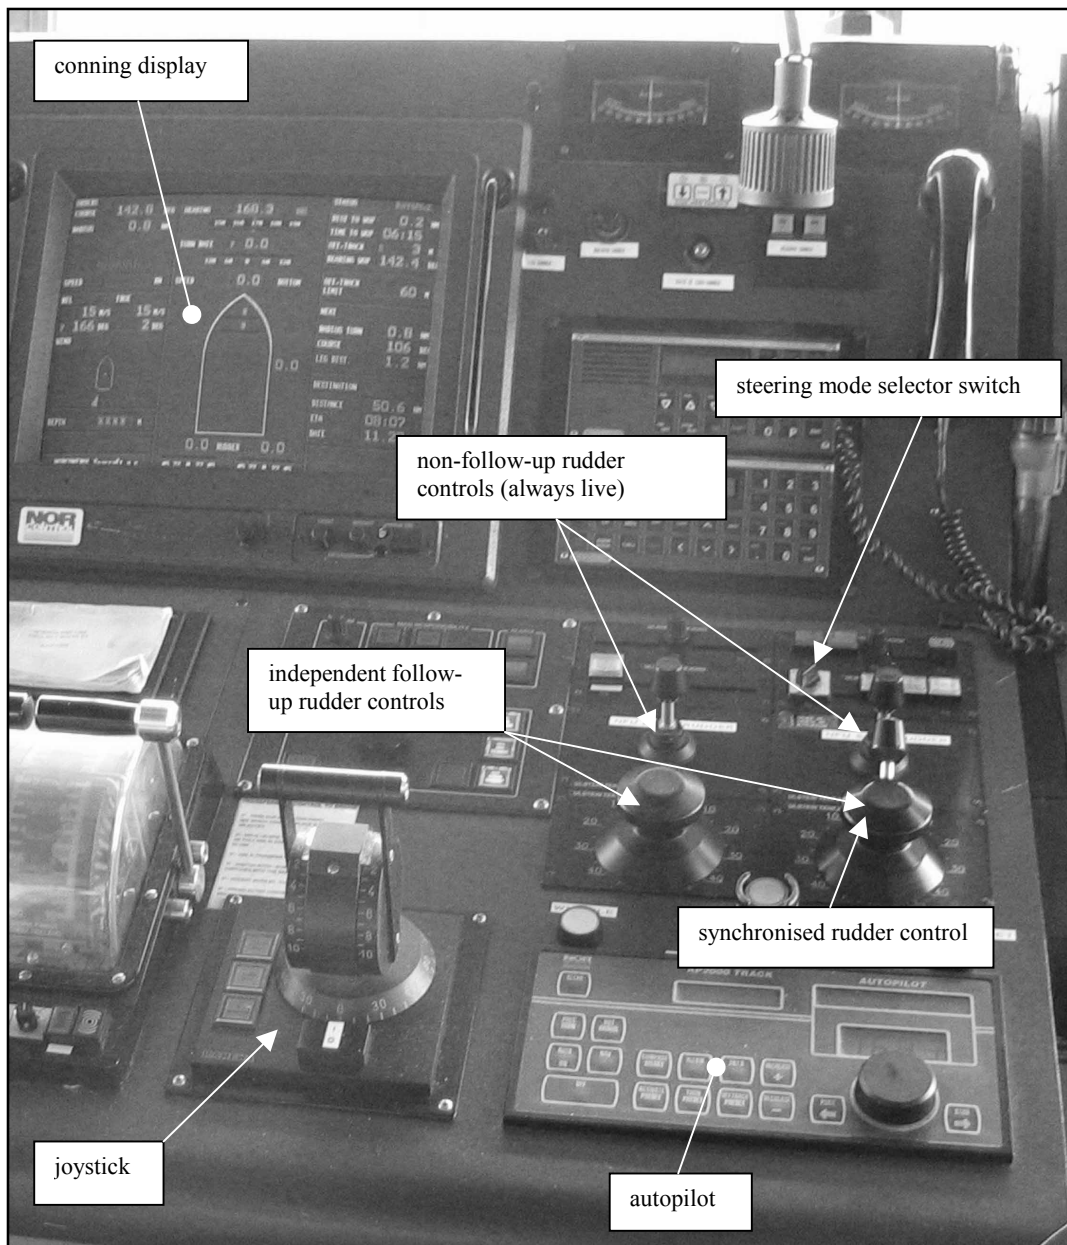
**Figure 7**  
**Steering selection controls**

1.3.15 Once autopilot was selected on the steering panel of the main console, pressing the “sail” button once on the DB2000 (see Figure 5) selected inter-waypoint mode, and pressing the “sail” button twice selected the track following mode.
