MARINE OCCURRENCE REPORT

04-219

restricted limit passenger vessel *Tiger 111*, grounding, Cape Brett

18 December 2004

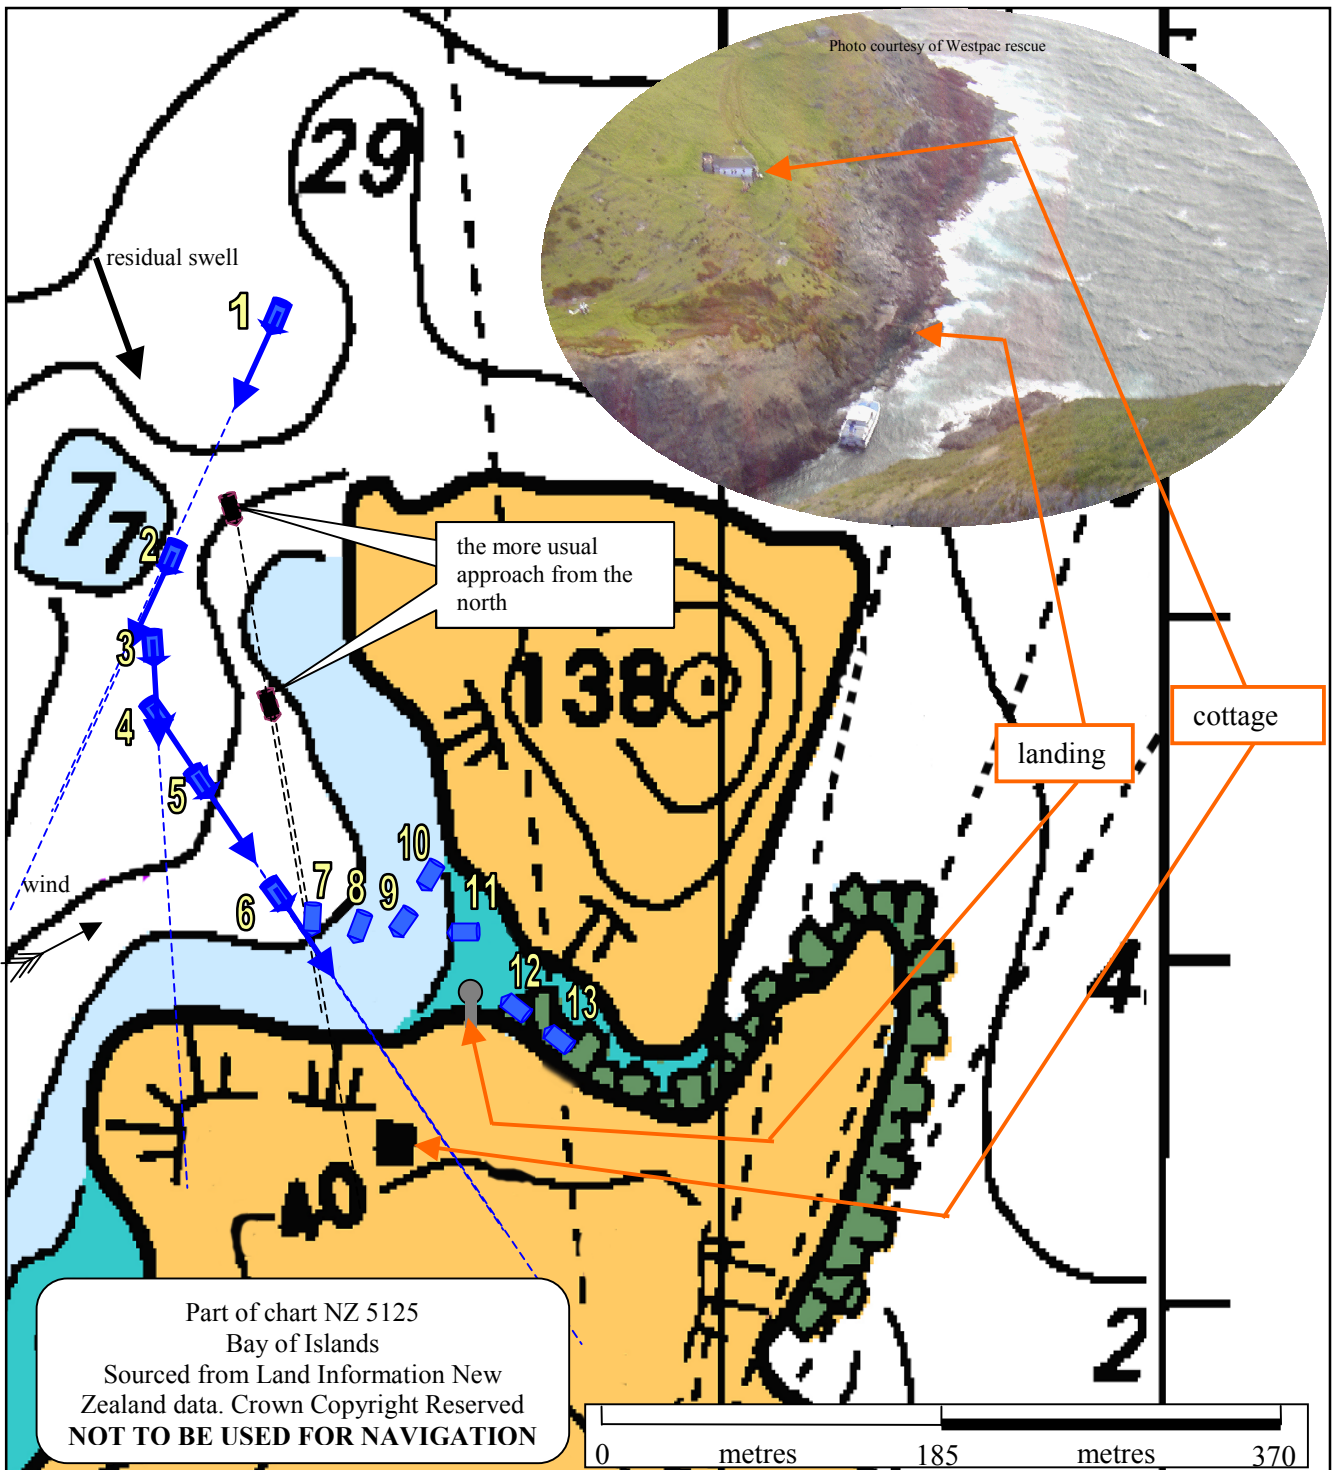
Figure 2
Part of chart NZ 5125 showing probable grounding sequence of the *Tiger III*

- 1.1.7 As they headed into the bay the Master said that he was a bit further to the south than he would normally have been, so he steered a course slightly to the left of the lighthouse keeper's cottage (see Figure 2). The trip from the Hole had been at cruising speed of about 20 knots, so as they entered the bay the Master had progressively pulled the throttles back to neutral (see Figure 2 position 4). Soon after, at a distance estimated by the Master of about 8 boat lengths or 160 m from the shore (see Figure 2 position 5), he applied some port helm and put the port engine astern. As he was doing this, a swell hit the stern, pushing the boat forward.

- 1.1.9 About 20 seconds later (see Figure 2 position 6), the Master, who was still describing Cape Brett and the lighthouse to the passengers, noticed that the boat was not turning to port as he expected it to; rather it was heading straight for the rocky shore ahead. Checking the engine readouts, he saw that the port engine was indicating 500 revolutions per minute (RPM), much less than he expected for the throttle setting he had applied. He pulled the port engine throttle further astern without any noticeable increase in RPM. At this point the Master assumed that the port engine had stalled.

1.1.10 By this time the boat was closing rapidly with the rocks, so the Master put the starboard engine astern to prevent the boat grounding ahead. The astern movement stopped the boat about 40 m from the shore, but it also screwed the stern to port, leaving the boat across the bay and across the wind and sea coming into the bay (see Figure 2 positions 7 and 8). He kept the starboard engine running astern to increase the distance between the bow and the rocks.

- 1.1.13 When the *Dolphin Seeker* arrived in the bay, about 3 or 4 minutes after the radio call, its Master found the *Tiger III* in line with the gut and a little way from the shore. That Master decided to turn the *Dolphin Seeker* and reverse towards the *Tiger III*. A tow rope was passed from the stern of the *Dolphin Seeker* to the starboard bow of the *Tiger III*. As the weight started to come on the towline, the *Dolphin Seeker* was set towards the rocks on the southern side of the bay. To prevent it grounding, the Master applied full ahead power on his port engine and astern power on the starboard engine; this turned his boat away from the rocks, but in the process the port propeller touched a rock, causing minor damage to that propeller. The power was too much for the towline, which parted. Rather than turning the *Tiger III* to starboard as might have been expected, the weight on the towline had caused the boat to sheer towards the rocks on the landing side of the gut where it grounded. The *Dolphin Seeker* was unable to again approach close enough to give any further assistance (see Figure 2 position 11).

- 1.1.15 The *Tiger III* continued to be pushed into the gut and with the bow aground on the rocks the boat swung so that it was parallel to the coast. The sea continued to push the boat into the gut and pound it on the bottom (see Figure 2 positions 12 and 13). The crew managed to jump ashore and secure some mooring lines to the rocks to keep the boat alongside the shore. The Master endeavoured to manoeuvre the boat using the starboard engine, but when it was in the gut the starboard engine stalled, probably due to the propeller hitting a rock.

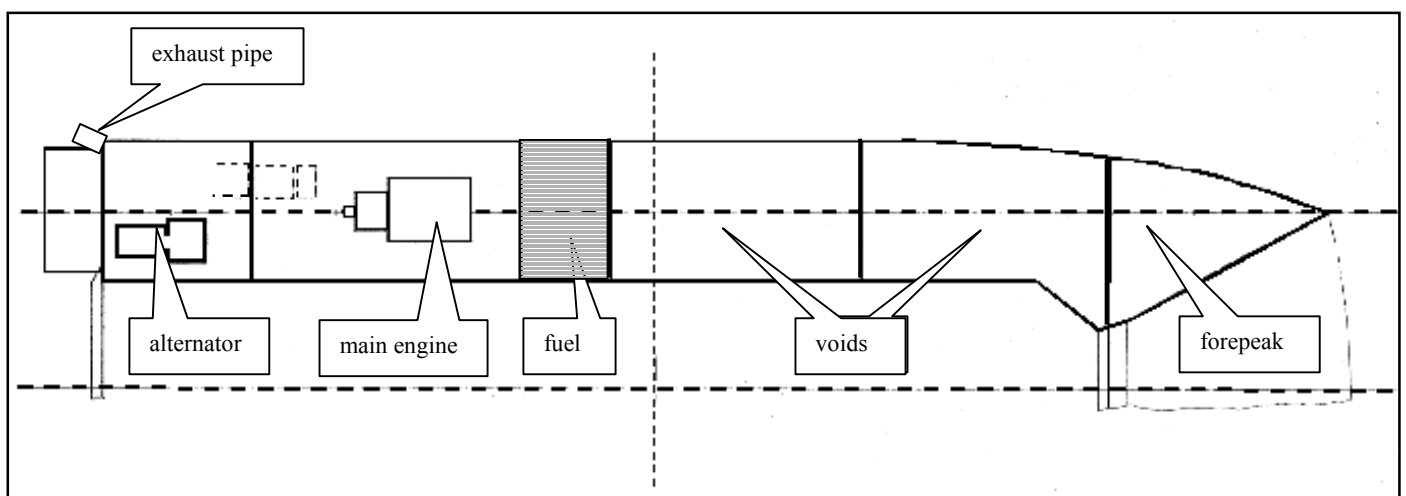
Figure 3
Line diagram of the port hull

- 1.3.2 The boat had 2 fuel tanks, one in the port hull (see Figure 3) and the other in the starboard hull, situated in the compartment immediately forward of the engine room. The starboard tank supplied the starboard engine, and the port tank supplied the port engine and the auxiliary alternator engine. On the outlet side of each of the fuel tanks there was a remote solenoid-operated fuel cut-off valve. From that valve, flexible hoses fed the fuel to a common inlet rail connected to which were 2 Racor primary filters that were mounted on the forward engine room bulkhead. The Racor filters had valves that allowed one or other or both filters to be used at any one time. However, it was usual practice for only one Racor filter to be used at a time, with the other being on stand-by. When the maintenance period was reached or if the in-use filter became blocked, the crew or maintenance staff could quickly switch to the stand-by filter while the other was changed. At the time of the grounding the port engine inboard Racor filter was in use and the outboard one was isolated.

- the port outboard Racor filter was found to be full of clean diesel fuel
- the port inboard Racor filter was found to contain seawater with about 15 mm of diesel fuel on top

- 1.3.19 The exhaust pipes were only a short distance above the seawater level and extended from the corner where the transom met the side plating at a horizontal angle of about 15° to the fore and aft line (see Figure 3). At the time the Master put the port engine astern, a swell struck the stern of the boat, pushing the boat ahead and possibly forcing seawater into the exhaust pipe.

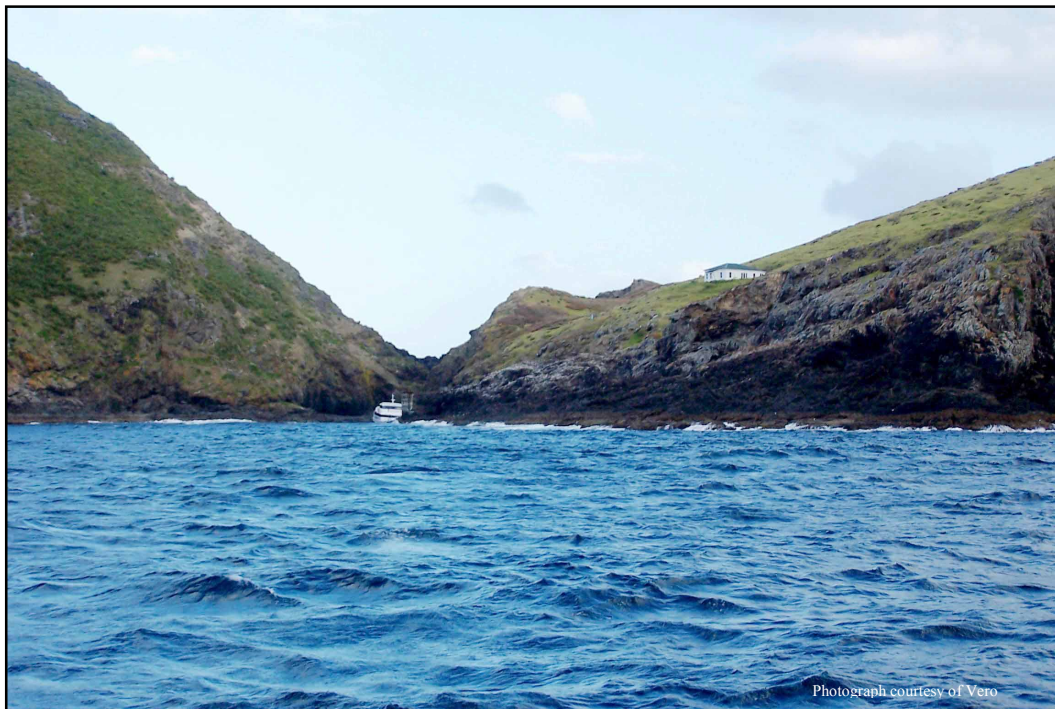
Figure 9
The landing from seaward

1.8.2 Otuwanga Island and Cape Brett on the mainland are separated by a narrow cleft or gut that runs virtually east to west. This gut is navigable by small vessels. The topography of the area is very steep with cliffs on both the Cape and the Island. The bay on the western side is relatively open but narrows rapidly towards the gut. The coast around the bay is very rugged with jagged rocks close to the shore (see Figure 9), however there were no reports of any isolated rocks in the deeper water away from the coast in an area frequently used by many boats for a number of years.

- 1.8.5 During the morning cruise on the day of the accident, the Master decided that the conditions were too rough at the landing and had chosen to pass the area without stopping. In the afternoon the Master was also considering bypassing the landing but at the last moment decided that the sea had eased enough for him to go in. Because of his late decision, his approach towards the landing was more acute than it would normally be and the boat was travelling slightly faster than normal.
