AVIATION OCCURRENCE REPORT

05-008

Cessna U206G, ZK-WWH, loss of control on take-off,
Queenstown Aerodrome

10 August 2005

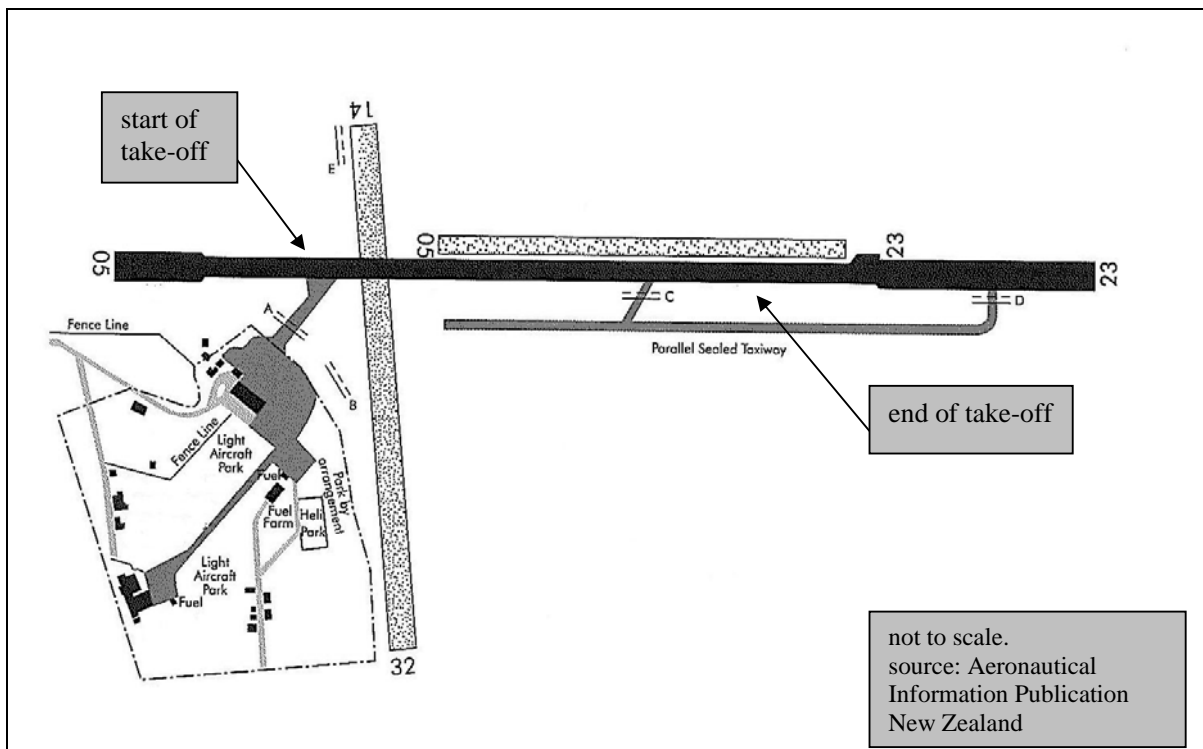
Figure 1
Queenstown Aerodrome plan

- 1.1.10 The 3 aircraft taxied at about the same time. The duty aerodrome controller (the controller) cleared all 3 aircraft to line up on runway 05 at the intersection with taxiway A (see Figure 1). The use of multiple line-ups was an air traffic control (ATC) procedure that was often used at Queenstown when many VFR light aircraft departed in a stream. ZK-TFW was lined up first, just to the left of the runway centreline. ZK-WWH was behind, near the left side of the runway, and the Islander was further back, right of the runway centreline.
