MARINE OCCURRENCE REPORT

05-202 and 05-204 passenger freight ferry *Aratere*, steering malfunctions,
Wellington Harbour and Queen Charlotte Sound,

9 February and
20 February 2005

TRANSPORT ACCIDENT INVESTIGATION COMMISSION
NEW ZEALAND

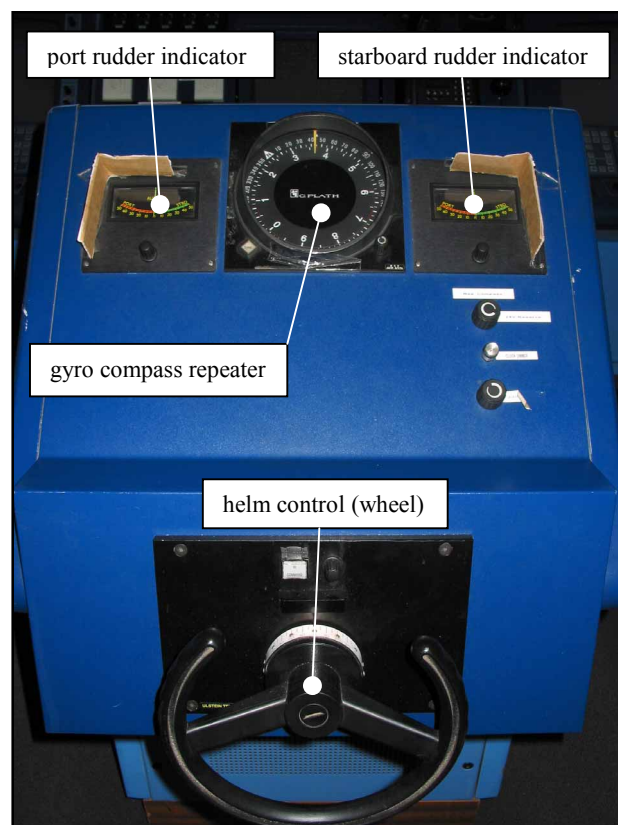
Figure 5
Helmsman's console

- 1.2.6 The helmsman steered the ship, when in pilotage and other congested or difficult waters, under the command of the Master or the officer of the watch. He steered the ship from the helmsman's console located aft of the main console on the bridge. This console was equipped with compass repeater, helm control [wheel] and 2 analogue rudder indicators, one each for the port and starboard rudders (see Figure 5). The illumination on the console could be dimmed so as to prevent glare for the helmsman and other bridge team members.

- 1.2.7 At the time of the Wellington Harbour incident the helmsman was steering the *Aratere* using both visual references through the windows at the front of the bridge, and the compass. Out of choice the helmsman tended to use the compass repeater located above the bridge front windows. The lighting on the console had been dimmed so as not to overly distract his attention, with the starboard rudder indicator brighter than the port indicator. The helmsman stated later that he used the starboard indicator for reference, although both were readable, as it was confusing trying to look at both at the same time.
