## MARINE OCCURRENCE REPORT

05-206

passenger freight ferry *Arahura*, loss of propulsion, Cook Strait

24 April 2005

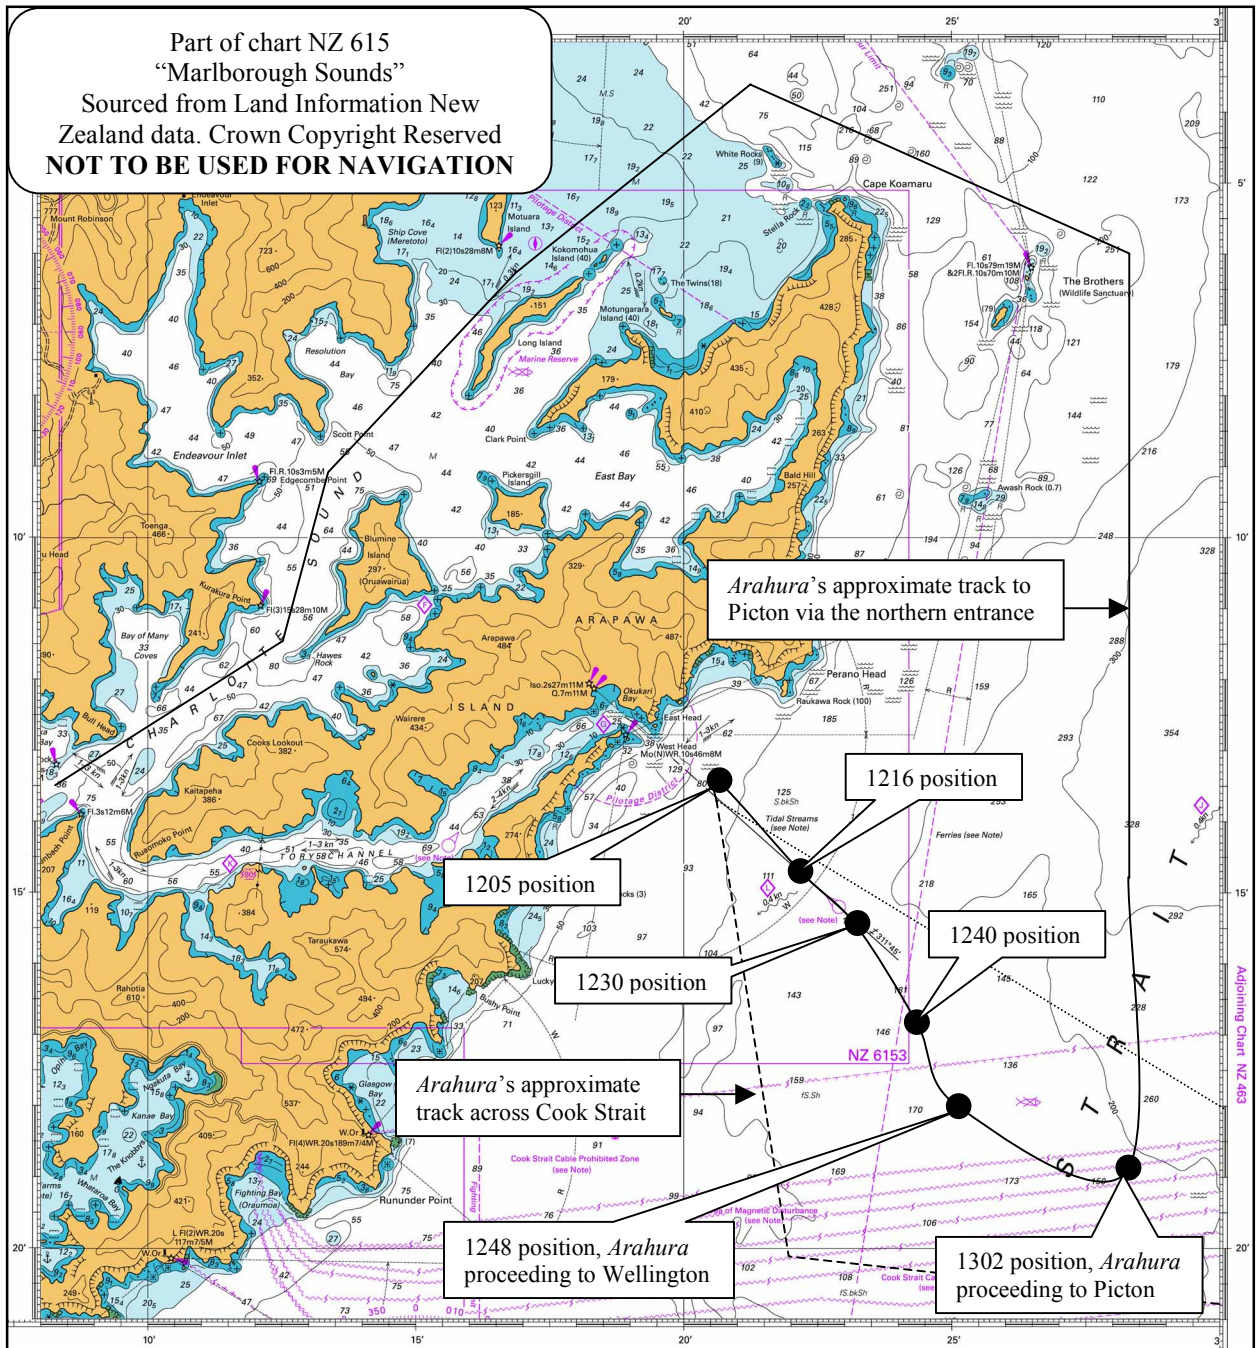
**Figure 1**  
**General area of the incident**

- 1.1.3 At about 1012, the *Arahura* cleared Wellington Harbour entrance and the Master decided to take a more southerly route than usual (see Figure 1), as was normal under such weather conditions. Such a course kept the swell on the port bow until the ship's course could be altered to make Tory Channel entrance with the swell abaft the beam.

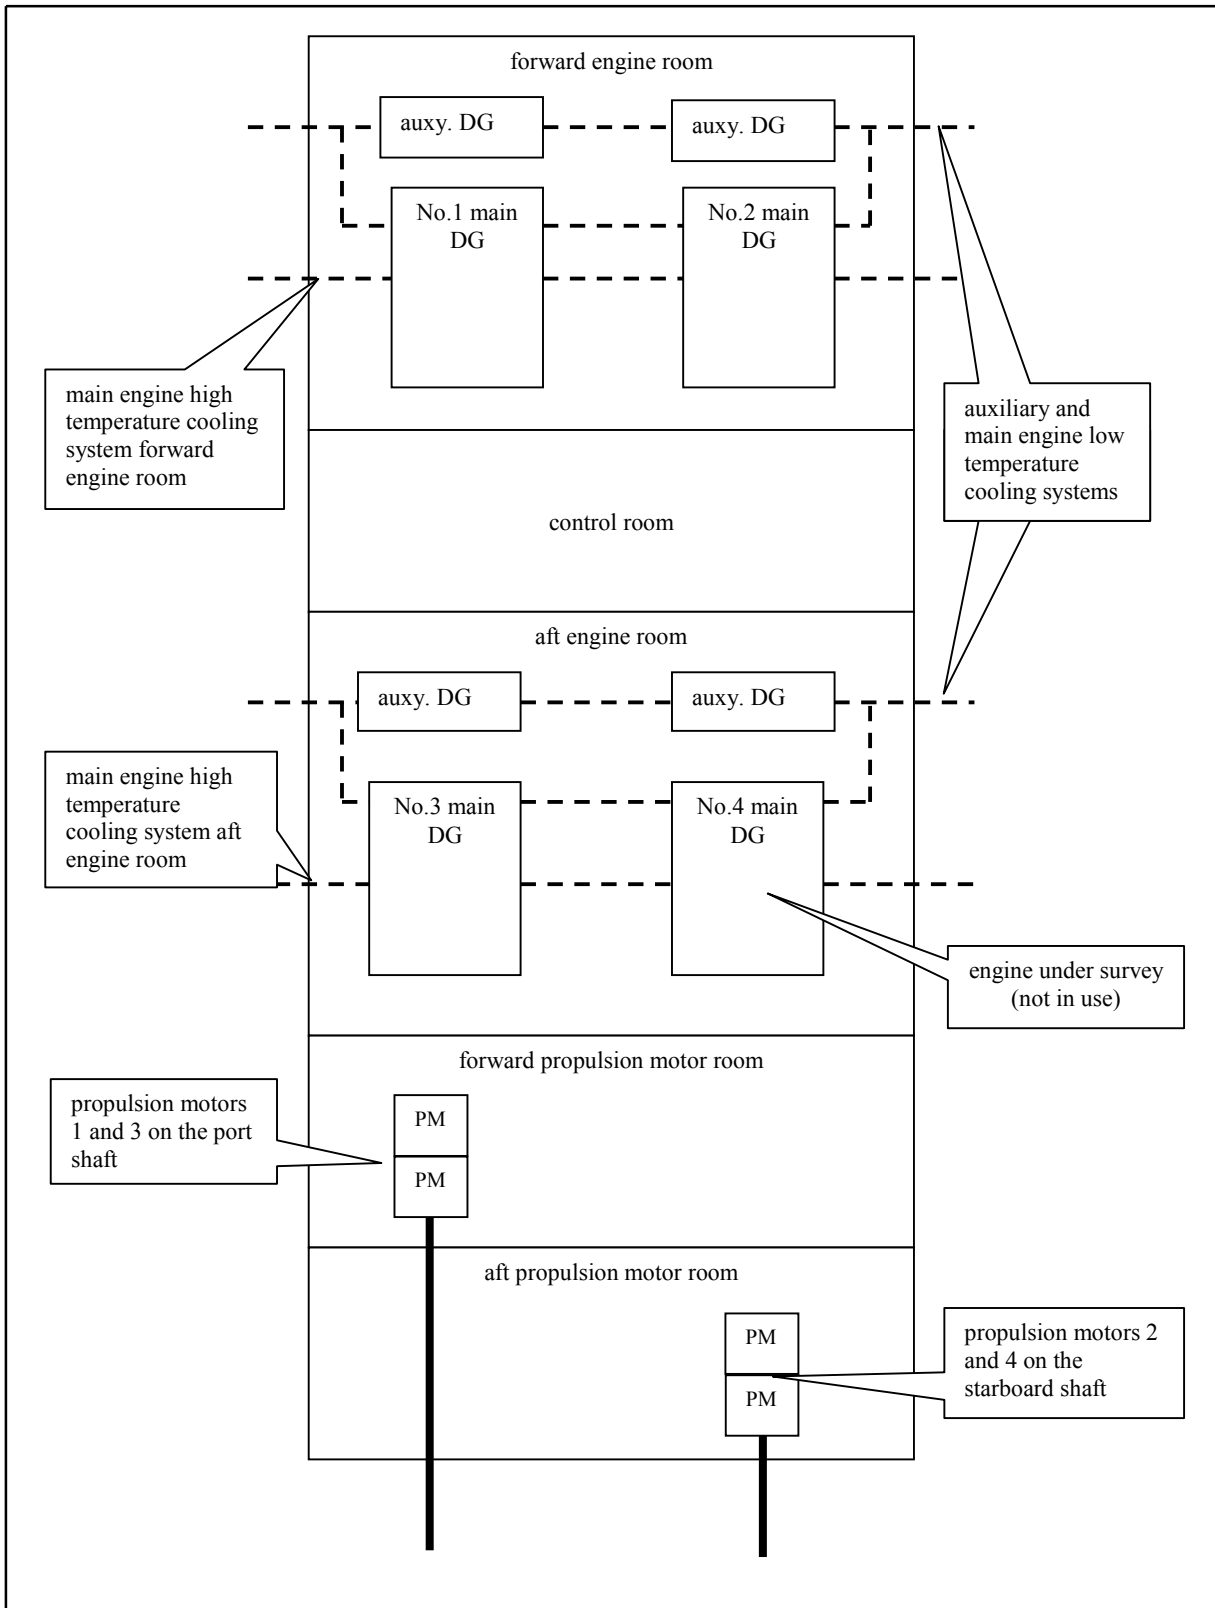
**Figure 2**  
**Diagram of the *Arahura*'s machinery space layout (not to scale)**

- 1.1.9 During stand by, the duty engineer was required to remain in the control room (see Figure 2) so he was unable to go to the forward engine room to inspect No.1 diesel generator. The duty engineer therefore telephoned the Chief Engineer and advised him of the problem. The Chief Engineer started to make his way to the engine room from the accommodation. The duty engineer then advised the navigating bridge team by telephone that he was experiencing problems in the engine room, and recommended that the ship not enter Tory Channel until the problems were resolved.

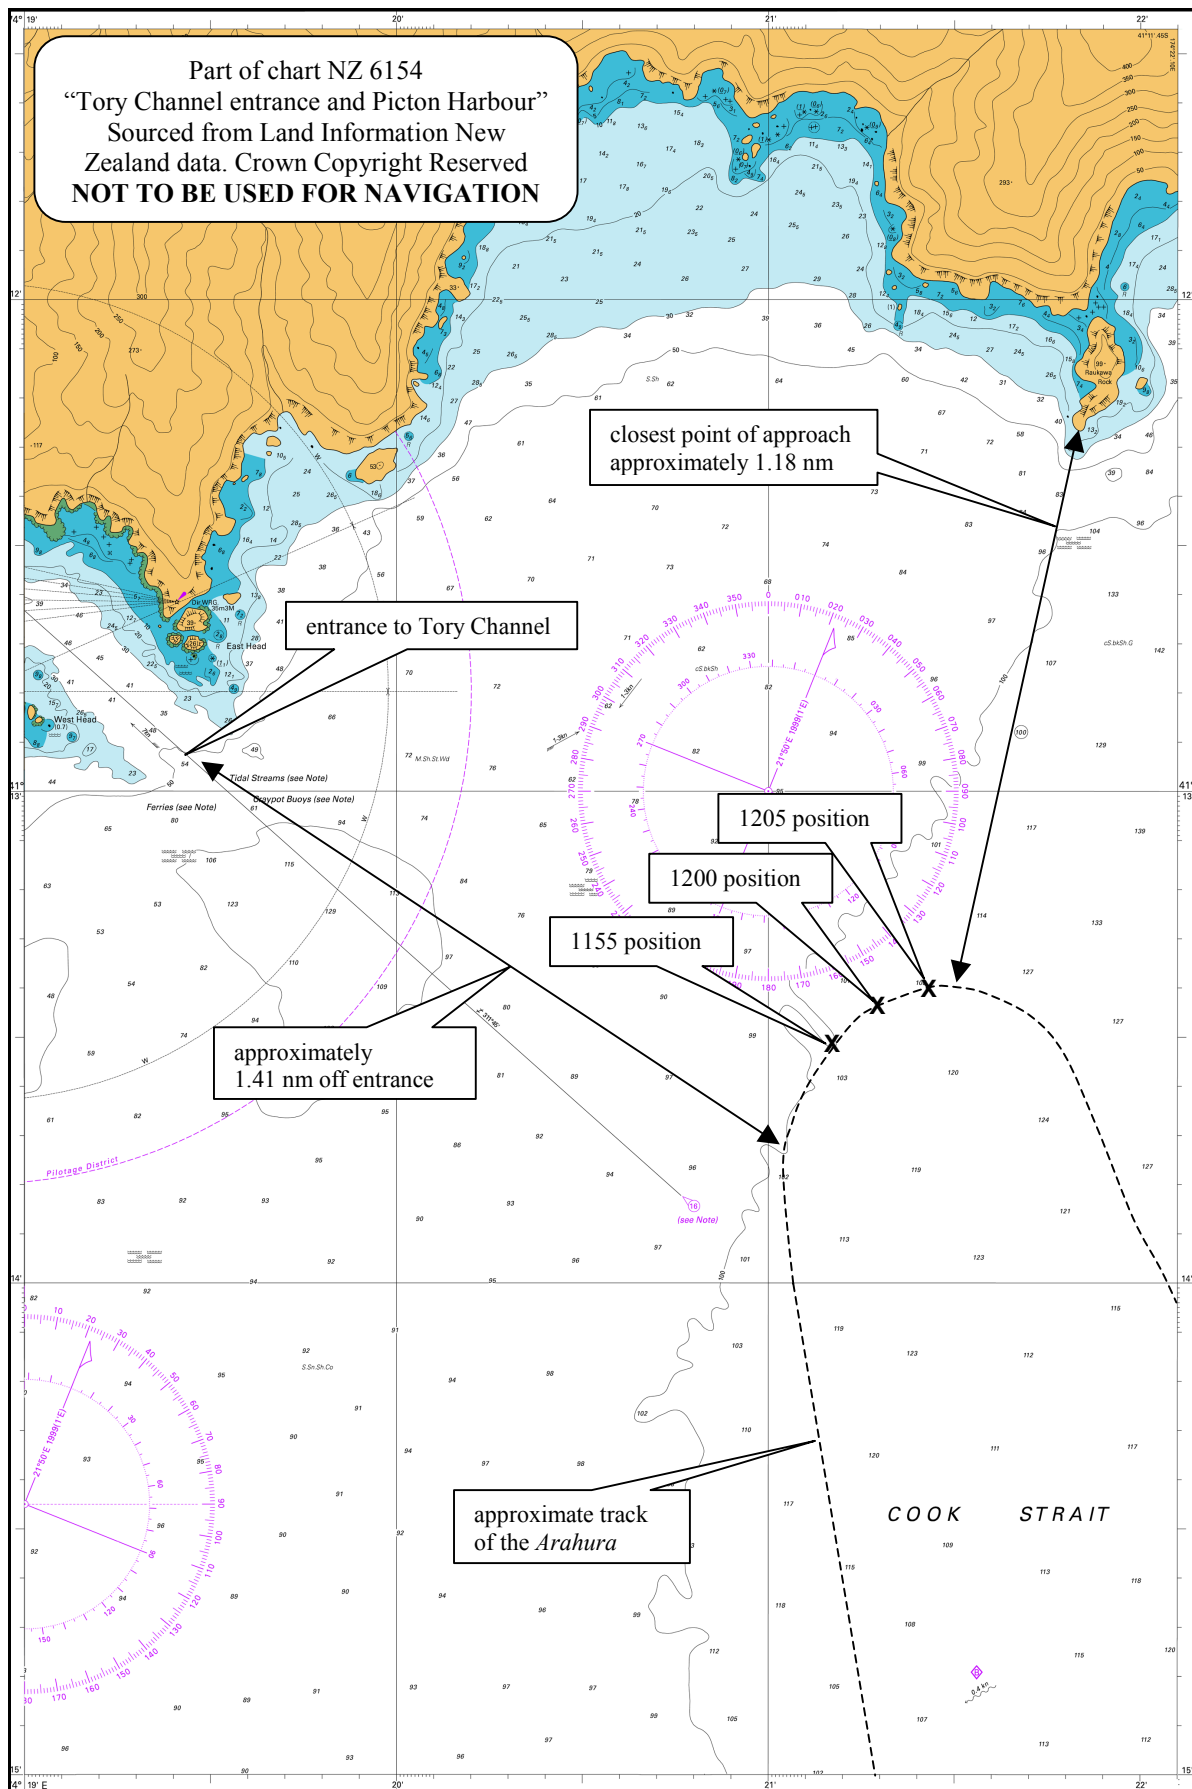
**Figure 3**  
**The *Arahura*'s track and closest point of approach during the incident**

- 1.3.1 At about 1152, the bridge team noted that the propulsion motors had stopped. The Master ordered that the anchors be cleared ready for use and, using the remaining headway, continued to con the ship away from the coast.
- 1.3.2 At about 1155 (see Figure 3), the Master informed Interislander's Operations Manager and the Interislander ferry *Aratere*, which was in the vicinity, of the situation. At about 1157, after reassessing the situation, the Master issued an urgency message on VHF radio channel 16. This message was received by Maritime Radio and relayed to the Rescue Co-ordination Centre. The *Aratere* was asked to stand by to render assistance if necessary.
