## M A R I N E   O C C U R R E N C E   R E P O R T

05-210      restricted limit passenger vessel *Milford Mariner*, engines' stall      18 September 2005  
resulting in grounding, Harrison Cove, Milford Sound

## **Report 05-210**

**restricted limit passenger vessel  
*Milford Mariner***

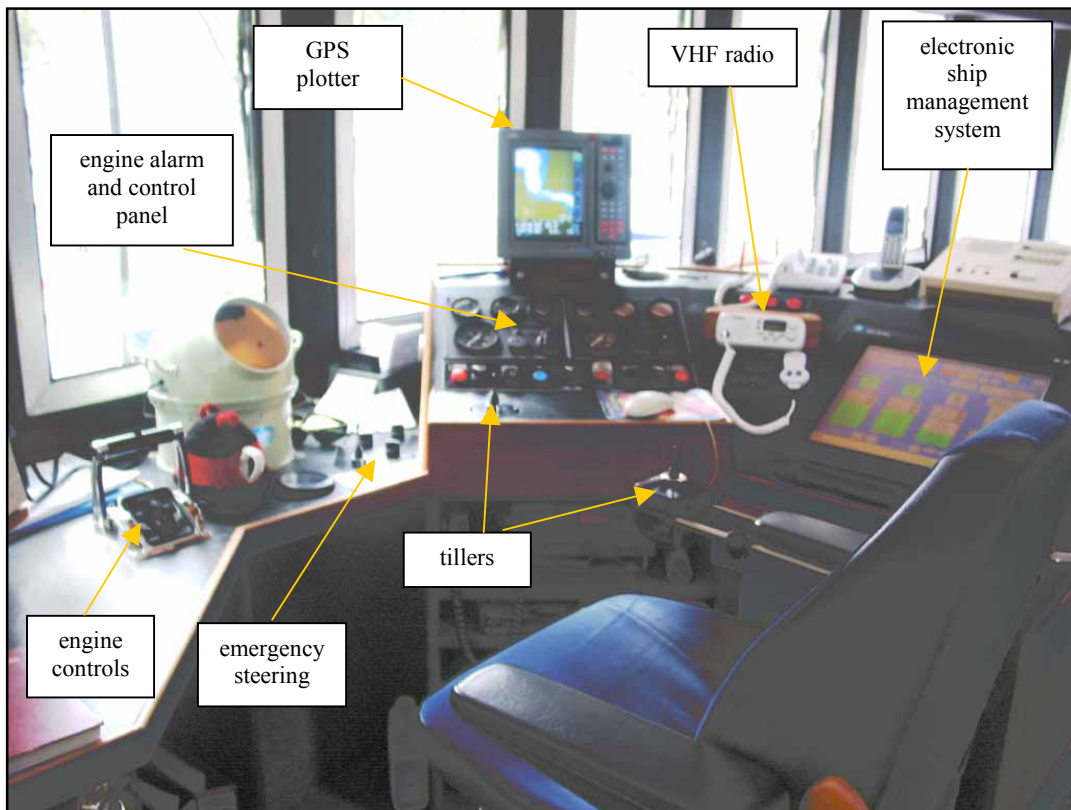
**Figure 2**  
**The central control station**

- 1.2.4 The Master usually conned the ship from the central, cockpit-style steering position (see Figure 2), which had the main controls within easy reach. The ship was fitted with the following navigation equipment:

- a Si-Tex Mariner very high frequency (VHF) radio.
- 1.2.5 The cockpit style of the central control console required that the person steering the ship sat in the chair, so it was usual for the helmsman to operate all the main controls, including the engines and other equipment. In addition to the central console, there were control stations on the port and starboard sides of the bridge.

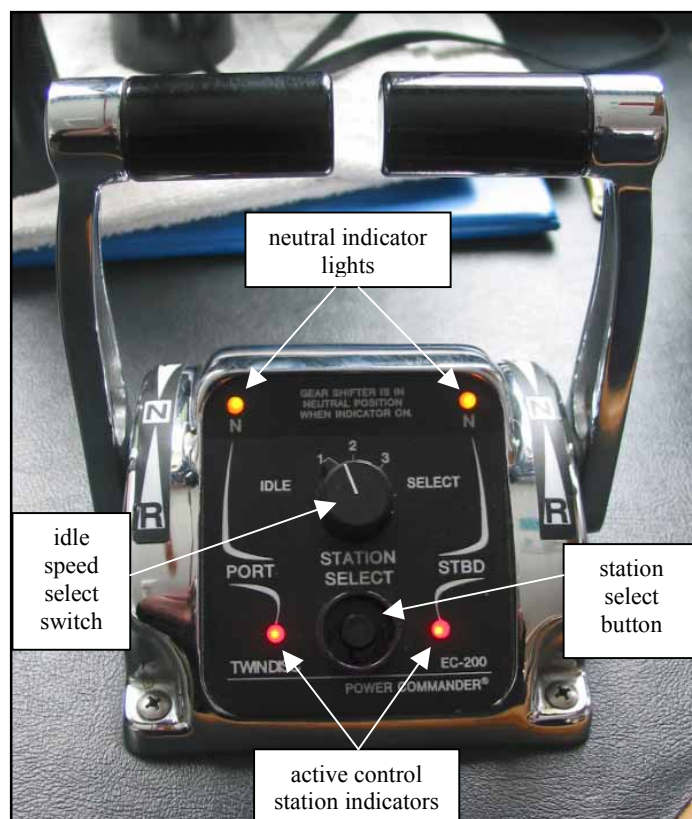
**Figure 3**  
**Engine control, with indicator lights showing it is active and both levers are in neutral**

- 1.2.6 The engine control was a Commander EC 200 manufactured by Twin Disc Incorporated that used a single lever to control both the throttle and transmission of each engine. The Commander EC 200 control system was a combination of electronic and cable control. The 3 bridge control heads were electrically linked and they controlled 2 electronic control units (ECUs), one for each engine, situated in the engine room. The ECUs were linked by cables to the engine and transmission actuators. Only one of the 3 control heads could be active at any one time. A red indicator light on each head unit showed when that station was active (see Figure 3). A yellow light indicated when neutral was selected. An idle speed switch allowed selection of 3 different idle speeds, a useful function when manoeuvring in close situations where selective increased speed was required.
