M A R I N E O C C U R R E N C E R E P O R T

05-211

container ship *Spirit of Resolution*, collision with bridge,
Onehunga

8 October 2005

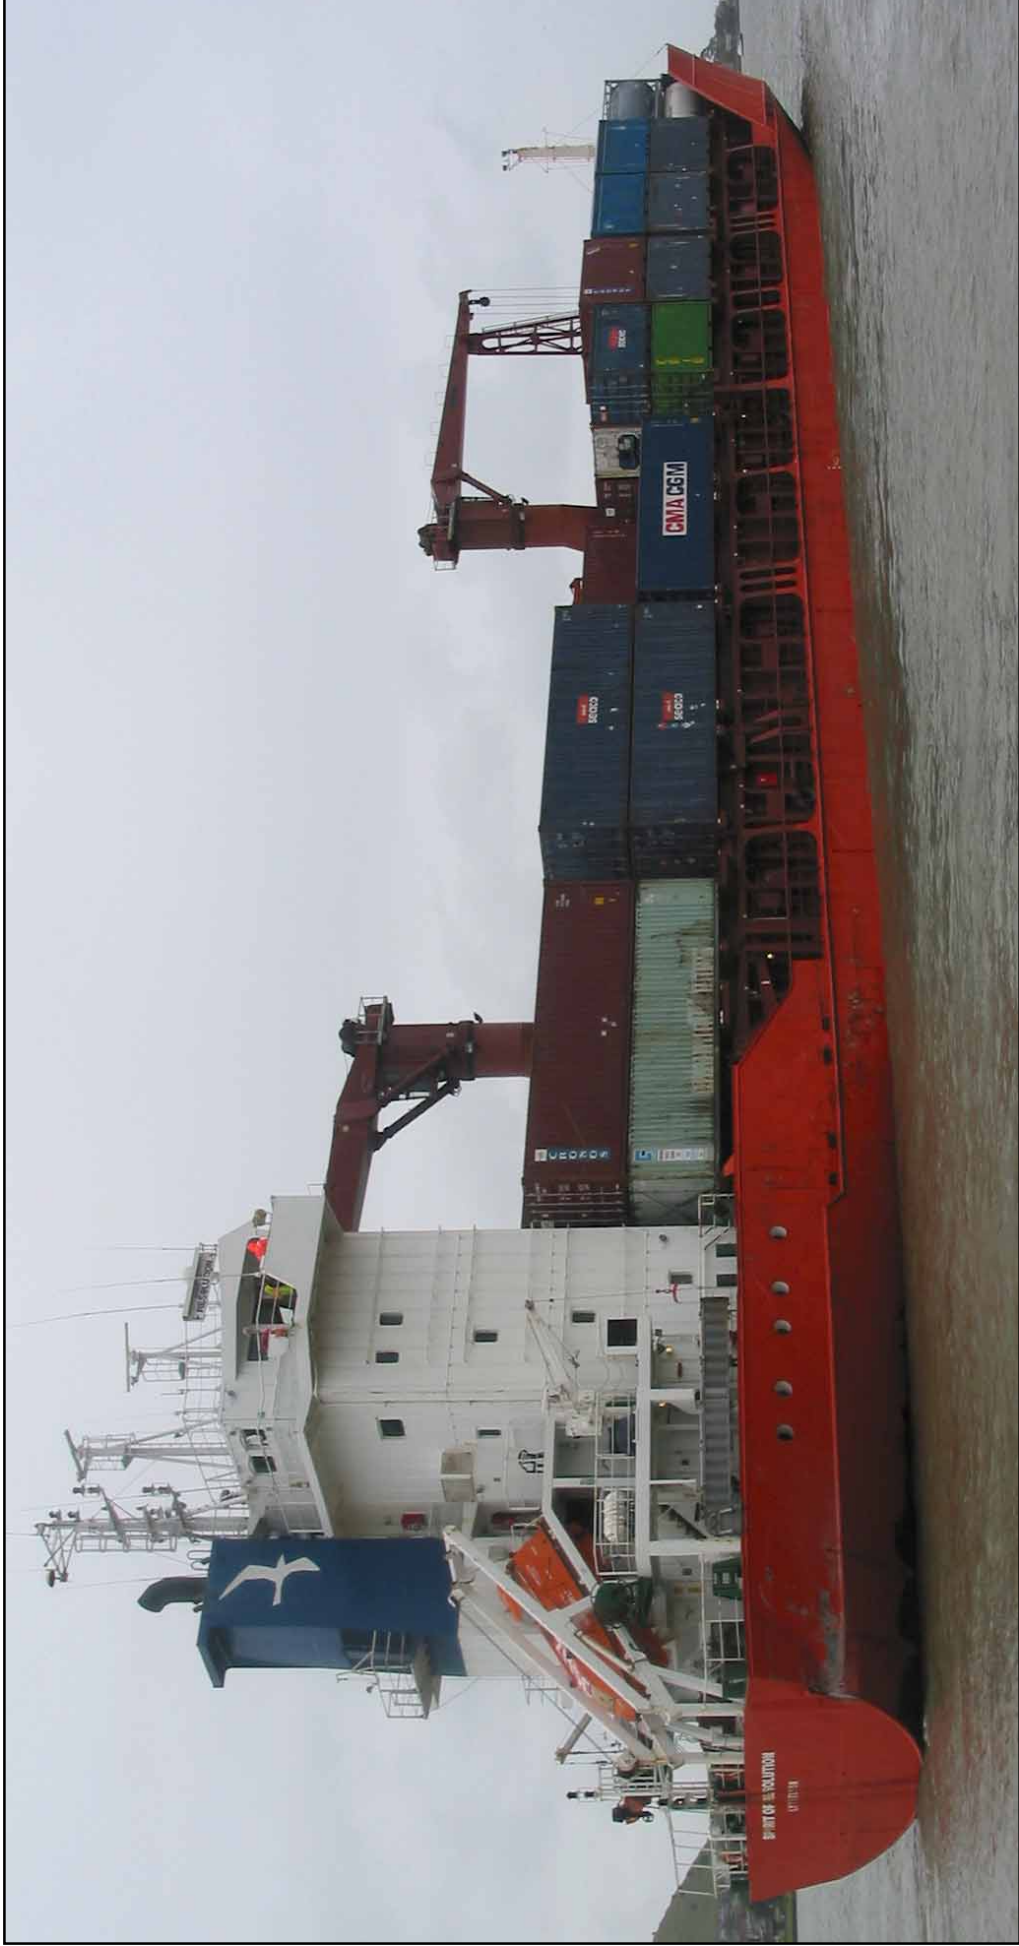
The Spirit of Revolution leaving Onehunga

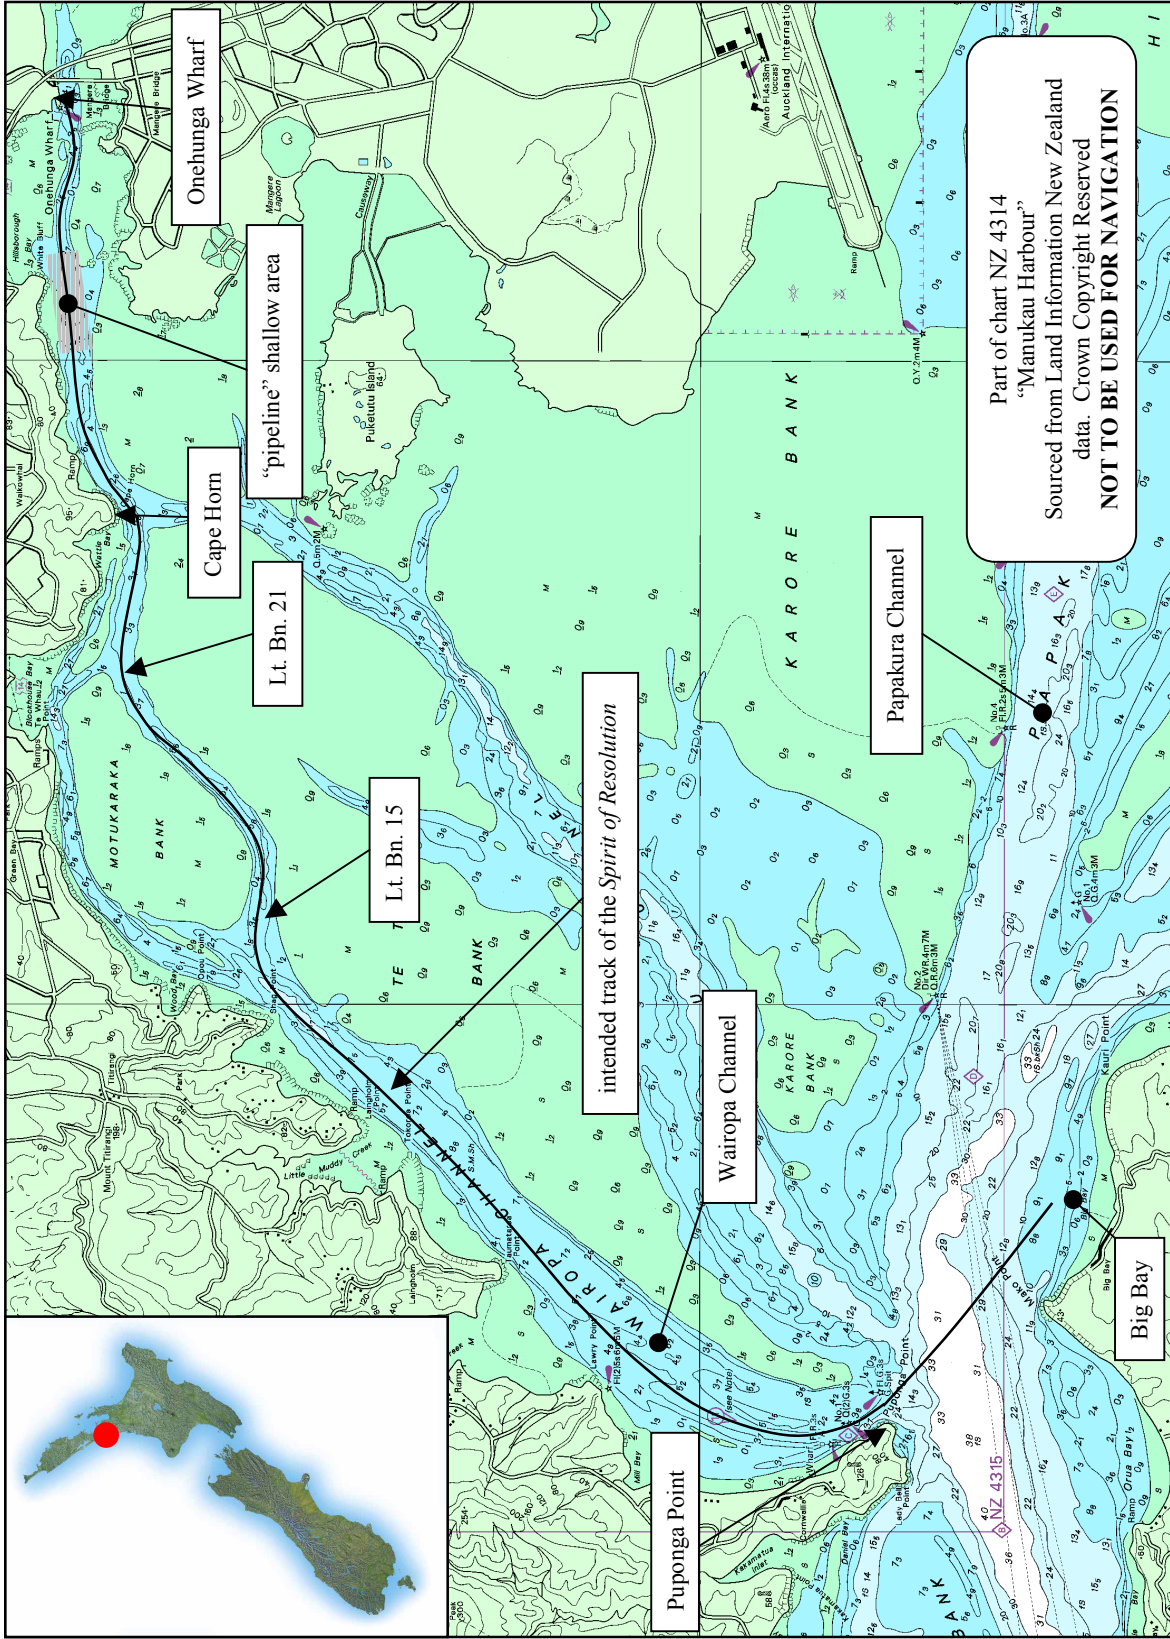
Figure 1
 General area of the accident

- 1.1.2 The *Spirit of Resolution* successfully crossed the Bar without incident, the Master reporting a 3 m swell occasionally rising to 4 m to 5 m. The ship proceeded across Manukau Harbour, along the Wairopa Channel to Onehunga (see Figure 1), where the Master berthed port side to the Wharf at “B” berth, on an ebb tide (see Figure 2).

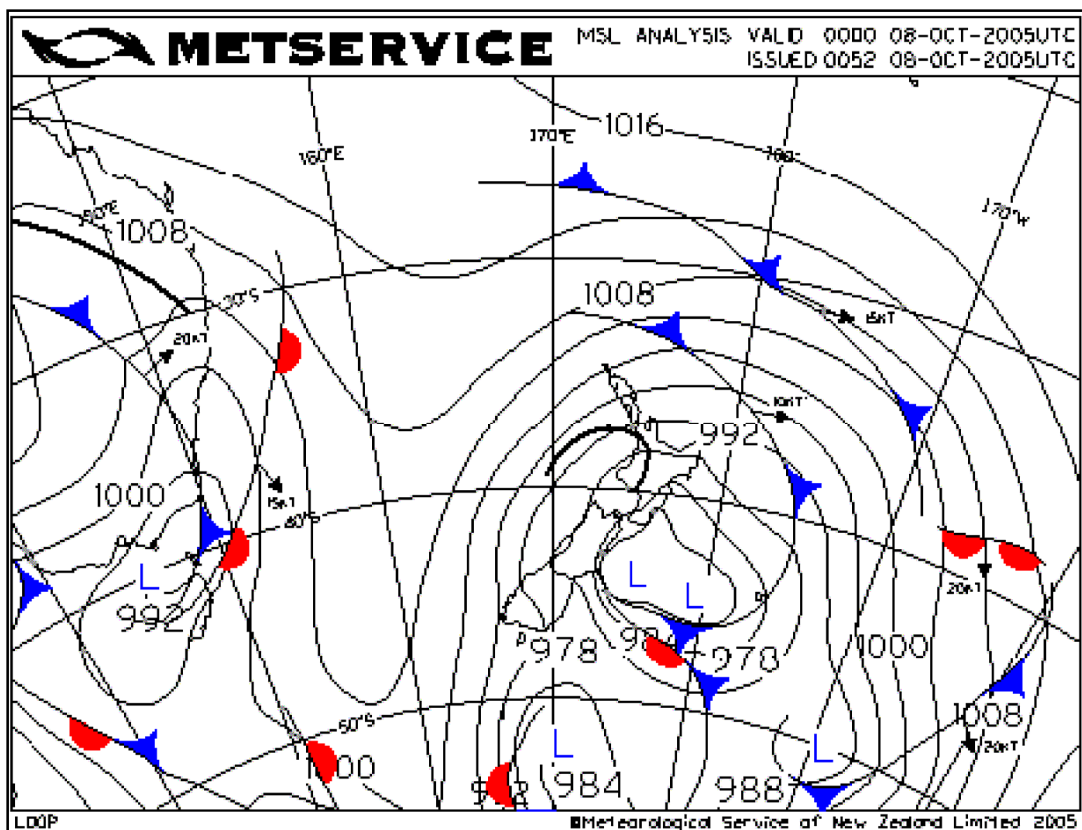
Figure 6
Mean sea level analysis synoptic chart for 1300 8 October 2005

A gale warning had been in force for all areas from Tuesday 4 October. In the 11am issue of the forecast for the Auckland Harbours, gale force westerly winds (25 to 35 knots) were specifically forecast for Saturday.

The forecast for Saturday remained more or less the same (gale force winds) throughout.
