## M A R I N E   O C C U R R E N C E   R E P O R T

- 05-212            restricted limit passenger vessel, *Milford Sovereign*, loss of      20 November 2005  
directional control, Milford Sound
- incorporating:
- 06-206            restricted limit passenger vessel *Fiordland Navigator*,      8 July 2006  
heel due extreme wind gust in Milford Sound

## **Report 05-212**

### **restricted limit passenger vessel *Milford Sovereign***

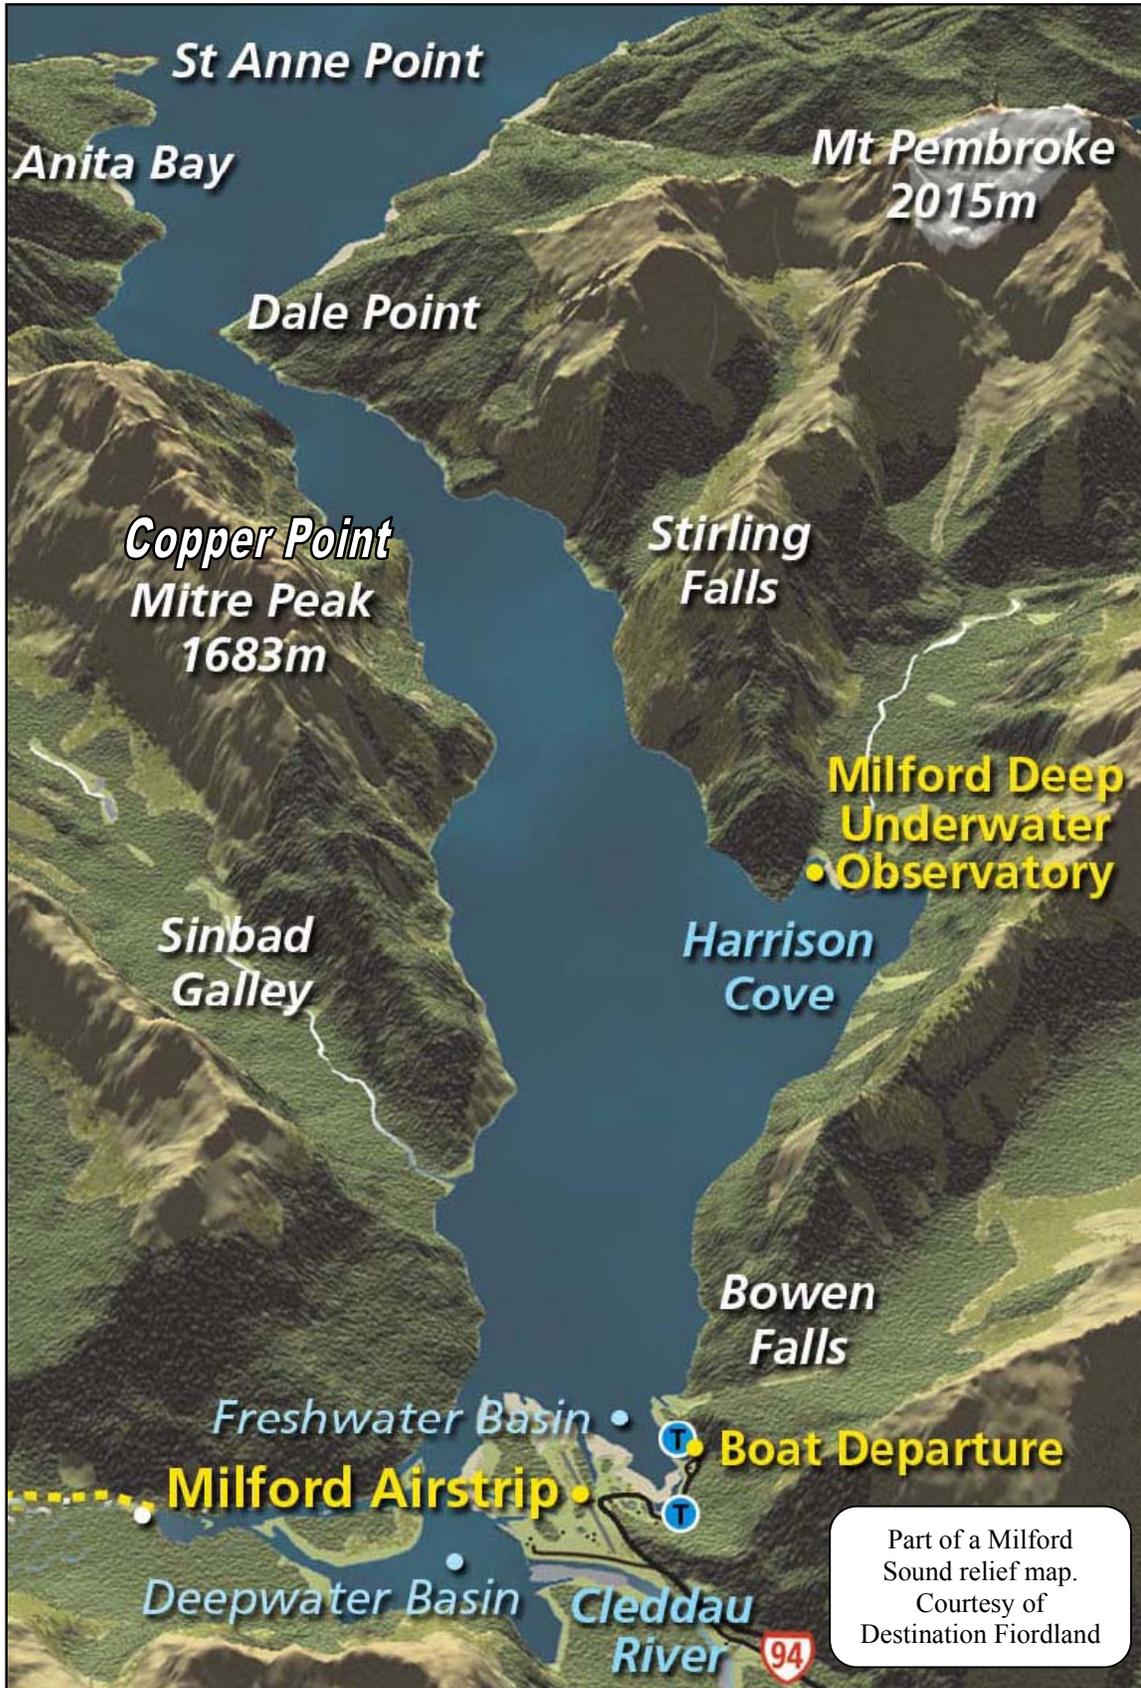
Figure 4  
Relief map of Milford Sound

1.8.1 Milford Sound is smaller than many of the other sounds in Fiordland. It is entered from the Tasman Sea between Saint Anne Point and Yates Point (see Figure 1). At Dale Point, about 2 nautical miles inside the entrance, the Sound turns at almost right angles towards the east and decreases in width to about 450 m. In this area the shore becomes precipitous, with sheer cliffs rising towards the adjacent mountains (see Figure 6), resulting in a region where stronger winds were often experienced. At the inner end of the narrow section lies Copper Point, locally known as “Windy Point”; once past this, the Sound increases to about one nautical mile in width. Harrison Cove lies on the eastern side of the inner Sound, with the Milford Deep Underwater Observatory lying close to Williamston Point at the entrance to this Cove. Fresh Water Basin lies at the southeastern extremity of the Sound and is where the local tourist vessels berth. Further towards the southern side of the Sound lies Deep Water Basin, which is used principally for fishing vessels.
