Report 06-201

passenger freight ferry *Aratere*

heavy weather incident resulting in cargo shift

3 March 2006

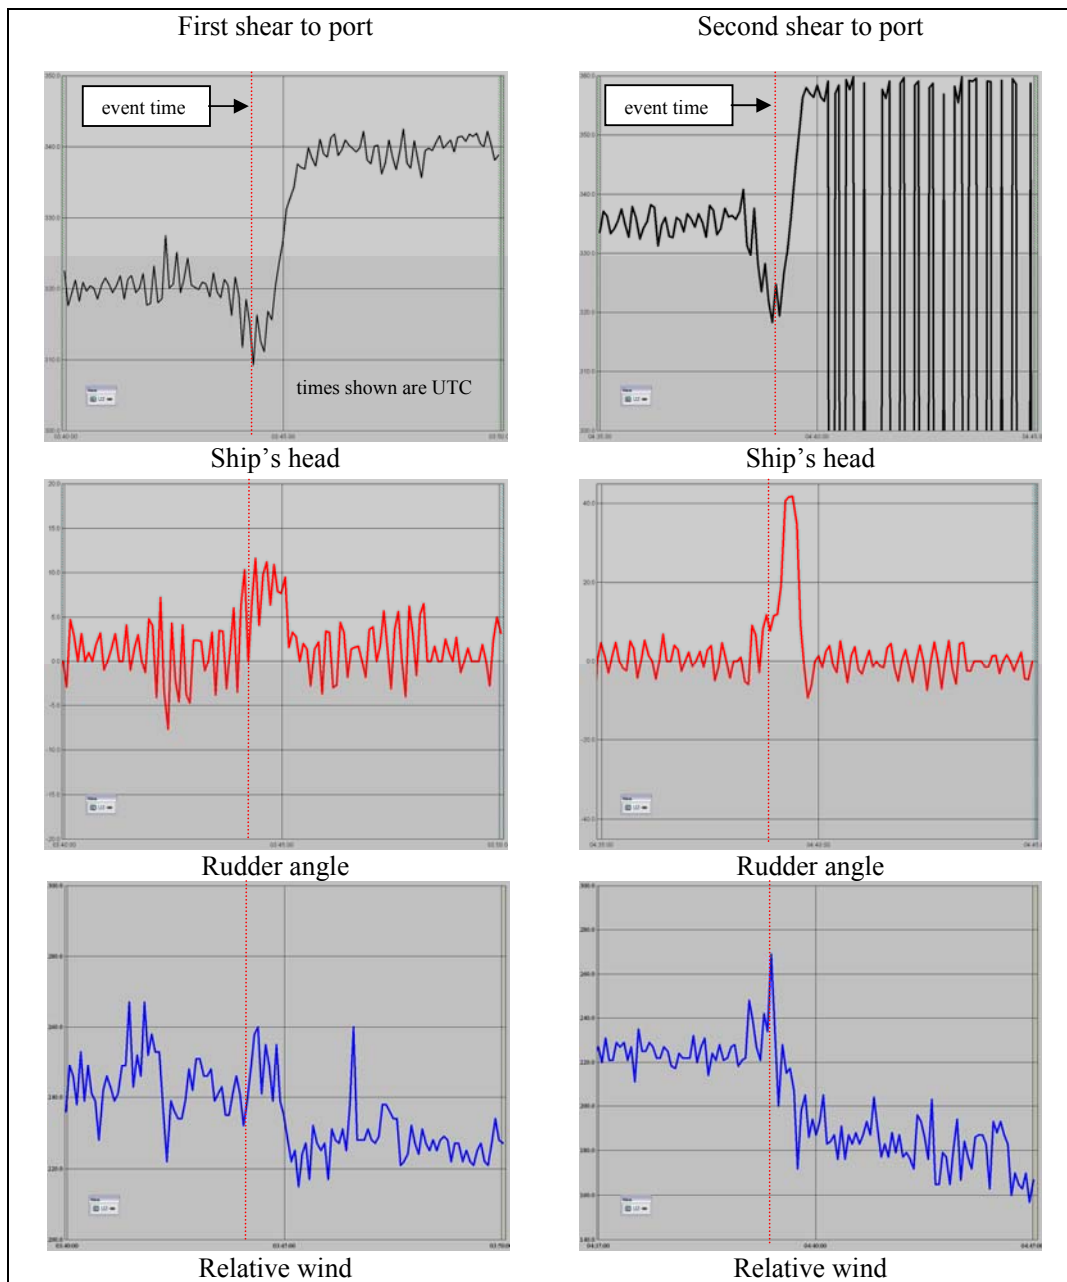
Figure 6
Printouts of downloaded VDR information

- 2.43 The Commission concluded that the vessel did not broach for the following reasons:
- despite some of the perceptions of various crew members, the course of the ship did not alter sufficiently during either of the shears (see Figure 6) to bring the ship beam on to the sea and swell. This was evidenced by the gyro records contained on the VDR

- when a ship broaches it goes beam on to the wind and waves, so, the relative wind direction would be either 090° or 270°. The graphical representation of the data downloaded from the VDR (see Figure 6) of the relative wind shows that the relative wind direction did not reach 270° during the first heavy roll, and only reached 270° momentarily during the second heavy roll. Relative wind direction is the direction of the wind relative to the ship's head in 360° notation. This input relies on information transmitted from the anemometer independent of all other inputs and would not be affected by any errors from other equipment such as gyro compasses

- when a ship broaches it remains captured by the wind and waves without the power to steer out of the situation. From comparisons of the rudder angle graphs with the ship's heading (see Figure 6) at the time of each shear, it can be seen that the rudders were effectively counteracting the shear to port and actively steering the ship back towards the set heading

- 2.47 Had the gyro compass failed totally, the heading would have remained constant and an alarm would have sounded. The data from the VDR would have indicated a straight line (flatlining) on the heading graph; a steady straight line could not be found on this graph during analysis of the VDR data. From analysis of the ship's heading graph in Figure 6, no flatlining could be found during either heavy roll.

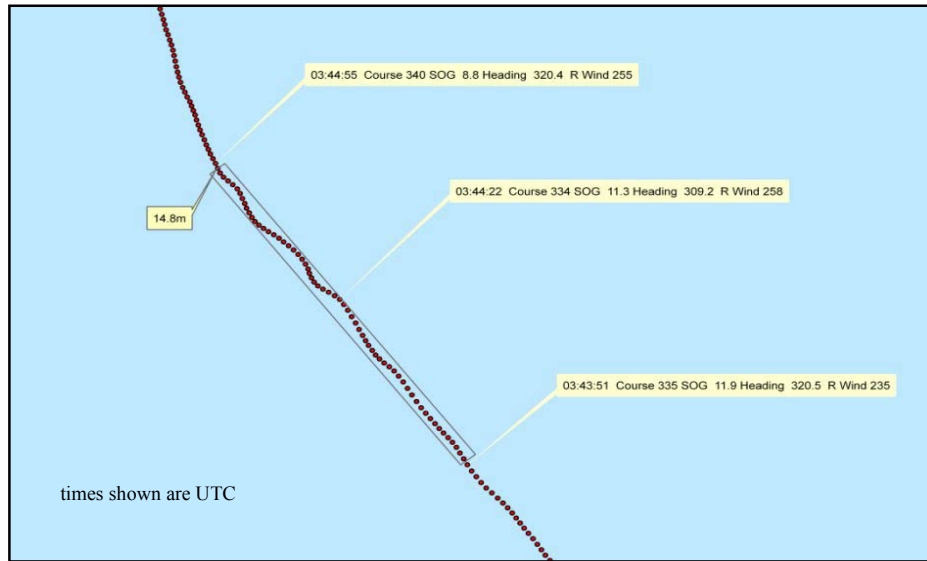
Figure 7
The MAIB's plot of the *Aratere's* position at one-second intervals from GPS co-ordinates for the first shear to port

positional data and relative wind, both of which were independent from the ship's gyro input. The GPS data was downloaded and displayed at intervals of one second. From these, it is evident that the GPS aerial remained within a 15m corridor during the first event, and a 24m corridor during the second event [see Figures 7 and 8]. Had the ship broached, while the ship's ground track might have remained similar as the ship slid transversely, the ship would have then been perpendicular, or near perpendicular, to the sea and wind on completion.

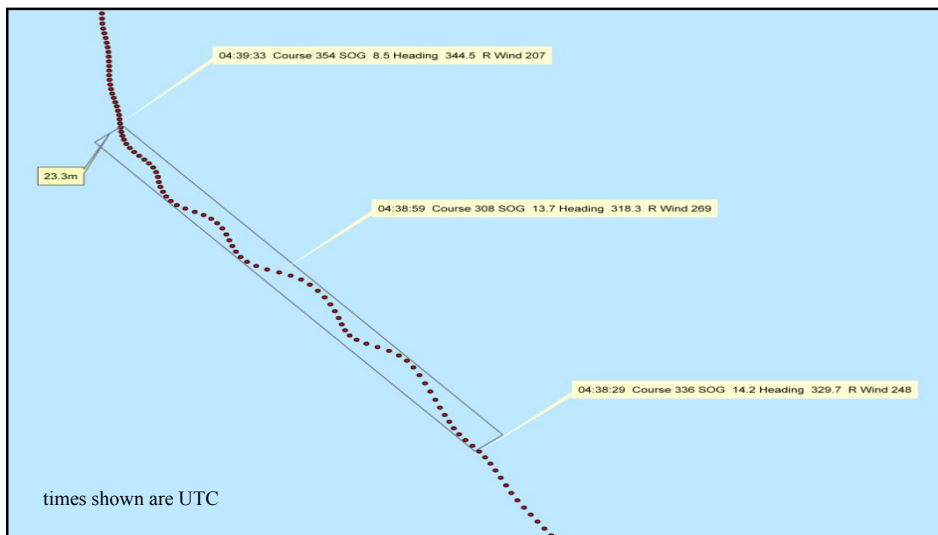
Figure 8
The MAIB's plot of the *Aratere's* position at one-second intervals from GPS co-ordinates for the second shear to port

Accordingly, it would then have taken the ship some time and distance (advance) to resume her original course, particularly noting the time taken to resume course following the attempted course reversal at 0419Z. As there is no indication of such movement from the GPS plots, there is little evidence, other than witness accounts and the fact that the gyro's operating parameters were momentarily exceeded, it is unlikely the ship's heading altered significantly more than indicated by the recorded gyro input. The fluctuations in the recorded relative wind during the two events are consistent with this hypothesis.

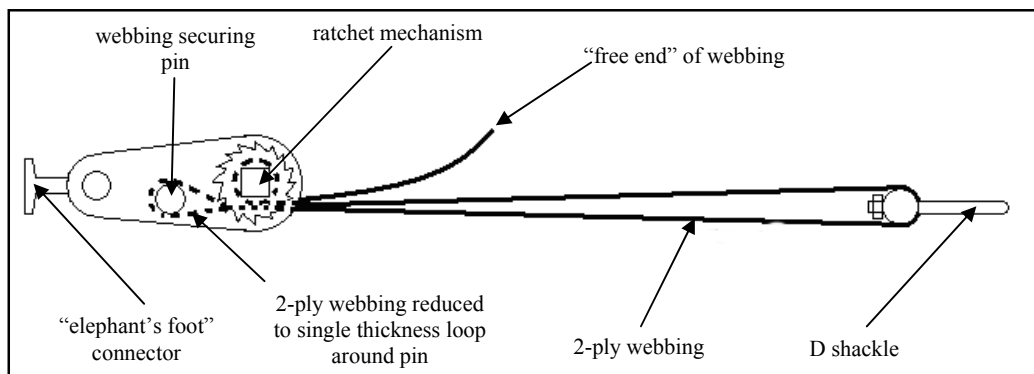
Figure 16
Diagram of web lashing

The webbing lashing was constructed from 100% woven polyester looped around a securing pin then fed around the “D” shackle pin and back through the ratchet mechanism. This allowed the webbing to be tightened by winding it around the ratchet mechanism. At least one full turn of the webbing was required around the ratchet mechanism to allow it to bind itself effectively (see Figure 16).

- 1.9.18 The *Aratere* was the only Interislander ferry to use web lashings. The other ships used chains to lash the road and rail wagons. The IMO-recommended maximum stretch for web lashings was 5% at 80% of the breaking load. However, chains, due to their different construction and material, exhibited about 0.5% stretch at their proof load.
