**Report 06-204, fishing vessel, *Kotuku*, capsize and sinking, Foveaux Strait,
13 May 2006**

**fishing vessel
*Kotuku***

capsize and sinking

13 May 2006

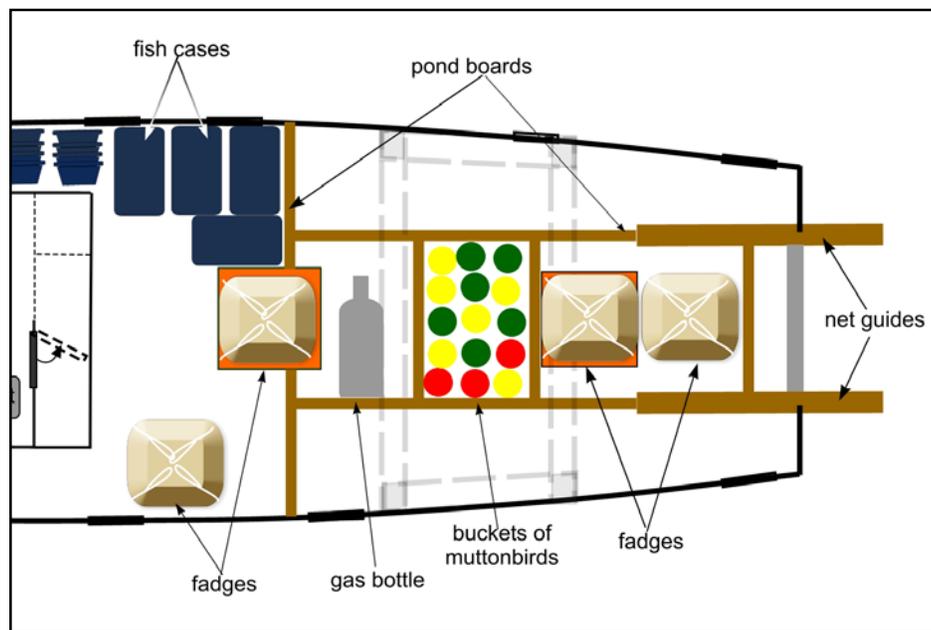
Figure 2
Approximate stowage position of cargo

1.1.4 Cargo, consisting of 4 fadges and a large gas bottle, was loaded onto the *Kotuku* in 3 lifts. The first fadge, containing buckets of muttonbirds, was landed in the afterdeck pond and some of the buckets were removed from the fadge and stowed into the next forward pond (see Figure 2). The second fadge, containing more muttonbirds, was landed behind the remnants of the first fadge in the after pond. The remaining 2 fadges, containing personal effects, a generator, spare fuel and muttonbirding equipment, and the gas bottle, were transferred in one lift. The fadge containing the generator and fuel was landed on the fish hold hatch and the other on the port side deck between the fish hold hatch and the wheelhouse. The gas bottle was laid in the pond, immediately aft of the fish hold hatch. It is unclear whether the cargo was lashed in place, although a rope was said to have been fastened across the fadge on the hatch. The total weight of the cargo was later estimated to be about 1000 kilograms (kg), comprising:

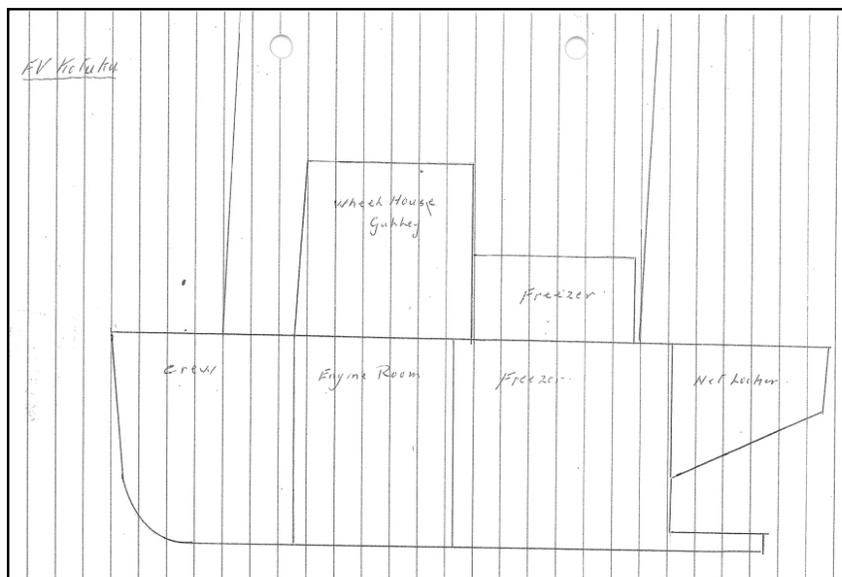
Figure 3
Original profile drawing of the *Kotuku*

- 1.2.5 The vessel was originally fitted with 3 non-watertight bulkheads, one forward of the engine room, one between the engine room and the fish hold (freezer) and the other between the fish hold and the steering gear compartment (net locker) (see Figure 3). In 1968, a watertight collision bulkhead was erected in the forepart of the vessel to comply with survey requirements.

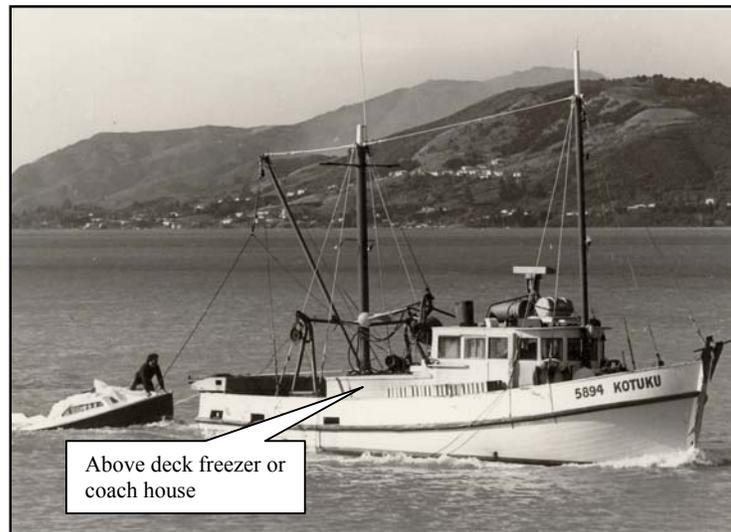
Figure 4
Kotuku circa 1973

- 1.2.7 Over the years, the vessel had been used for many types of fishing, including crayfishing, dredging for scallops and oysters, trawling and trolling. The original vessel had a large deck structure above the fish hold aft of the wheelhouse; this was referred to as the coach house (see Figures 3 & 4).

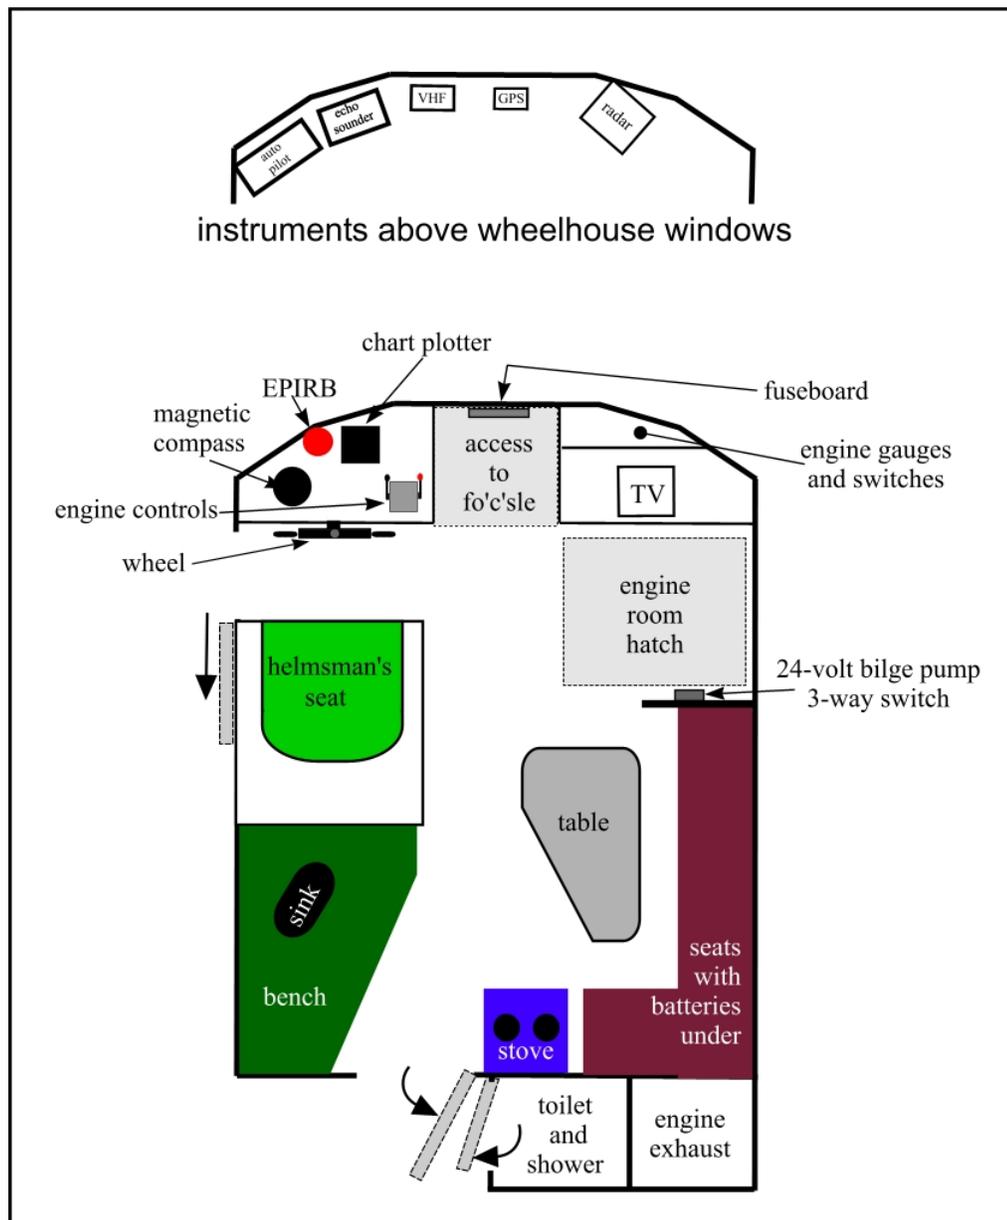
Figure 6
Wheelhouse layout

- 1.2.18 The vessel was fitted with the following navigation and communication equipment at the time of its capsize (see Figure 6):
- a Furuno FR 711 radar

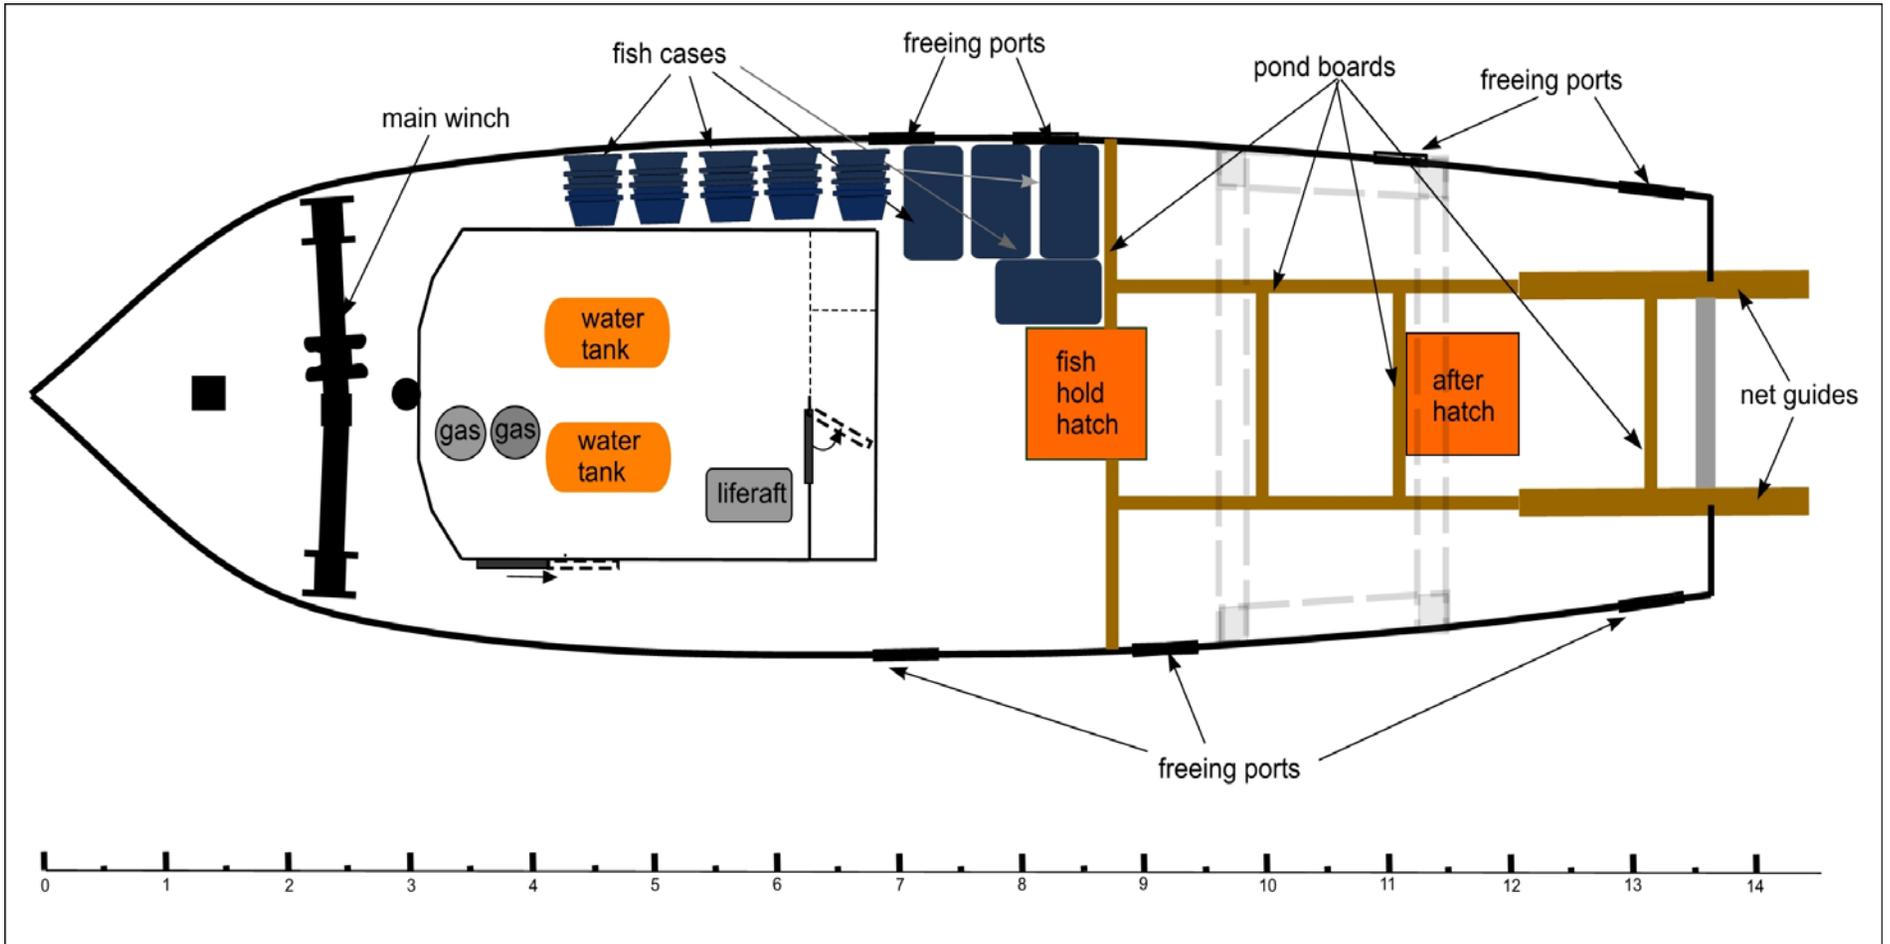
Figure 9
Plan of the *Kotuku*, approximately to scale

- 1.2.28 There were 7 rectangular freeing ports along the length of the afterdeck (3 on the port side and 4 on the starboard side) (see Figure 9). Each freeing port was fitted with a vertically sliding cover, which had jamming wedges at the top to allow the covers to be held in the open position. The covers were made of plywood or aluminium. Each of the covers had small cut-outs along their lower edges, triangular in shape on the aluminium covers and half-moon shaped on the plywood ones. The freeing ports were of differing sizes and varied between 495 mm x 170 mm and 520 mm x 210 mm. The total available freeing port area when the covers were fully open was 0.66 m². Part 40D.23(1) prescribed a formula to calculate the minimum freeing port area. Using the formula the *Kotuku* required a total freeing port area of 0.4 m². The cut-outs in the freeing port covers provided a freeing area of about 0.04 m².

- 1.2.31 The crew usually stowed empty fish cases between the starboard bulwark and the wheelhouse, and on the starboard side of the afterdeck up to the forward pond board, as shown in Figure 9. On the accident trip, the owner estimated that there were about 50 empty fish cases stowed in those areas.

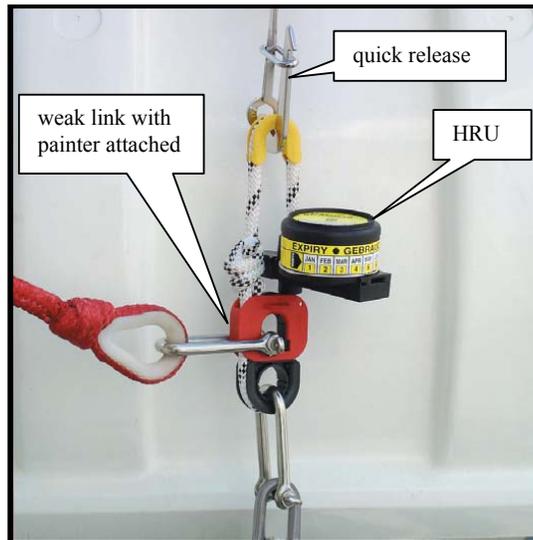
Figure 10
Hammar H2O hydrostatic release unit

- 1.10.2 In November 2004, the owner had bought an RFD Pacific-4 liferaft from RFD in Christchurch, when his previous RFD Surviva-6 RF liferaft was condemned during a survey. At the same time he bought a new Hammar H2O hydrostatic release unit (HRU) (see Figure 10) as was required for a fishing vessel that was licensed to operate in the coastal area. The new liferaft and HRU were transported to Bluff for the owner to install. The liferaft supplier said that it had representatives in Auckland, Wellington, Christchurch and Nelson. New liferafts delivered in those areas were installed by them, but this was not usually the case in other ports such as Bluff, where installation by the manufacturer incurred an additional charge and so purchasers usually installed the liferafts themselves. The owner requested that the supplier pack a 121.5 MHz EPIRB into the liferaft as an additional safety measure. The Pacific-4 liferaft was manufactured for RFD by the French company Plastimo and had been type approved by Maritime NZ in 1991. The liferaft of the *Kotuku* had been serviced by RFD Christchurch, as required, in November 2005.

- 1.10.6 The HRU was operated by a pressure device that activated a spring-operated blade, which severed a loop of line through which the liferaft securing lanyards were secured. The installation instructions that accompanied each HRU explained that a slip hook or similar should be used to allow easy manual deployment of the liferaft. The HRU was fitted with a weak link, which was designed to release at 2.2 ± 0.4 kilonewtons, to which the liferaft painter was intended to be secured. On the *Kotuku* there was no manual quick release provision in the liferaft securing system.

- 1.10.7 The operating part of the *Kotuku* HRU was never recovered, having activated at some point during the capsize and sinking: however, the lower securing part and the weak link were still attached to the inboard securing rope. The HRU manufacturer was able to provide quality control test results for the batch of 500 units from which the *Kotuku* HRU came. Twenty HRUs, chosen at random from each batch, were tested in a pressure chamber and their activation depth recorded. The 20 HRUs from the *Kotuku* batch that were tested activated between 2.2 m and 2.8 m. In addition to these pre-distribution tests, the manufacturer said that it routinely tested units returned after they had passed their expiry date, without any failures.

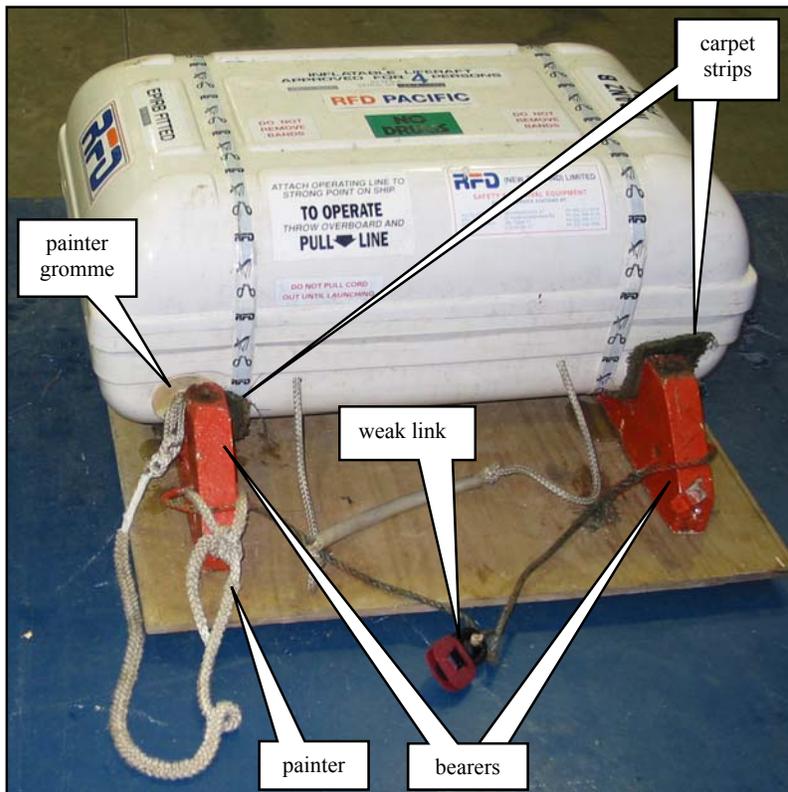
Figure 12
Pacific-4 liferaft on the reconstructed cradle

- 1.10.11 When the *Kotuku* was recovered it was noticed that the liferaft was wedged into the cradle (see Figure 12), so tests were carried out to determine what force was required to free it (see Appendix 6). There was a slight difference in the test results between when the carpet strips between the cradle and the liferaft were wet or when they were dry. An overall force of about 60 kg was needed to lift the liferaft from the cradle. The dry weight of the case and liferaft was about 40 kg, so a holding force of 20 kg was being exerted on the liferaft. The vertical shoulders on the cradle indent prevented any sideways movement of the liferaft. The painter grommet was aligned with one of the cradle indents, further tightening the fit.

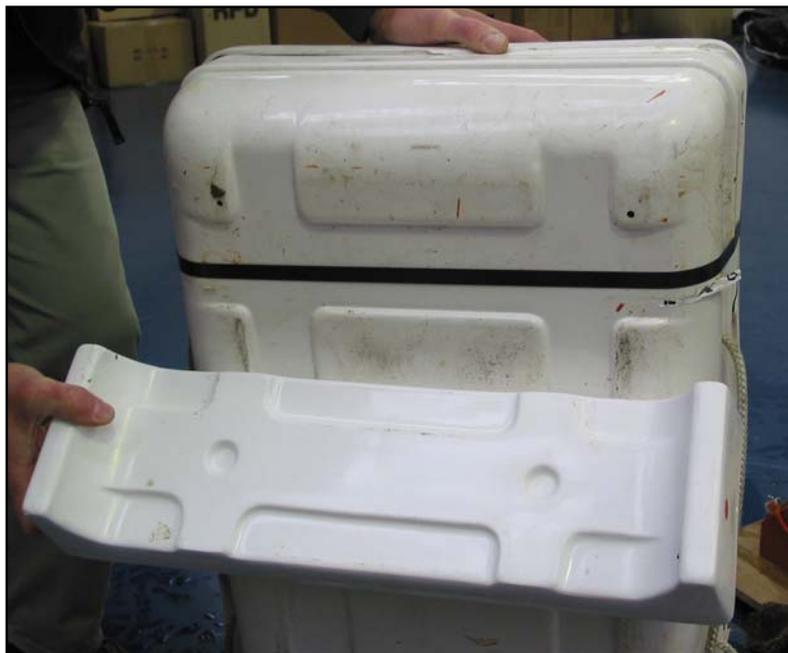
Figure 13
Specially designed cradle for the Pacific-4 liferaft

- 1.10.12 Specially designed cradles (see Figure 13) were available for the stowage of the Pacific-4 liferaft, at an additional cost of about \$120. These cradles had raised cruciform sections that were designed to interlock with corresponding cruciform indents in the liferaft case. The cradles provided a secure base on which to store the liferaft that did not pinch or exert any holding force on it. In addition, the shoulders of the cradles were curved and low enough to allow the liferaft to disengage should the liferaft deploy with the cradle at a large angle.

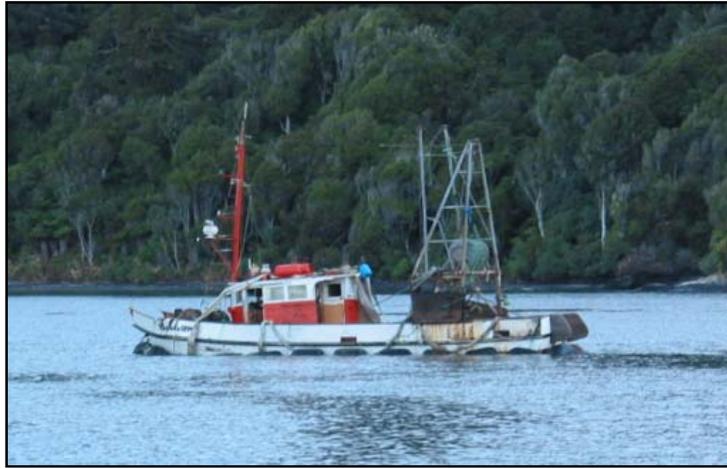
Figure A4.1
The *Kotuku* with flotation collar attached

A4.9 On 28 May the decision was made that any flotation would have to be independent of the original buoyancy of the vessel. A flotation collar of plastic buoys, of the type usually used in the aquaculture industry, was prepared and attached to the vessel (see Figure A4.1). In addition, more buoys were positioned in the fish hold and after hold with their hatches battened down. Cargo separation airbags were also inflated in the forward accommodation.

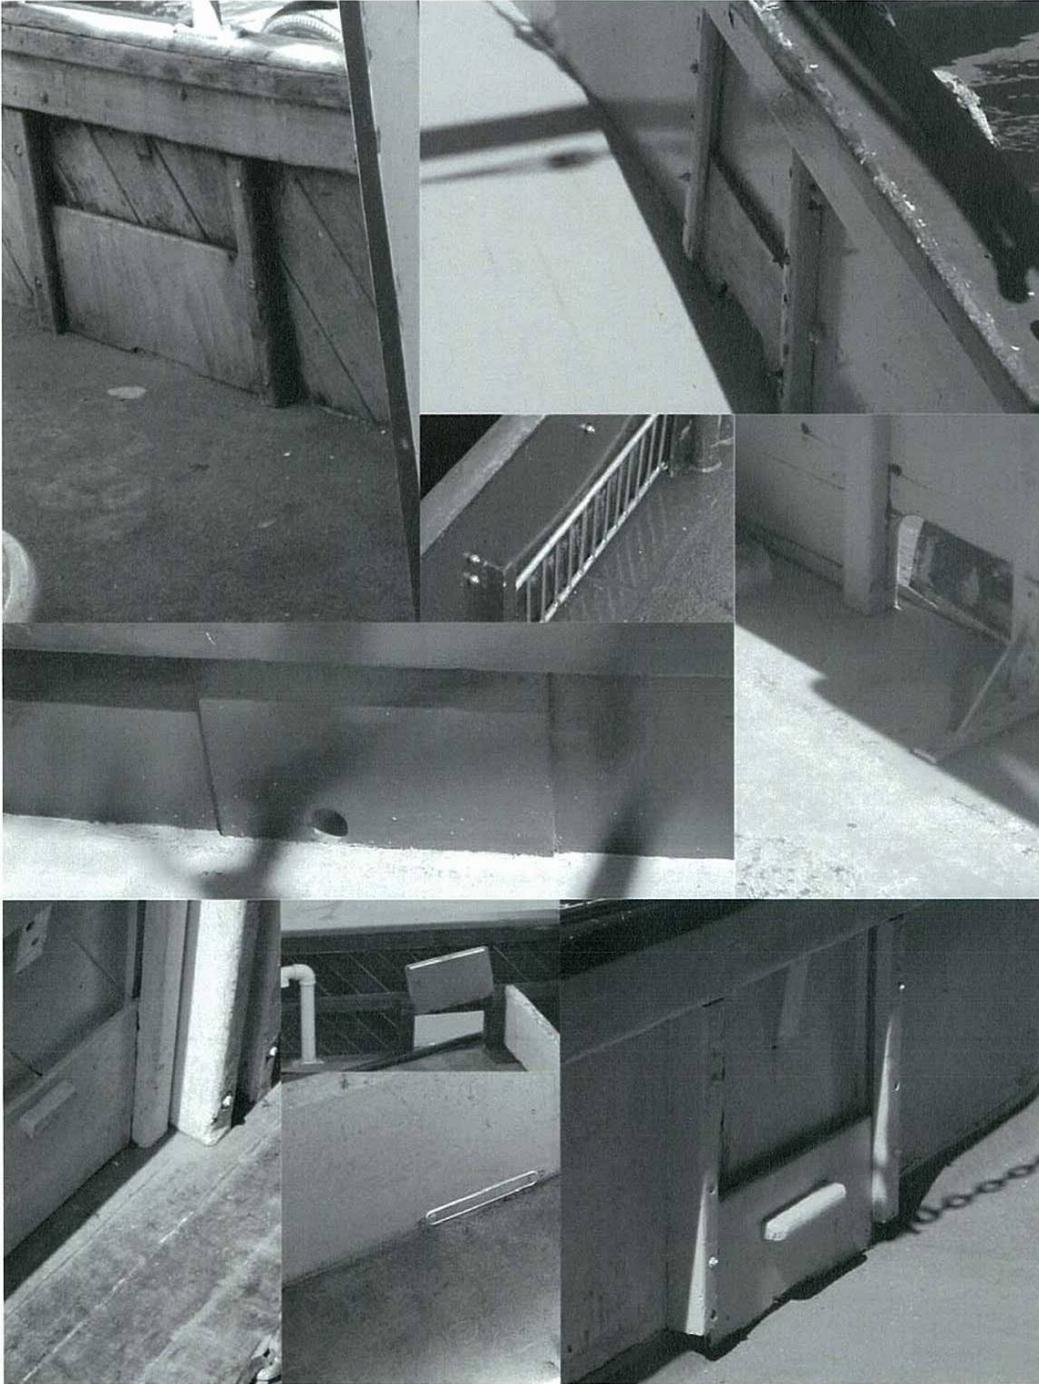
Examples of unacceptable covers are illustrated below:

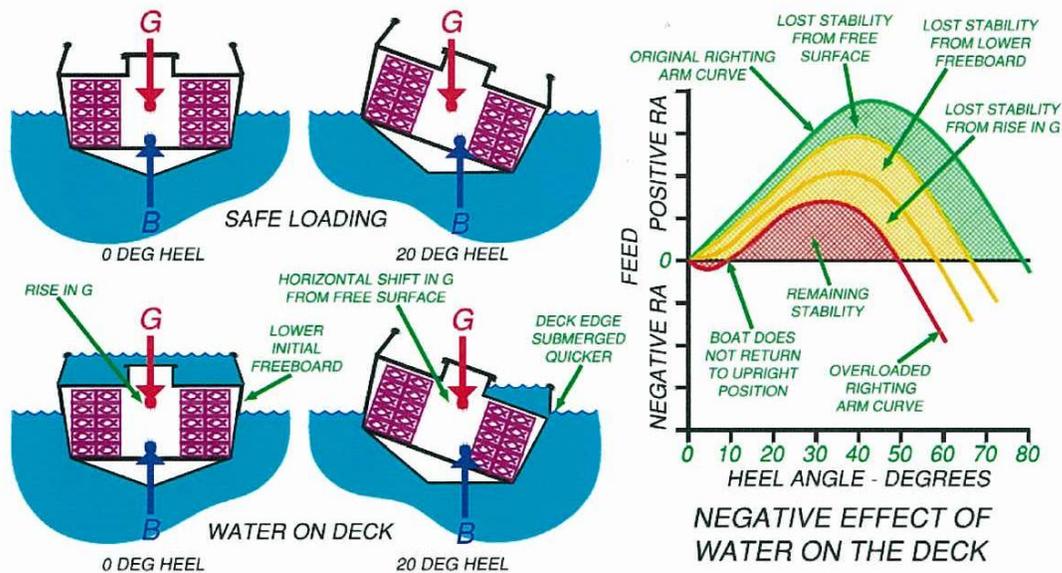
Water trapped on deck is extra weight. It will cause the vessel to sink further into the water and reduce the freeboard of the vessel. As the vessel heels over, the deck edge will be submerged, allowing even more water to come onto the deck. This exaggerates the problem and can result in the rapid loss of the vessel.

The effects of water on deck are illustrated below:

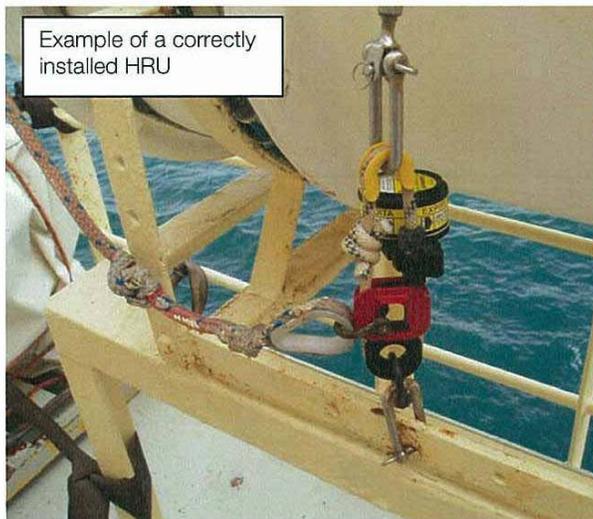
- Hydrostatic release unit (HRU) is connected correctly
- Liferaft is not prevented from escaping by extra lashings or rigging on the vessel, or by a cover on the liferaft

Example of a correctly installed HRU

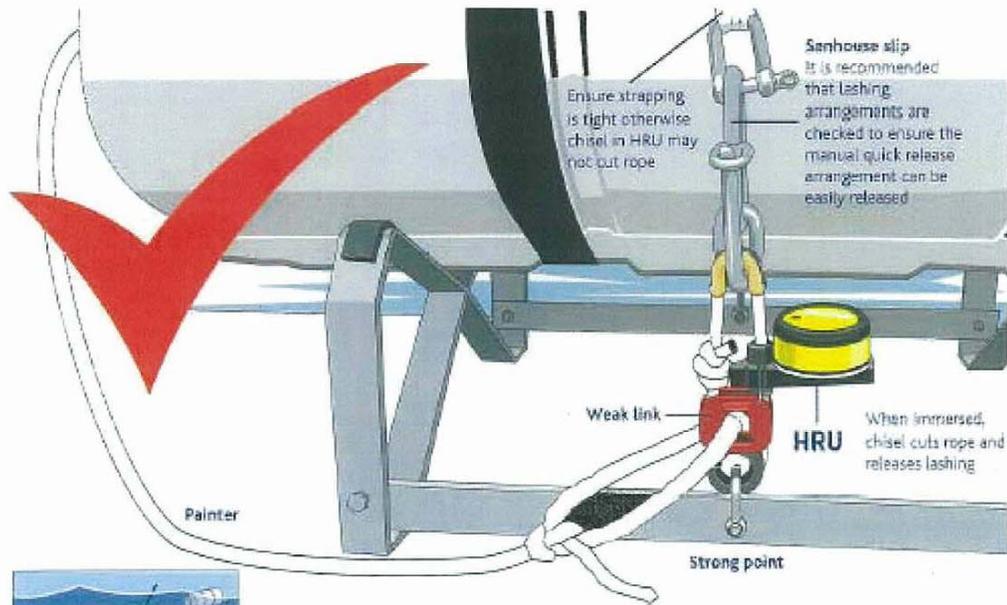
CORRECT INSTALLATION OF HYDROSTATIC RELEASE UNIT (HRU)

1. If vessel sinks, Hydrostatic Release Unit activates and liferaft attempts to float to surface

2. Tension on painter will cause liferaft to inflate

3. Tension on weak link will cause it to break ensuring liferaft does not go down with the boat

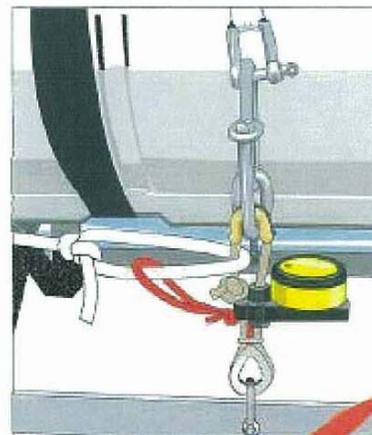
Correct installation of older version HRU

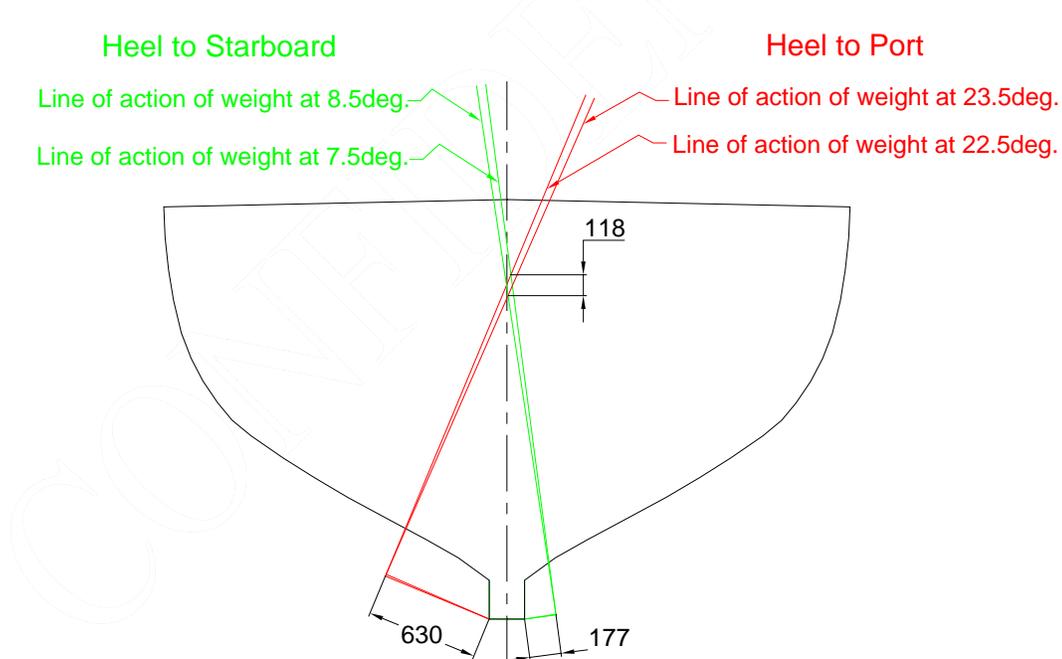
In this context, it is noted that the angles to which the vessel was taken are round numbers – precisely 23 degrees to port and 8 degrees to starboard. These figures may be correct, but since it must have been difficult setting the vessel up, there must be some question as to whether these angles are accurate. It is worth noting that a ½ degree variation in both port and starboard values could have resulted in a range of up to 118mm in the vertical CG position – see diagram below.

It is entirely understandable, given the hull's particular fragility on the starboard side, that the heel angle to that side had to be limited to 8 degrees – a greater angle might have increased hull distortion, reducing the accuracy of the trial and risking a serious failure of the weakened hull structure.

Nevertheless, the limited heel angle to starboard must inevitably have reduced the accuracy of the trial, and it is noted that, having calculated a figure of 1.895 m, the author then qualified this by considering the VCG to lie between 1.80 and 1.95 m above

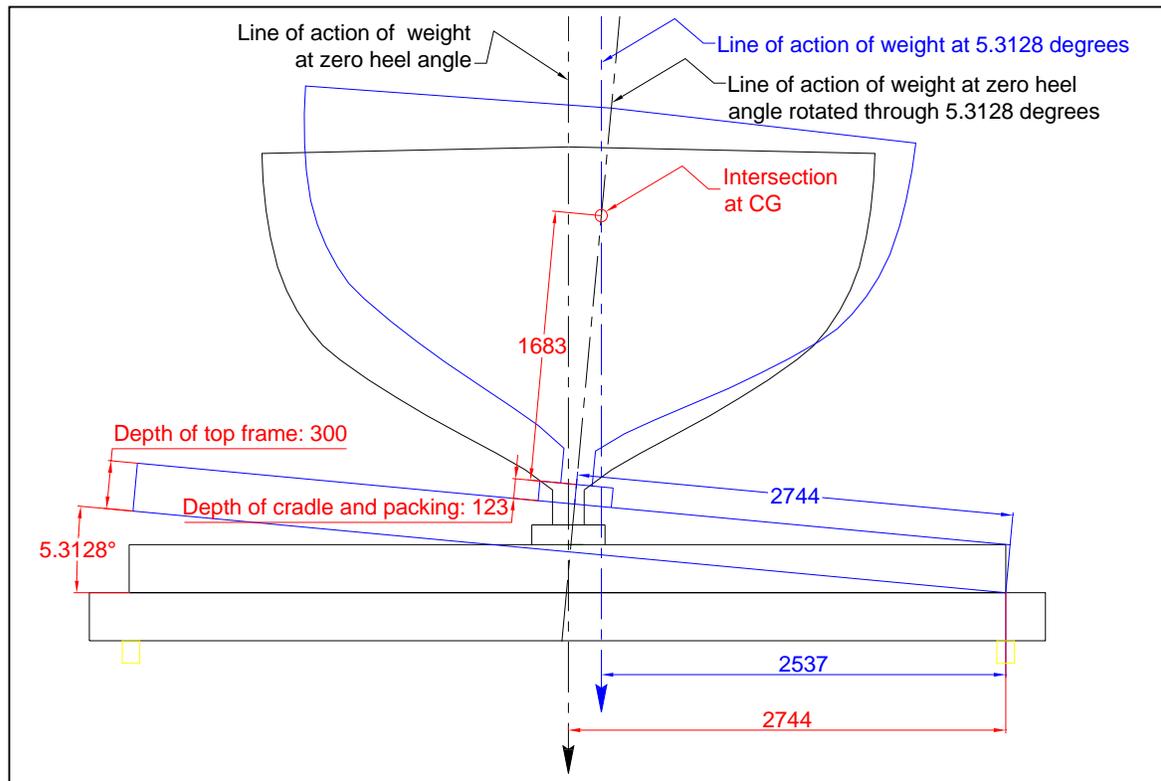
intersecting lines of action of the weight was a very low 5.3128 degrees – by contrast, this angle was 31 degrees in the TAIC inclining. The effect this had was to make the MNZ VCG calculations very sensitive to minor variations in load cell readings. For example, the correction of a very small 15 kg error made in calculating the average inclined rig mass has the effect of reducing the transverse centre of gravity by 2 mm, but in turn this has the effect of increasing the VCG by a disproportionate 15 mm.

The diagram below illustrates the principle by which the VCG was calculated in the MNZ report. Note that the CG is shown at its corrected location.
