**Report 06-207, restricted limit passenger vessel, *Milford Sovereign*,
engine failure and impact with rock wall, Milford Sound, 31 October 2006**

On 31 October 2006, the restricted limit passenger vessel *Milford Sovereign* was on a cruise of Milford Sound with a master, 9 crew and 181 passengers on board. Shortly after rounding Dale Point at about 1400, the master slowed the vessel in order that the passengers could view some penguins. As the master put the engines astern they both stalled, and before he was able to restart them the bow of the vessel struck the rock wall. The underwater hull was not penetrated so the master resumed the cruise.

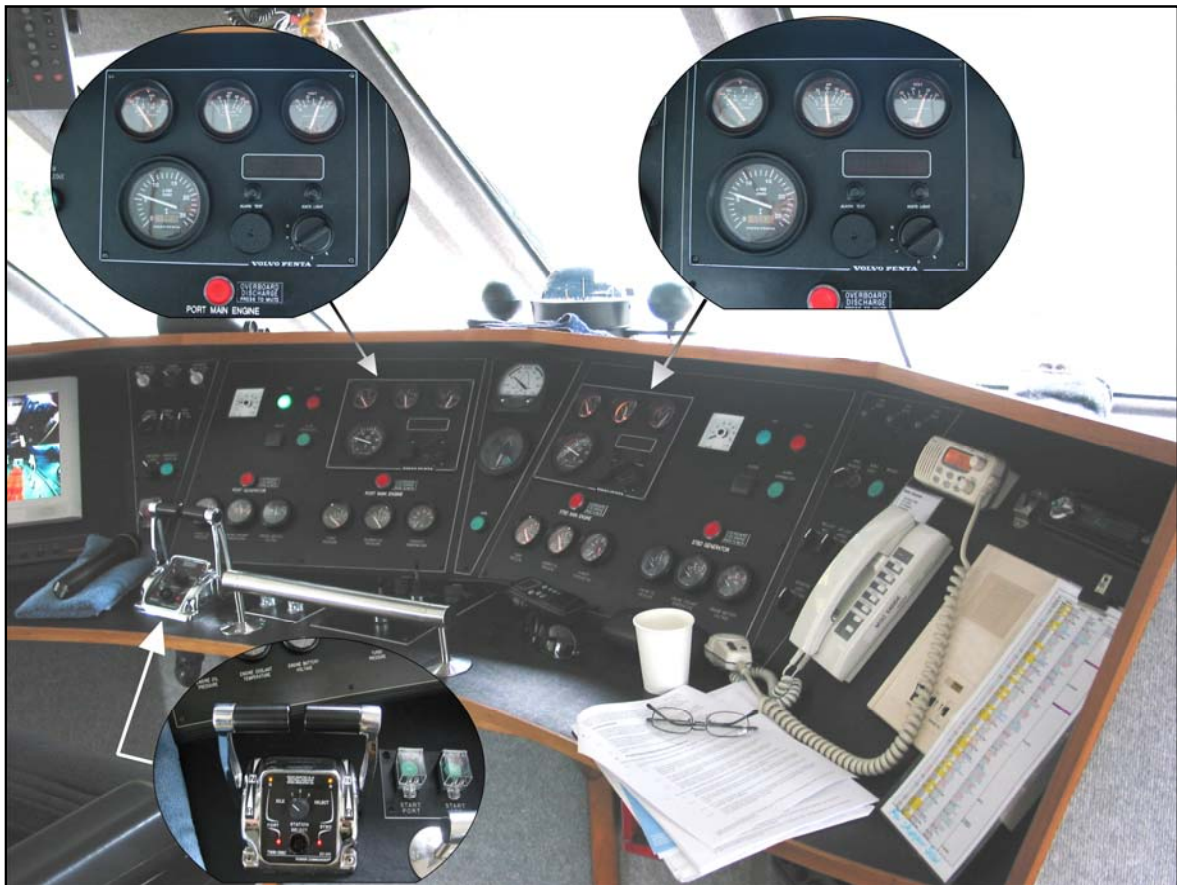
Figure 4
The *Milford Sovereign* bridge console

1.3.9 The engine control was a Twin Disc Commander EC 200 (see Figures 4 and 5) that used a single lever to control both the throttle and the transmission of each engine. There was an engine control unit at each of the 3 bridge control stations: the centre console, and port and starboard bridge wings. The master usually conned the vessel from the central console, which had the main controls within easy reach, but when manoeuvring he used the bridge wing control stations. The engine control units were electrically linked to electronic control units (ECUs) in the engine room; these ECUs were connected by cable to throttle and transmission actuators for the 2 main engines. Only one of the 3 engine control units could be active at any one time, with control being transferred between each of the engine control stations using the station select button at the desired engine control station. A red indicator light on each engine control unit was lit when that station was active (see Figure 5). A yellow light indicated when neutral was selected. A switch allowed the operator to select from 3 preset idle speeds, a useful function when manoeuvring in close situations where selective increased speed was required. The preset engine speeds for the idle settings were:

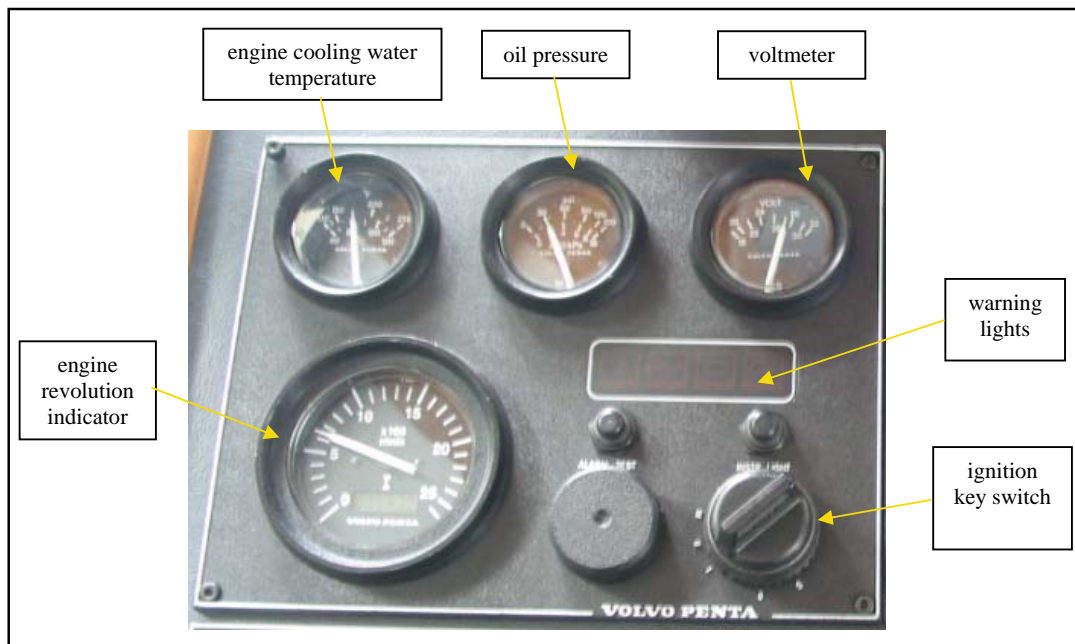
Figure 6
Engine ignition control board

1.3.10 The ignition key switch (see Figure 6) had a built-in restart inhibitor, which, once the engine had been started, deactivated the start function of the ignition key switch until it had been returned to the off position. This was a safety feature to prevent possible damage to the starter motor if an operator tried to start an engine that was already running. At each engine ignition control board there were gauges to indicate engine temperature, oil pressure, engine voltage and

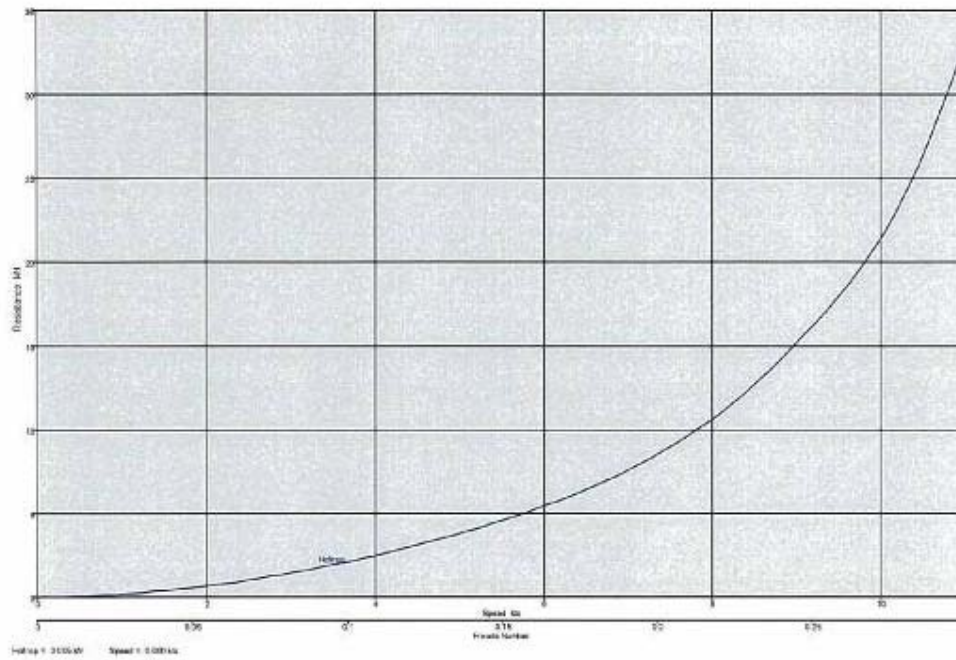
Figure 1: Calm water resistance of Sovereign

For each vessel we used a speed range of between 0 to 11 knots and used Holtrop's resistance formula to determine water resistance (Figure 1: Calm water resistance of Sovereign, Figure 2: Calm water resistance of Mariner). We assumed

The propeller torque demand was calculated using the resistance curves from Figure 1 and 2 to establish required power. An efficiency factor of 60% was added to account for energy losses in the propellers and drive gear. Equation 2 was then used to establish the propeller torque at the given RPM.

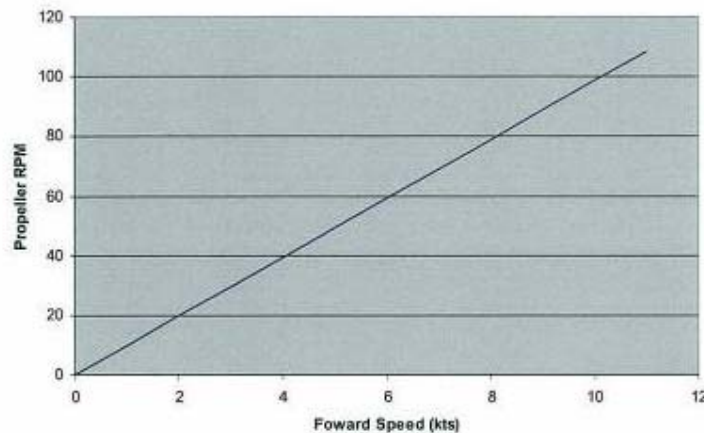
Figure 3

Since the propellers are disengaged from the engine, no rotational force or torque is transferred to the engine and the propeller speed is as shown in Figure 3.

However if the engine is engaged and returned to revs that are less than the revs exerted by the forward velocity on the propellers, then the engine will provide braking and the propellers will slow the rate at which engine revs drop. This braking effect will be lost if the Master puts the vessel straight into neutral.
