Report 07-115, express freight Train 533, derailment, 103.848 kilometres, near Tokirima, Stratford – Okahukura Line, 7 November 2007

Report 07-115

express freight Train 533

derailment

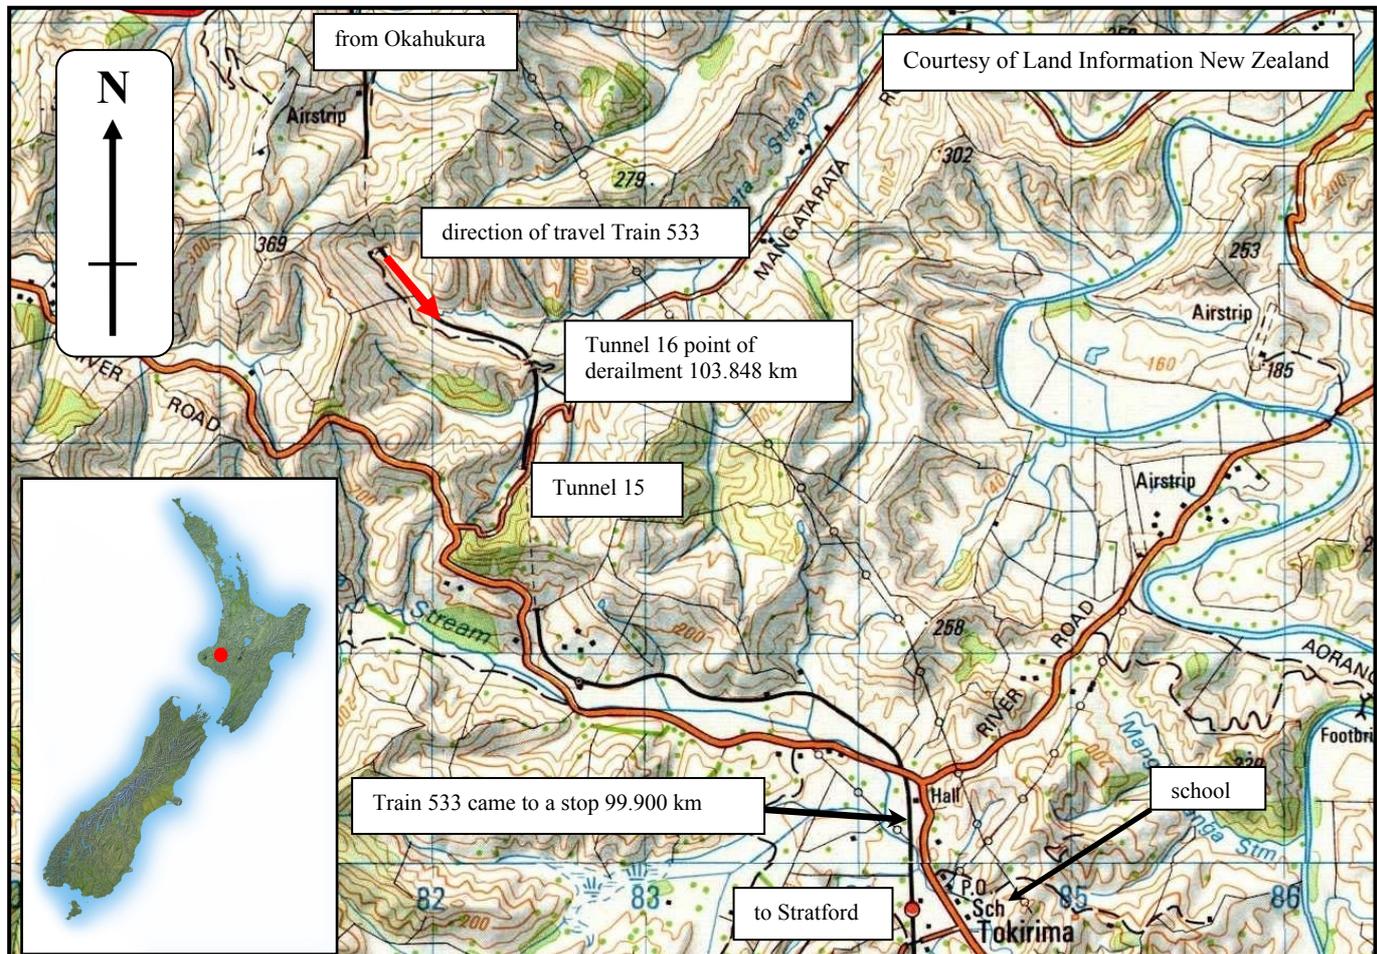
Figure 1
Map of derailment area

- 1.3.1 The point of derailment was confirmed as 103.848 km by a wheel flange mark on the left-hand rail in the direction of travel. The point of derailment was on a 250 m long, 180 m radius right-hand curve, in the direction of travel, including through Tunnel 16 (see Figure 2).
