**07-201** passenger vessel, *Cruise Cat*, collision with navigational light beacon, Waikato River entrance Lake Taupo 22 February 2007

## **Report 07-201**

**passenger vessel  
*Cruise Cat***

**collision with navigational light beacon**

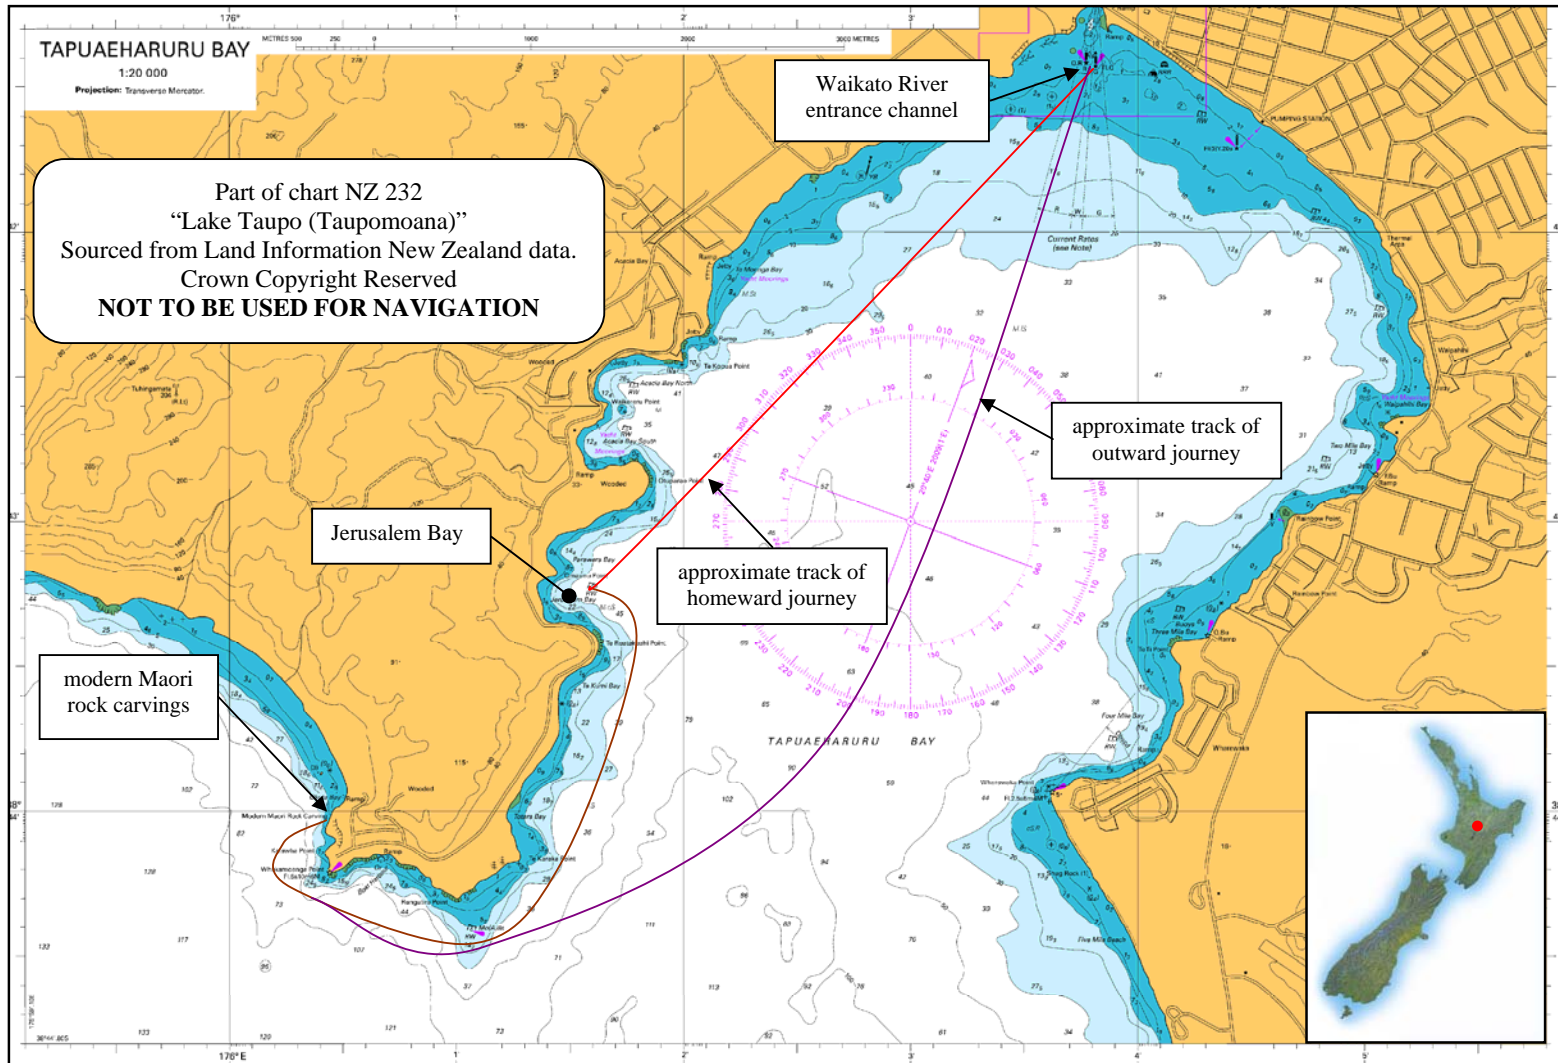
**Figure 1**  
**General area of the incident**

- 1.1.2 The skipper of the *Cruise Cat* gave a short safety briefing after which he ordered the lines let go and conned the vessel out of the boat harbour and up the river channel to Lake Taupo. Once out of the channel the skipper conned the vessel across Tapuaeharuru Bay around Rangatira Point to the modern Maori rock carvings near Okuta Bay (see Figure 1).
