Report 07-202, fishing vessel, *Walara-K* flooding and sinking, 195 nautical miles off Cape Egmont, 7 March 2007

**fishing vessel
*Walara-K***

flooding and sinking

7 March 2007

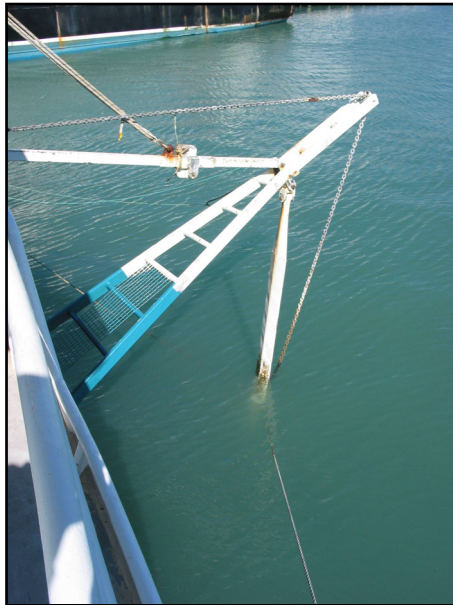
Figure 7
Stabiliser arm on the *Altair III*

- 1.4.4 In late January 2007 while hauling the longline, the plate on which the diagonal solid stay and the out-haul stay were mounted came away from the gantry, causing the stabiliser arm to drop. The hinge on the bulwark where the horizontal arm was attached was such that it prevented the arm falling completely, but it did allow it to fall to about 35° below the horizontal (see Figures 8 and 9). The crew were able to recover the arm and return to Nelson, where an engineering company repaired and reinforced the gantry, and reconnected the solid stay and out-haul stay. The owner did not consider it likely that the arm had contacted the hull, so did not carry out an inspection of the underwater hull.
