**Report 07-206, tug *Nautilus III* and barge *Kimihia*, barge capsized while under tow,
Wellington Harbour entrance, 14 April 2007**

Report 07-206

tug *Nautilus III* and barge *Kimihia*

barge capsized while under tow

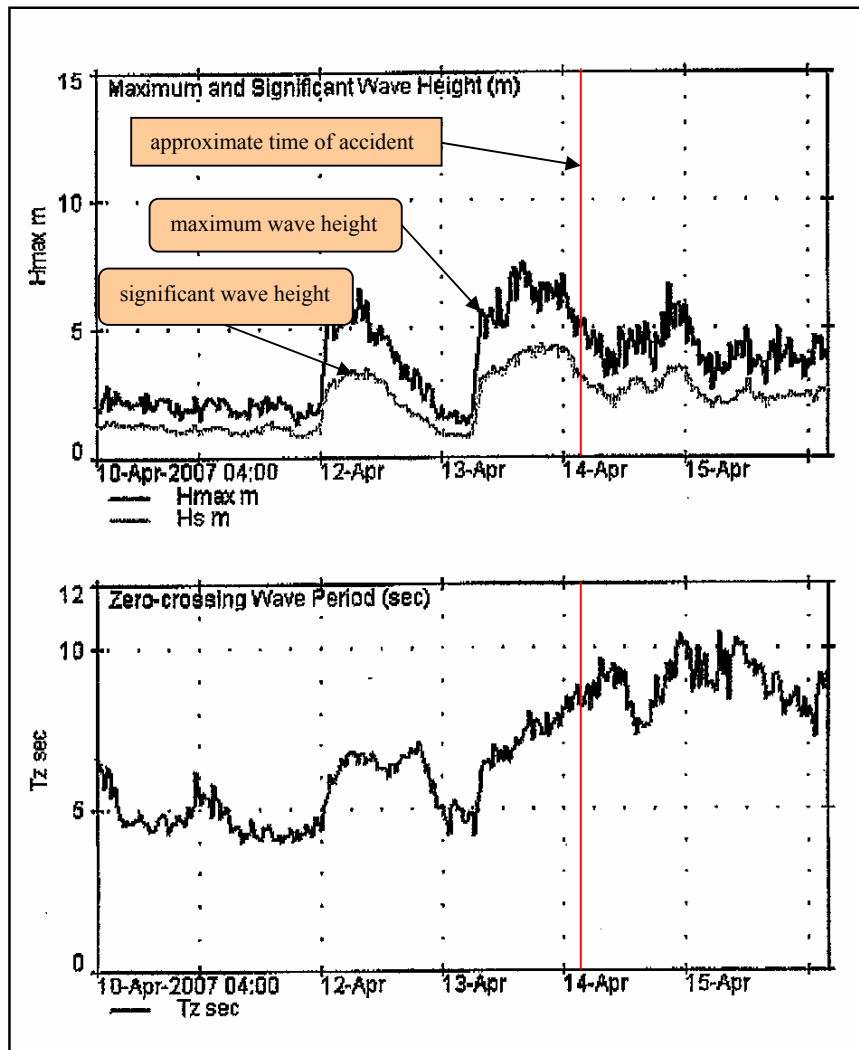
Figure 6
Significant wave height graph

- 2.8 The master and crew thought, as they drew close to the entrance of Wellington Harbour that the swell appeared to increase to such an extent that they were losing sight of the barge. From the significant wave height graph (see Figure 6) it can be seen that by the time they arrived off the port the swell as recorded at Baring Head had peaked and was starting to diminish. However, the shallowing of the water and the outgoing tide from the harbour would have made the swell heap up and the swell would have appeared to increase. Around the south coast and entering Wellington Harbour in southerly conditions would have been the most hazardous part of the journey, and would have been where progressive down flooding of the *Kimihia's* voids probably started.

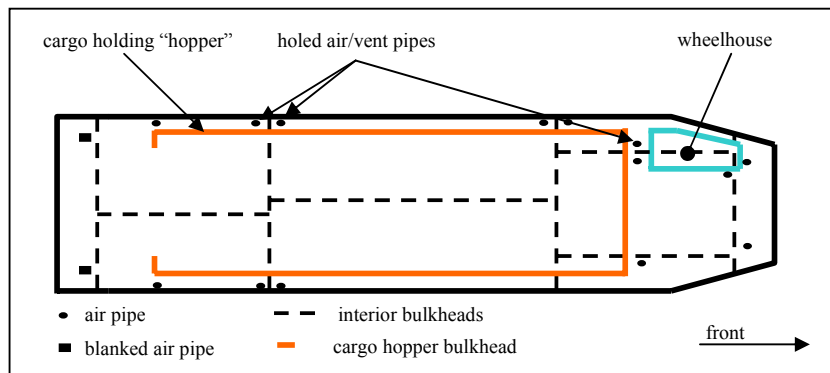
Figure 10
Plan of the *Kimihia*

The capsizing was most probably initiated by the barge taking on a progressive list due to compartment flooding via defective air escapes in the prevailing swell conditions. With about 18 t of water on board the deck edge would be immersed, leading to a rapid increase in the flooding rate.

In this scenario the righting arm (GZ values) would be steadily decreasing, due to combination of the free surface effects and the deck edge immersion. As the stability deteriorated, the prevailing conditions with the occasional large swells would inevitably lead to a capsizing situation.
