Report 08-001, Cessna 152 ZK-ETY and Robinson R22 ZK-HGV, mid-air collision, Paraparaumu, 17 February 2008

Cessna 152 ZK-ETY and Robinson R22 ZK-HGV

mid-air collision

17 February 2008

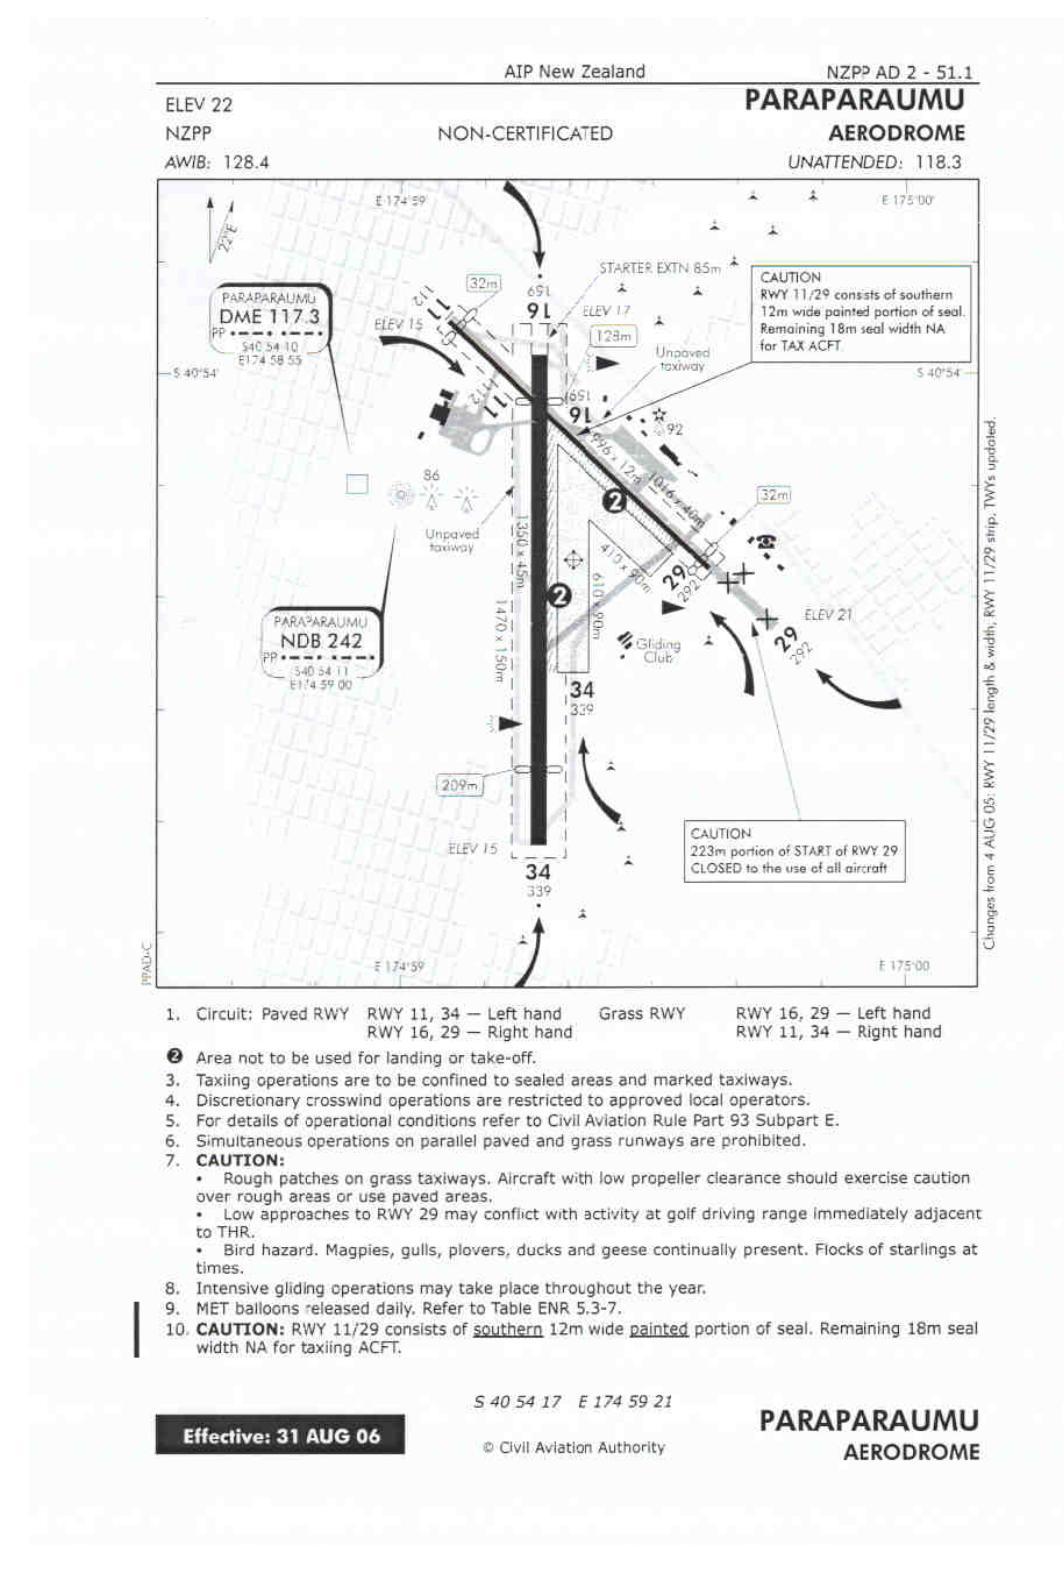
Figure 3 Landing chart (not to be used for navigation)

- 1.2.13 Paraparaumu Aerodrome was located near the coast and contained within the general boundary of the Paraparaumu township. The aerodrome had 2 paved runways and 2 parallel grass runways available for use.¹³ These were 11/29 paved and grass, and 16/34 paved and grass. Runway 16/34 was longer and used more often than runway 11/29 (see Figure 3).

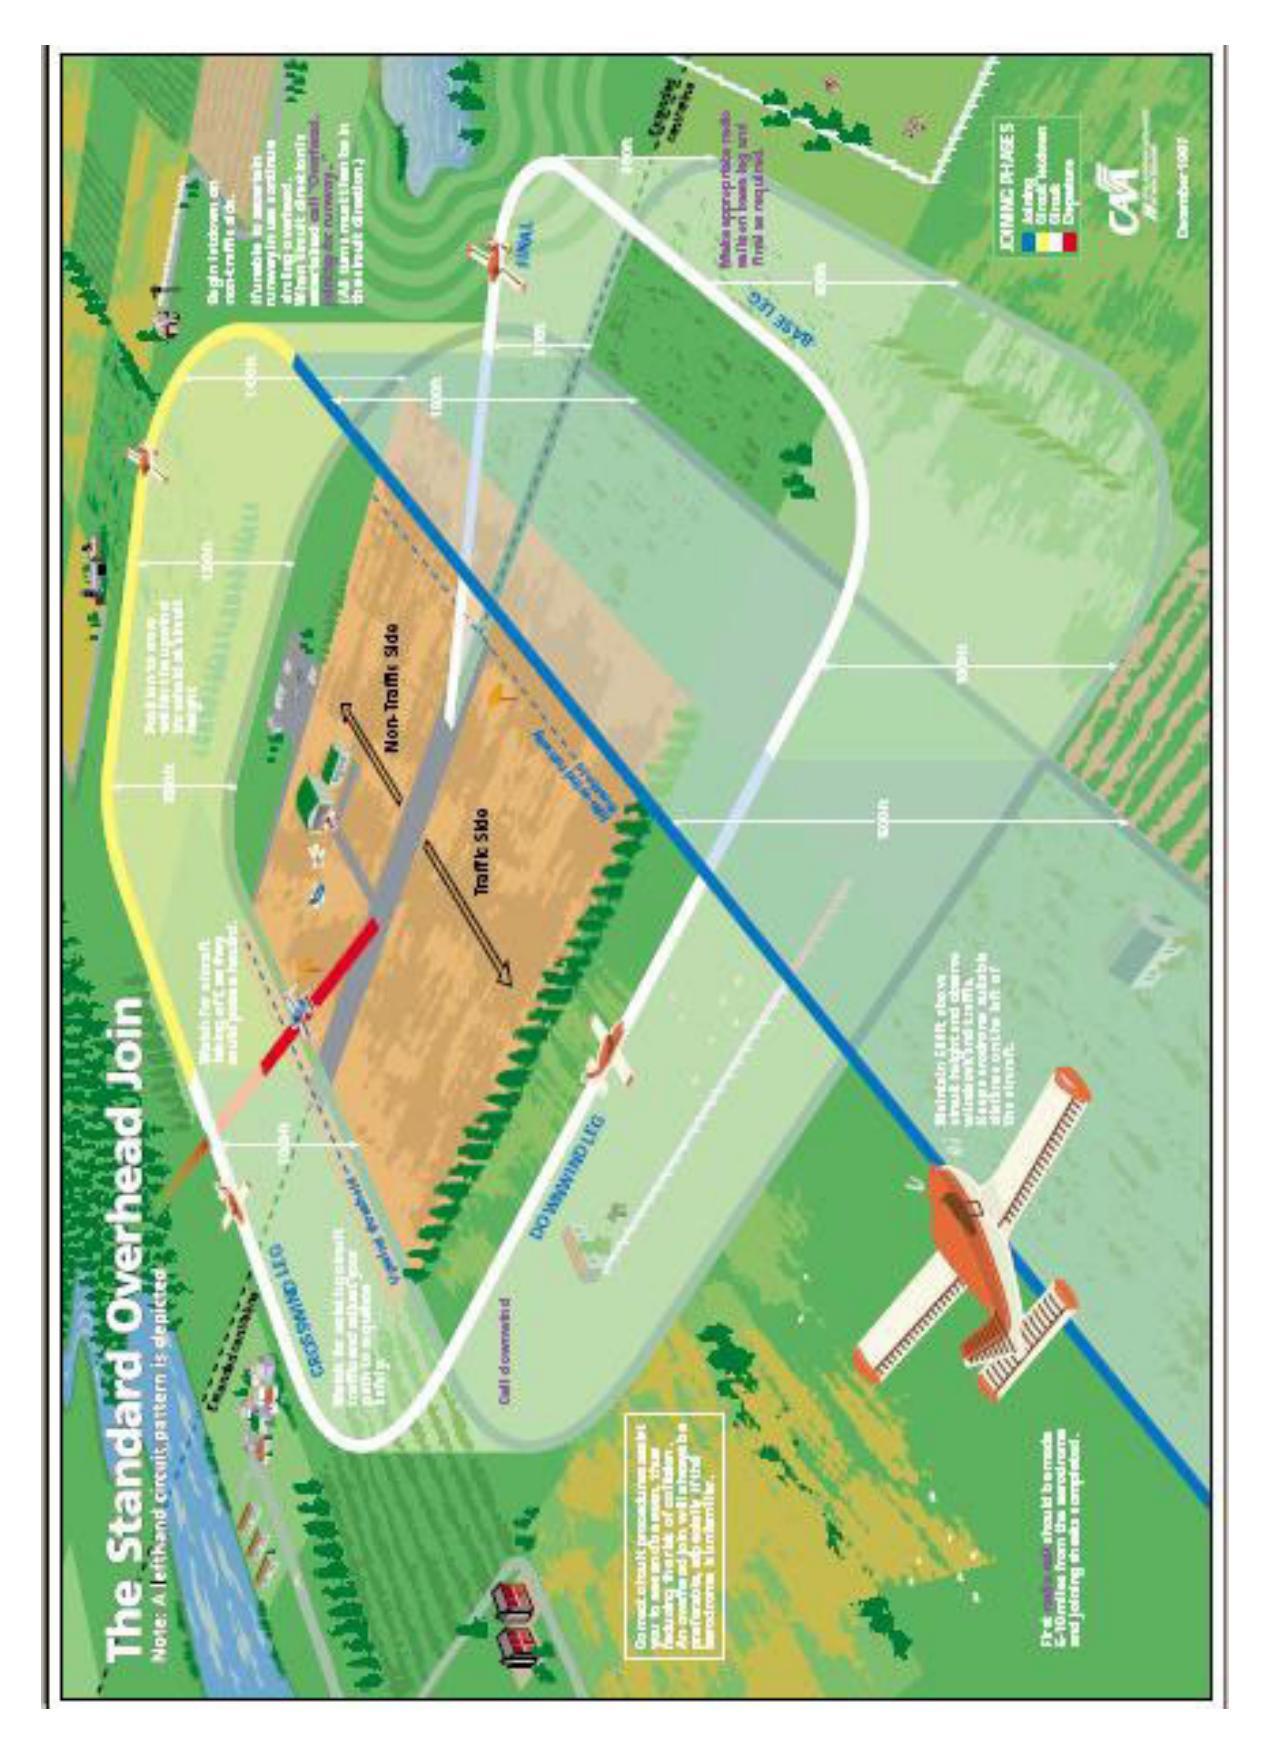
Figure 5 Standard overhead joining procedure (Courtesy of the CAA)

- 1.6.11 At controlled aerodromes, ATC instructions could be complemented by published arrival and departure procedures. Some uncontrolled aerodromes, for example Ardmore and Milford, also had published arrival and departure procedures. For other uncontrolled aerodromes the CAA promoted the use of a standard overhead joining procedure for pilots to follow when joining the circuit. The CAA's Aeronautical Information Publication (AIP) described the circuit and standard overhead joining procedure that should be flown at unattended aerodromes and when a pilot was unfamiliar with an aerodrome or needed to identify and fit in with circuit traffic.²⁹ The CAA also distributed additional material in the form of posters and articles describing the standard joining procedure and right of way (see Figure 5).³⁰
