**Report 08-206: passenger ferry *Monte Stello*, collisions with wharves,
Picton and Wellington, 8 and 9 August 2008**

Report 08-206

**passenger ferry
*Monte Stello***

collisions with wharves

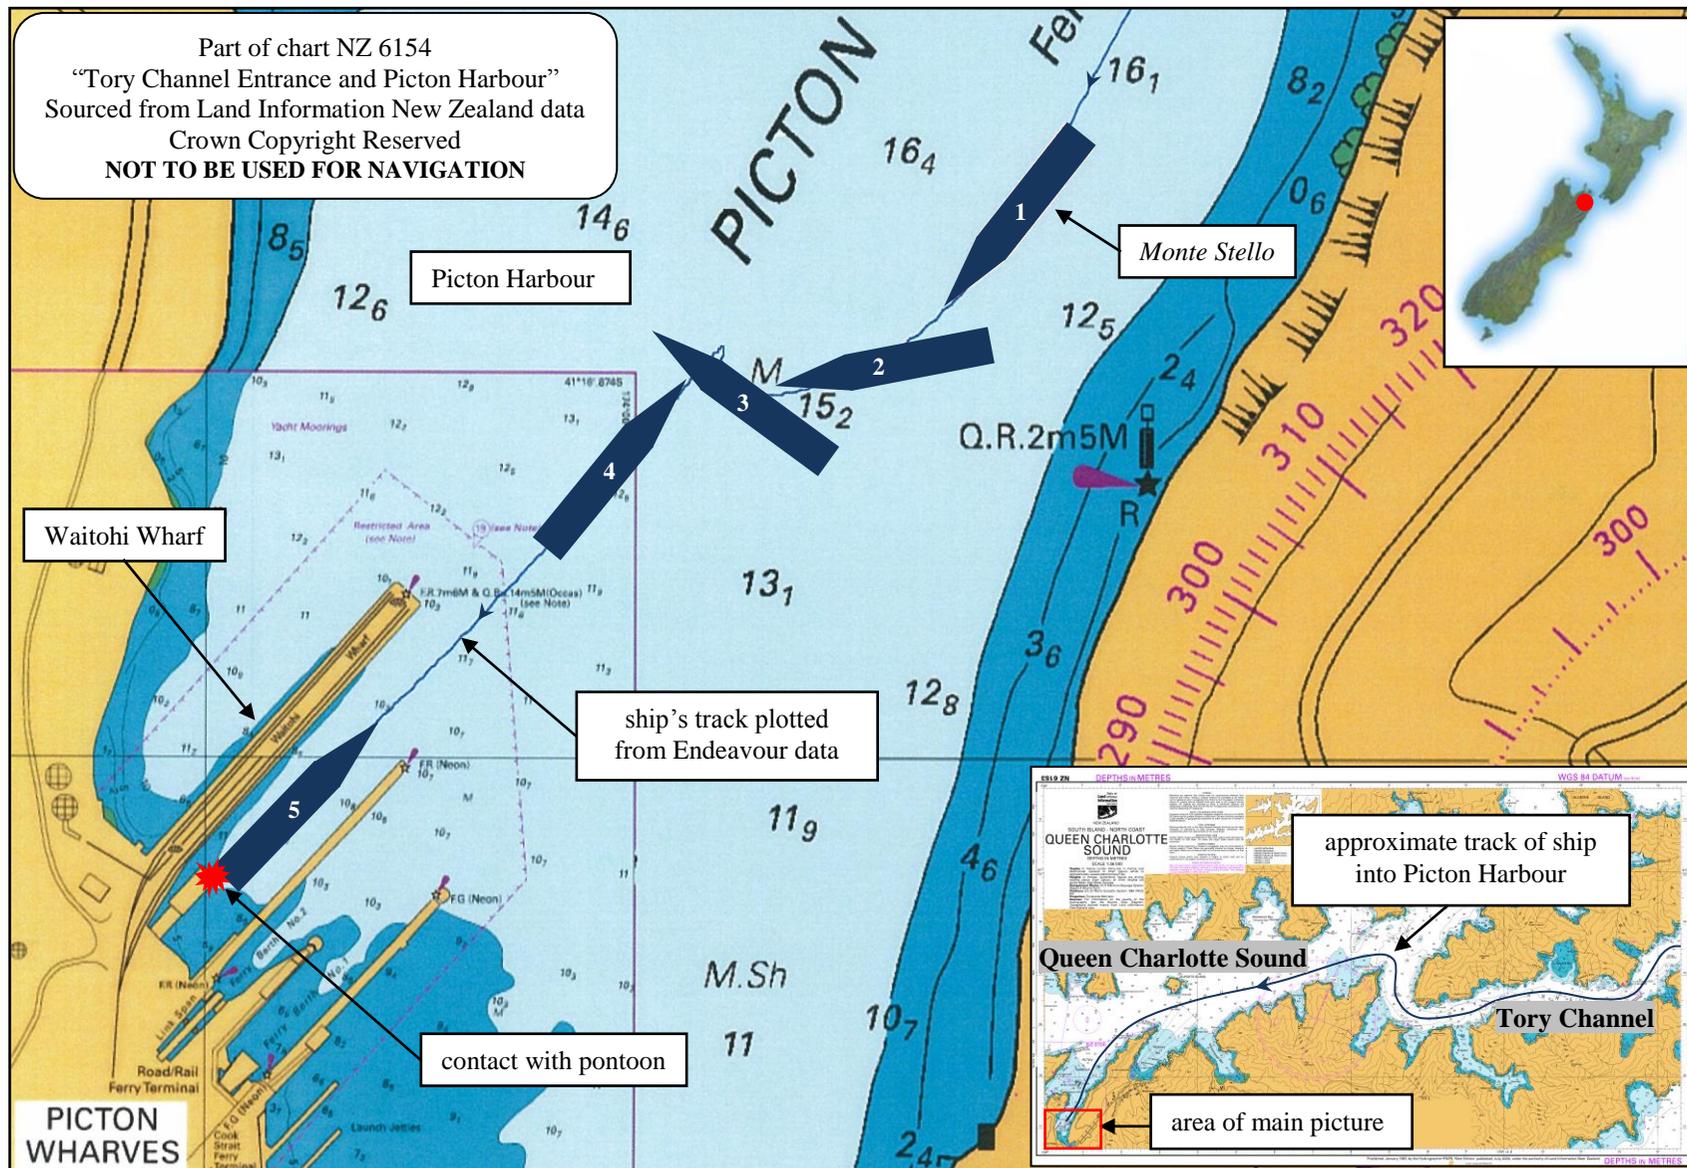
Figure 1
General area of Picton collision

- 1.1.1 At about 2300 on 7 August 2008, the passenger and freight ferry *Monte Stello* had crossed Cook Strait and was about 20 minutes from the entrance to Tory Channel. A master, who was additional to the ship's usual crew who was conning the ship handed over to the second officer for training purposes. The second officer was to con the ship under the supervision of the additional master for the remainder of the voyage through Tory Channel and Queen Charlotte Sound to Picton (Figure 1 inset). A lookout and helmsman were also present on the bridge.

- 1.1.3 The weather at the time was cold with a slight drizzle and light winds about 5 knots varying southeast to southwest.
- 1.1.4 The second officer operated the steering and bow thruster controls and was verbally giving propeller pitch orders to the additional master, who was operating the engine pitch controls. The ship was turned to starboard through 180 degrees by using astern thrust on the starboard engine, ahead thrust on the port engine and the bow thruster until it was parallel to Waitohi Wharf (Figure 1).

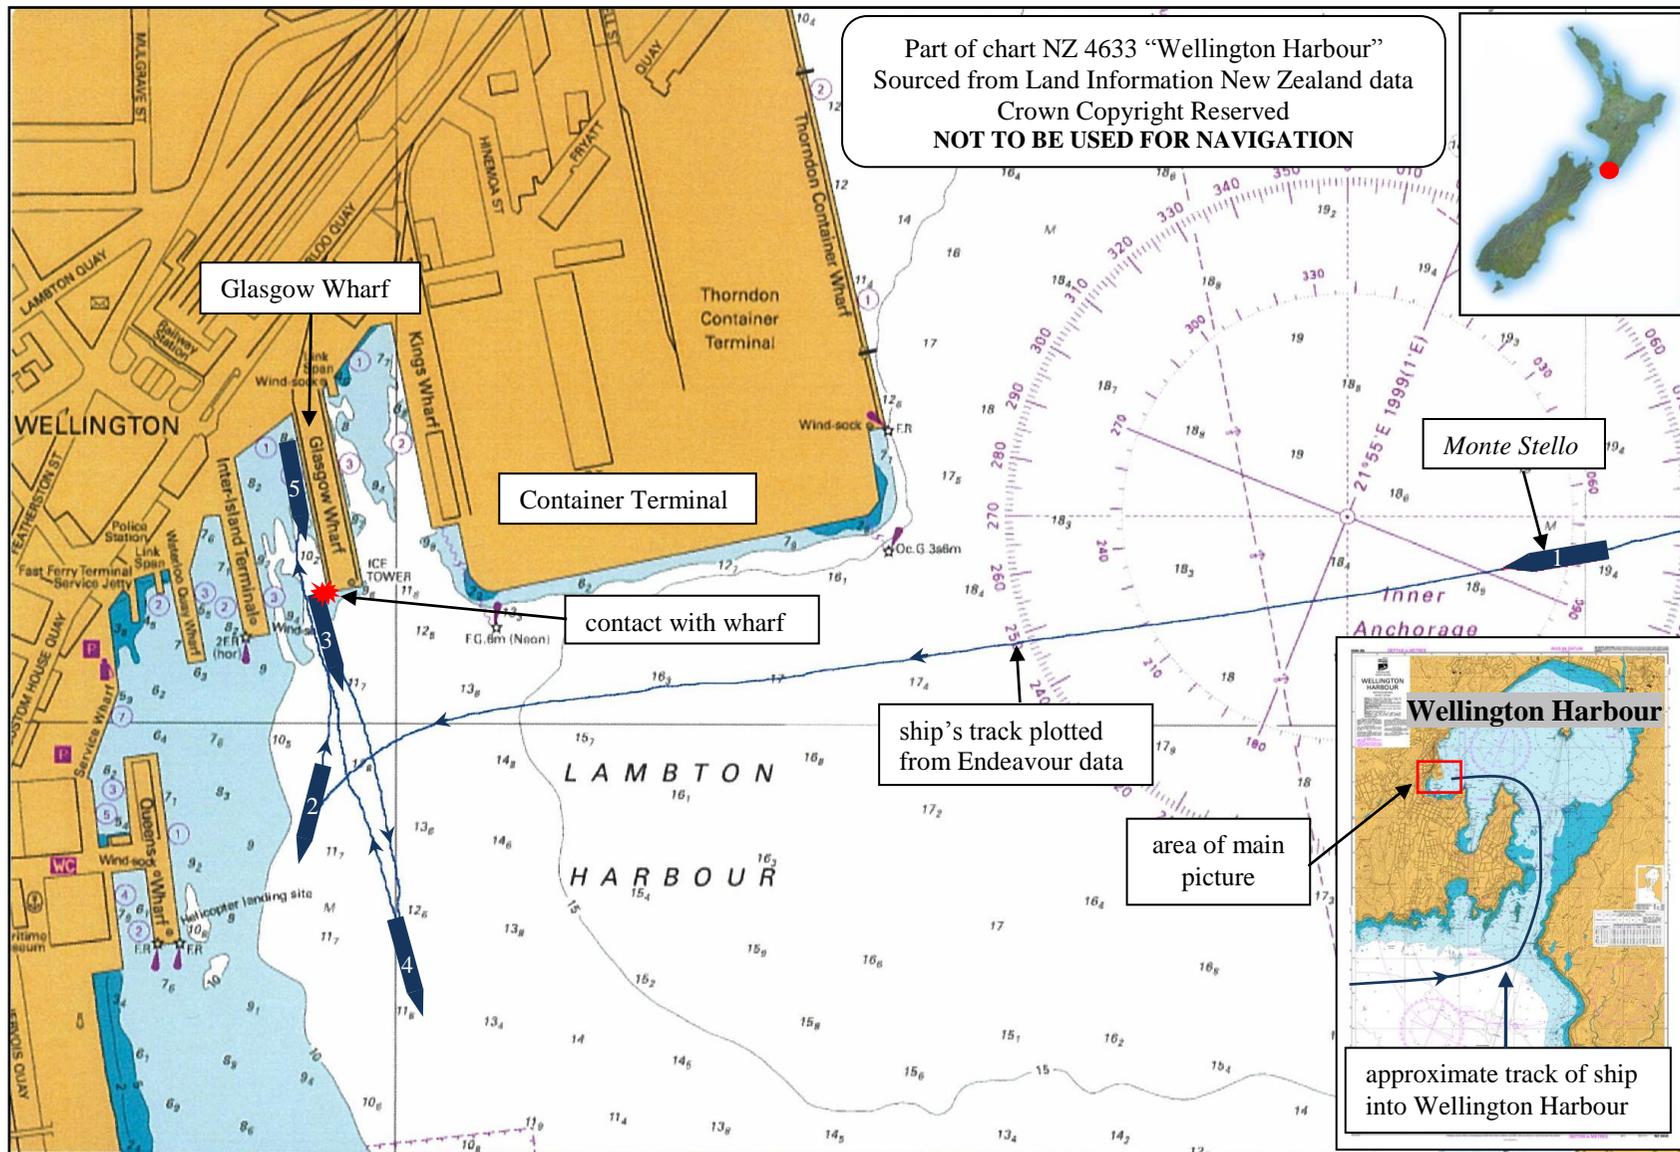
Figure 2
General area of Wellington collision

- 1.1.18 By about 0756, the ship had transited Wellington Harbour and was making a standard approach to Glasgow Wharf with some allowance being made for a south-southwest wind blowing at about 25 knots, gusting 30 knots. The ship was making about 13.9 knots (position 1 in Figure 2).

- 1.1.19 The master went to the starboard bridge wing with the remote steering control and swung the ship through a port turn, assisted by the second officer positioned at the centre console ready to operate the engine pitch and bow thruster controls to the master's orders. The turn was executed using rudder, zero pitch on the port propeller and keeping ahead pitch (+3) on the starboard propeller (position 2 in Figure 2).

- 1.1.32 The master brought the ship to rest towards the middle of the harbour (position 4 in Figure 2) and changed the pitch controls back to the bridge centre control station. The master then tested the pitch controls of both engines ahead and astern. Both were observed to operate but with different speeds of response.

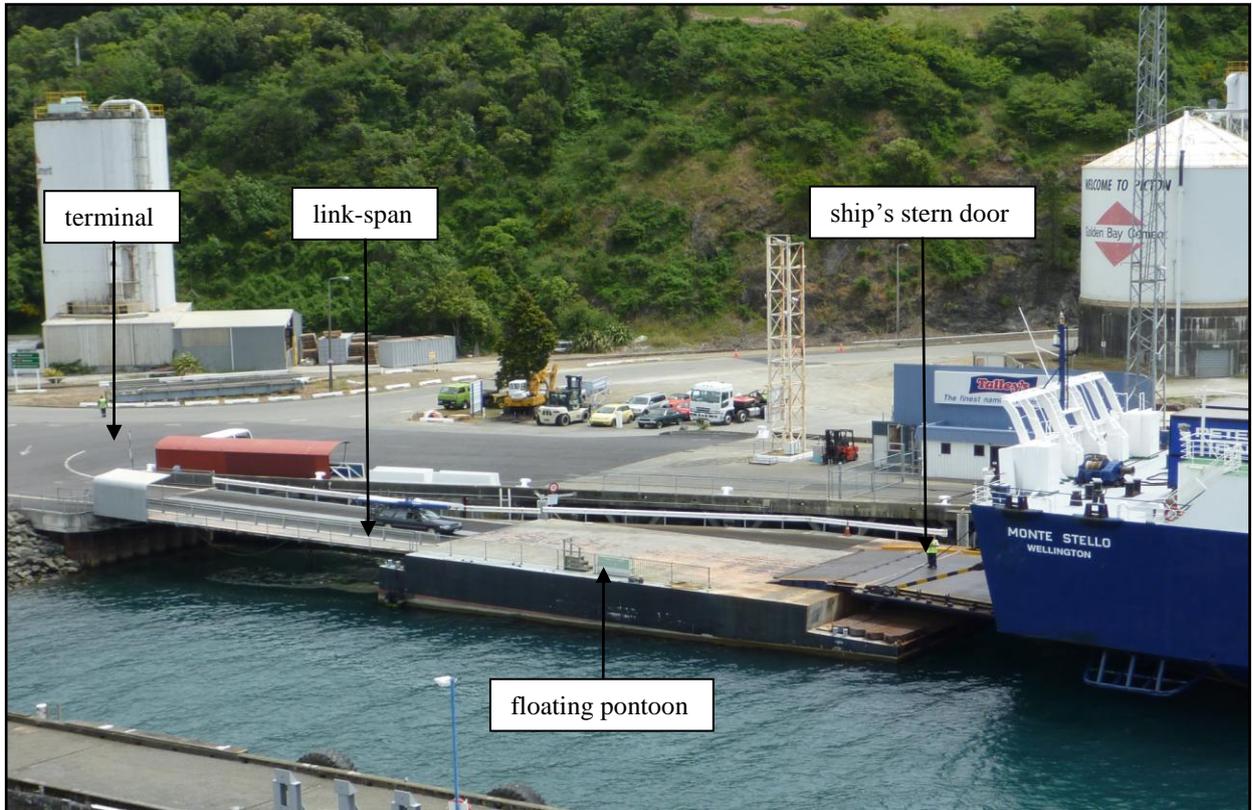
Figure 3
Picton link-span and floating pontoon

- 1.2.1 Waitohi Wharf in Picton utilised a link-span to facilitate the loading and unloading of Strait Shipping's 2 passenger ferries. The link-span was hinged at both ends, one of which was connected to the shore and the other to a floating pontoon onto which a ship's stern door was lowered (Figure 3).

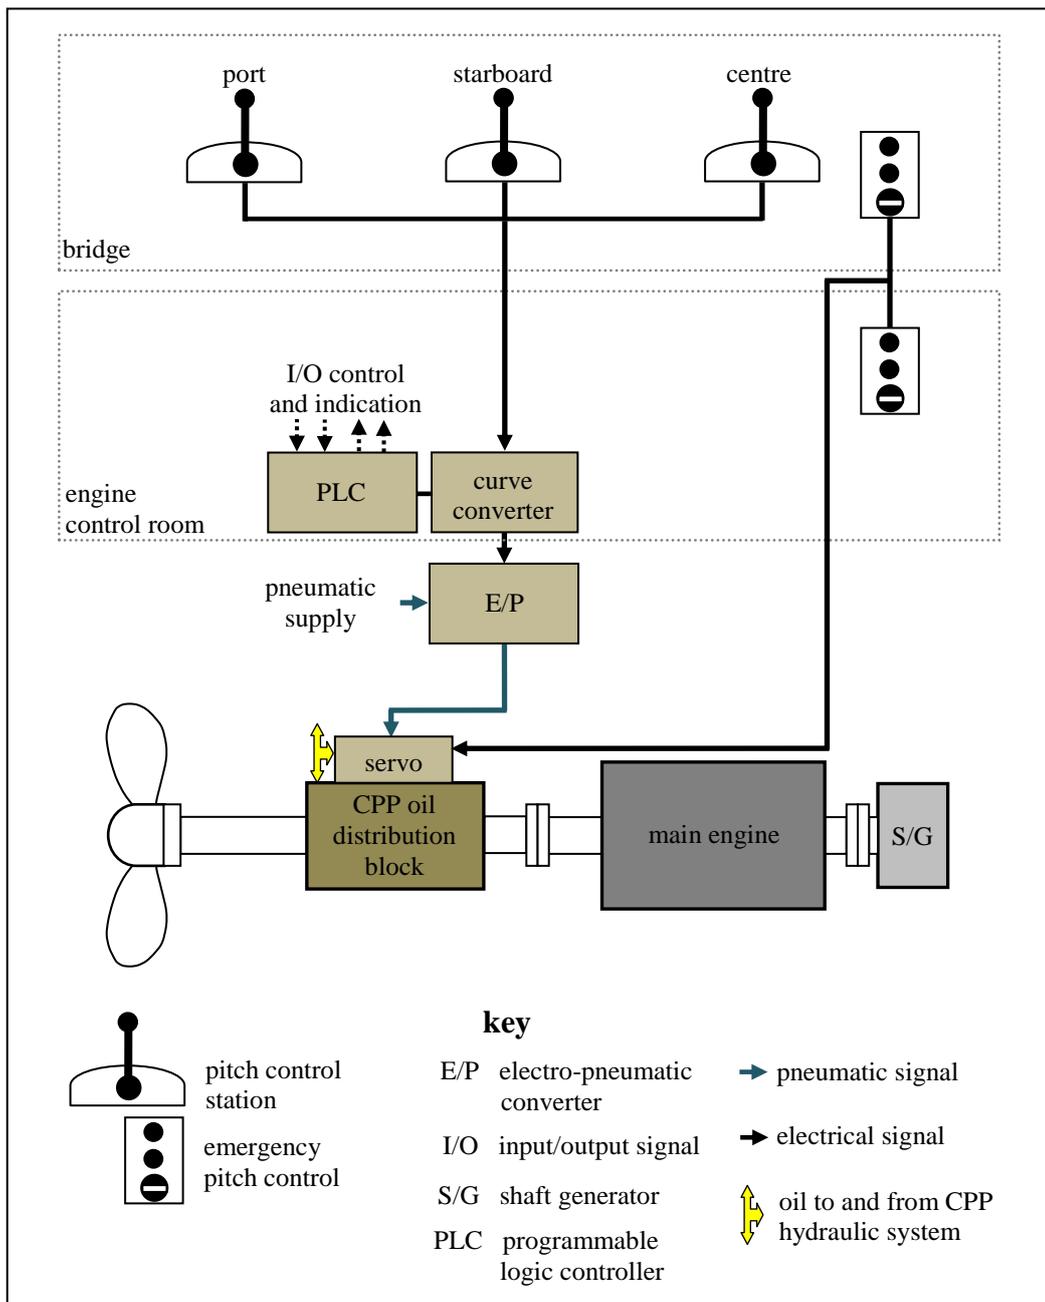
Figure 7
Simplified CCP system

- 1.5.3 The original CPP system had been installed by LIPS BV when the ship was built. In 1995 when the ship was reinstated after it grounded, the CPP control system had been modified. The system was originally capable of 2 modes of operation: "constant speed" and "combinator". Strait Shipping only operated in the constant speed mode, where the engine revolutions remained constant at all times and only the pitch was adjusted. The combinator mode was not used because the main engine-driven shaft generators required a constant speed and the system had not been tested. In the combinator mode adjustments would have been made to engine revolutions and pitch together through the manoeuvring range. The original control functions

for an automatic pitch reduction in the event of an overload of an engine also did not function, so pitch adjustments were made manually on the bridge, usually on advice from the engine room.

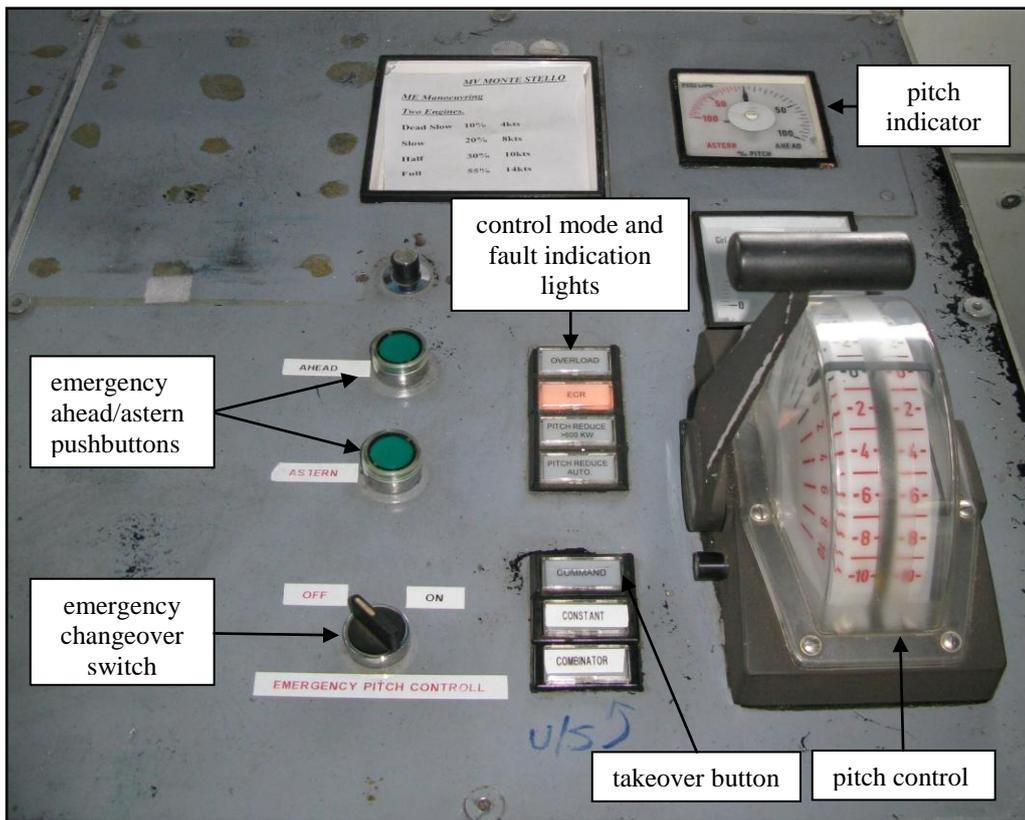
Figure 8
Port pitch control on bridge centre console

1.5.4 On the *Monte Stello* the pitch on the propellers was normally controlled from one of the 3 bridge control stations, one located at the centre console inside the bridge and one located on each bridge wing. Each control station had pitch levers for both propellers, but only one station could be used at any time. When the ship was secure alongside and the engines not required, control was transferred to the engine control room station.

taken. When a control station was active, the pitch control lever scale and take-over buttons were illuminated (Figures 8 and 9). Pitch indicators at each control station displayed the amount of pitch on each propeller.

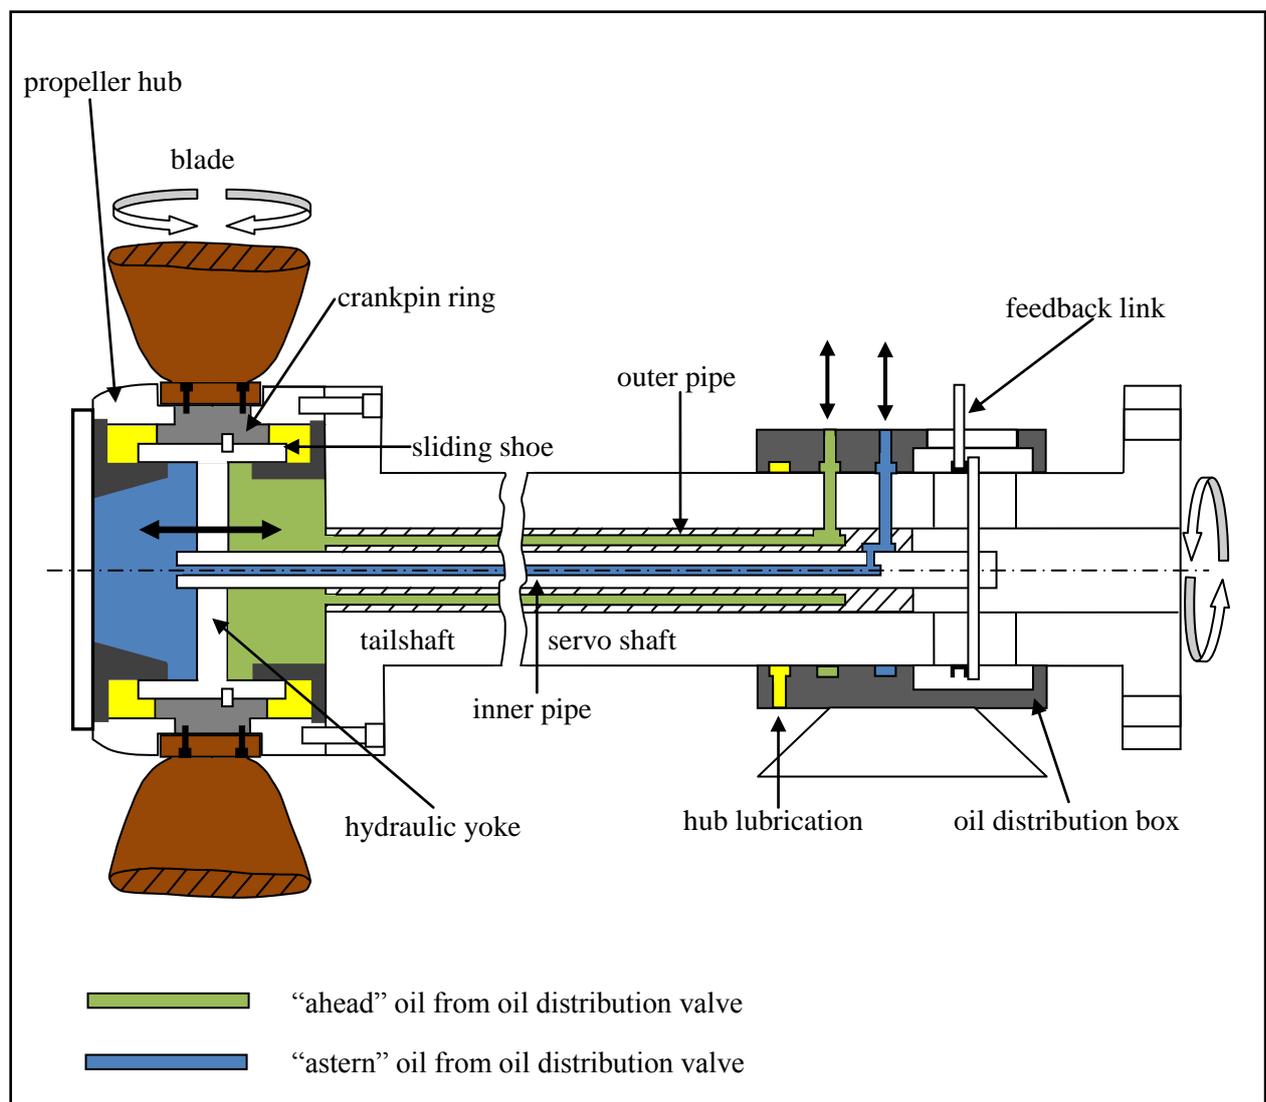
Figure 10
Simplified drawing of CPP operation

- 1.5.9 Figure 10 shows a simplified diagram of the general principle of operation for the CPP propellers on the *Monte Stello*. A cast propeller hub was bolted to each tail shaft, and inside the hub a hydraulic yoke was connected to the moveable propeller blades via a sliding shoe and crankpin ring. This arrangement converted an axial movement of the yoke to rotate the blades about their own axis.

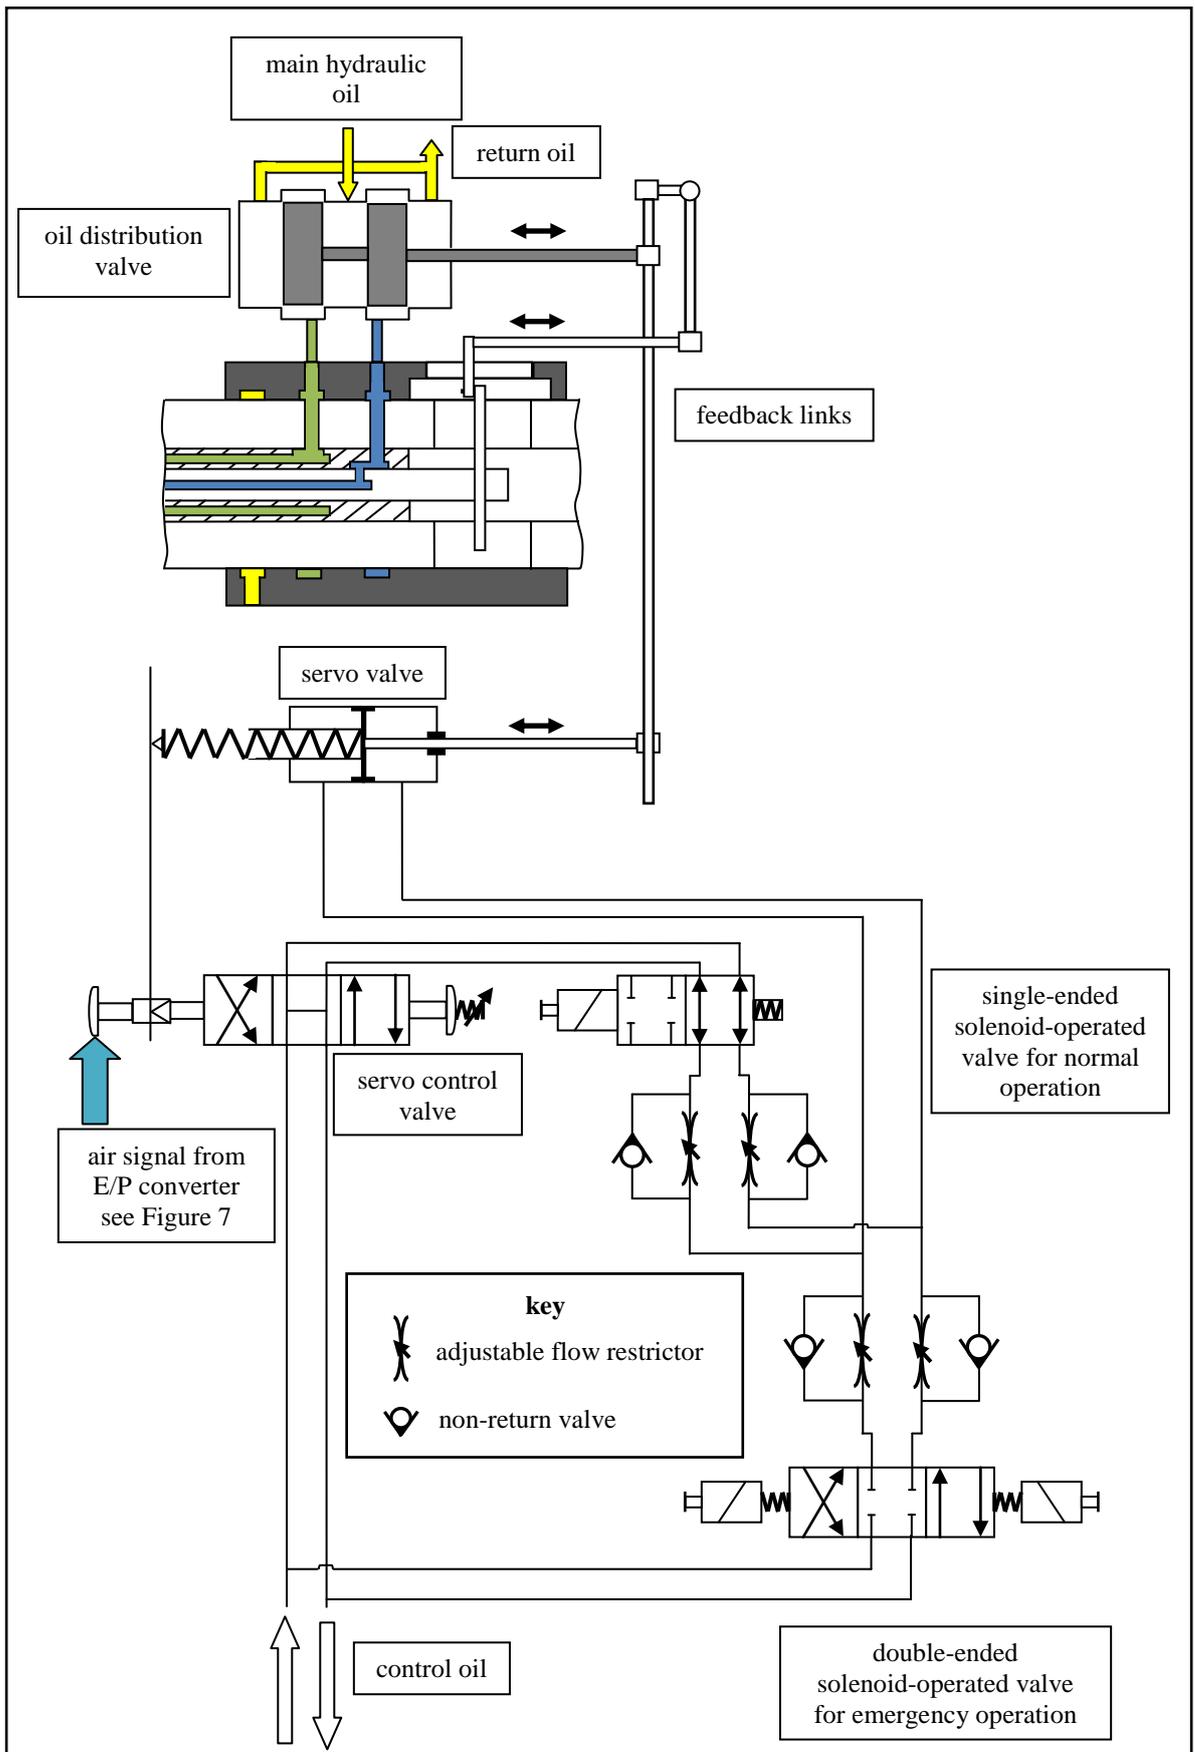
Figure 11
CPP control system

- 1.5.13 Figure 11 shows the principle of operation of the oil distribution valve.
- 1.5.14 In the event of a failure of the bridge controls, the first available option was to use the emergency pitch control (buttons) on the bridge. If this failed, the engine room could control the pitch in the same way using an identical set of emergency pitch controls in the engine control room. In the event of a total failure of the remote control systems, pitch could be controlled locally in the engine room at the oil distribution box by using a lever to operate the servo manually. A telegraph system and telephone were provided at these local stations to facilitate helm orders from the bridge.

- 1.5.16 Figure 11 has been developed from the manufacturer's drawing and shows in more detail the pneumatic/hydraulic control system for a single CPP system (Lips B.V Drunen- Holland, 1995). The air signal from the E/P converter operated a 3-position hydraulic valve (servo control valve) that was supplied with control oil from the main hydraulic system. In normal operation, oil from the servo control valve passed through the single solenoid valve to a servo valve. The position of the servo control valve determined the oil flow to and from the servo valve, which was mechanically linked to the oil distribution valve. The movement of the link operated the oil distribution valve, which applied main hydraulic oil to the oil distribution block to move the propeller blades in the required direction. In an emergency the servo valve could be disconnected and a lever on the link used to control the pitch at the oil distribution box in the event of a total control failure.

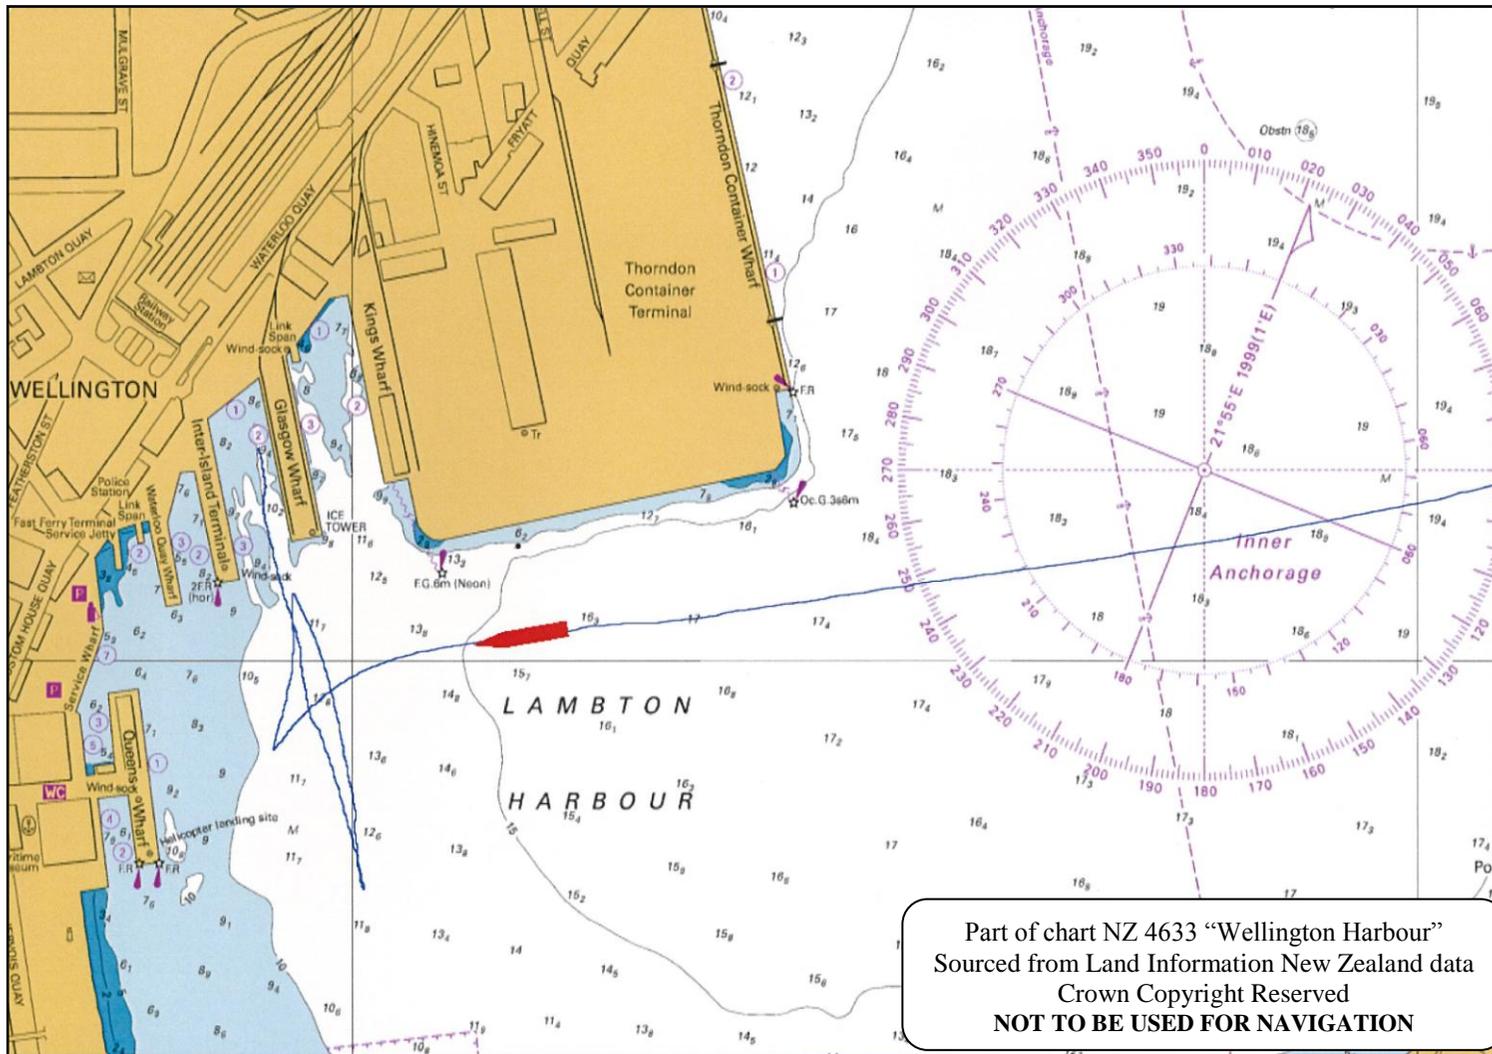
Monte Stello on approach about to turn to port

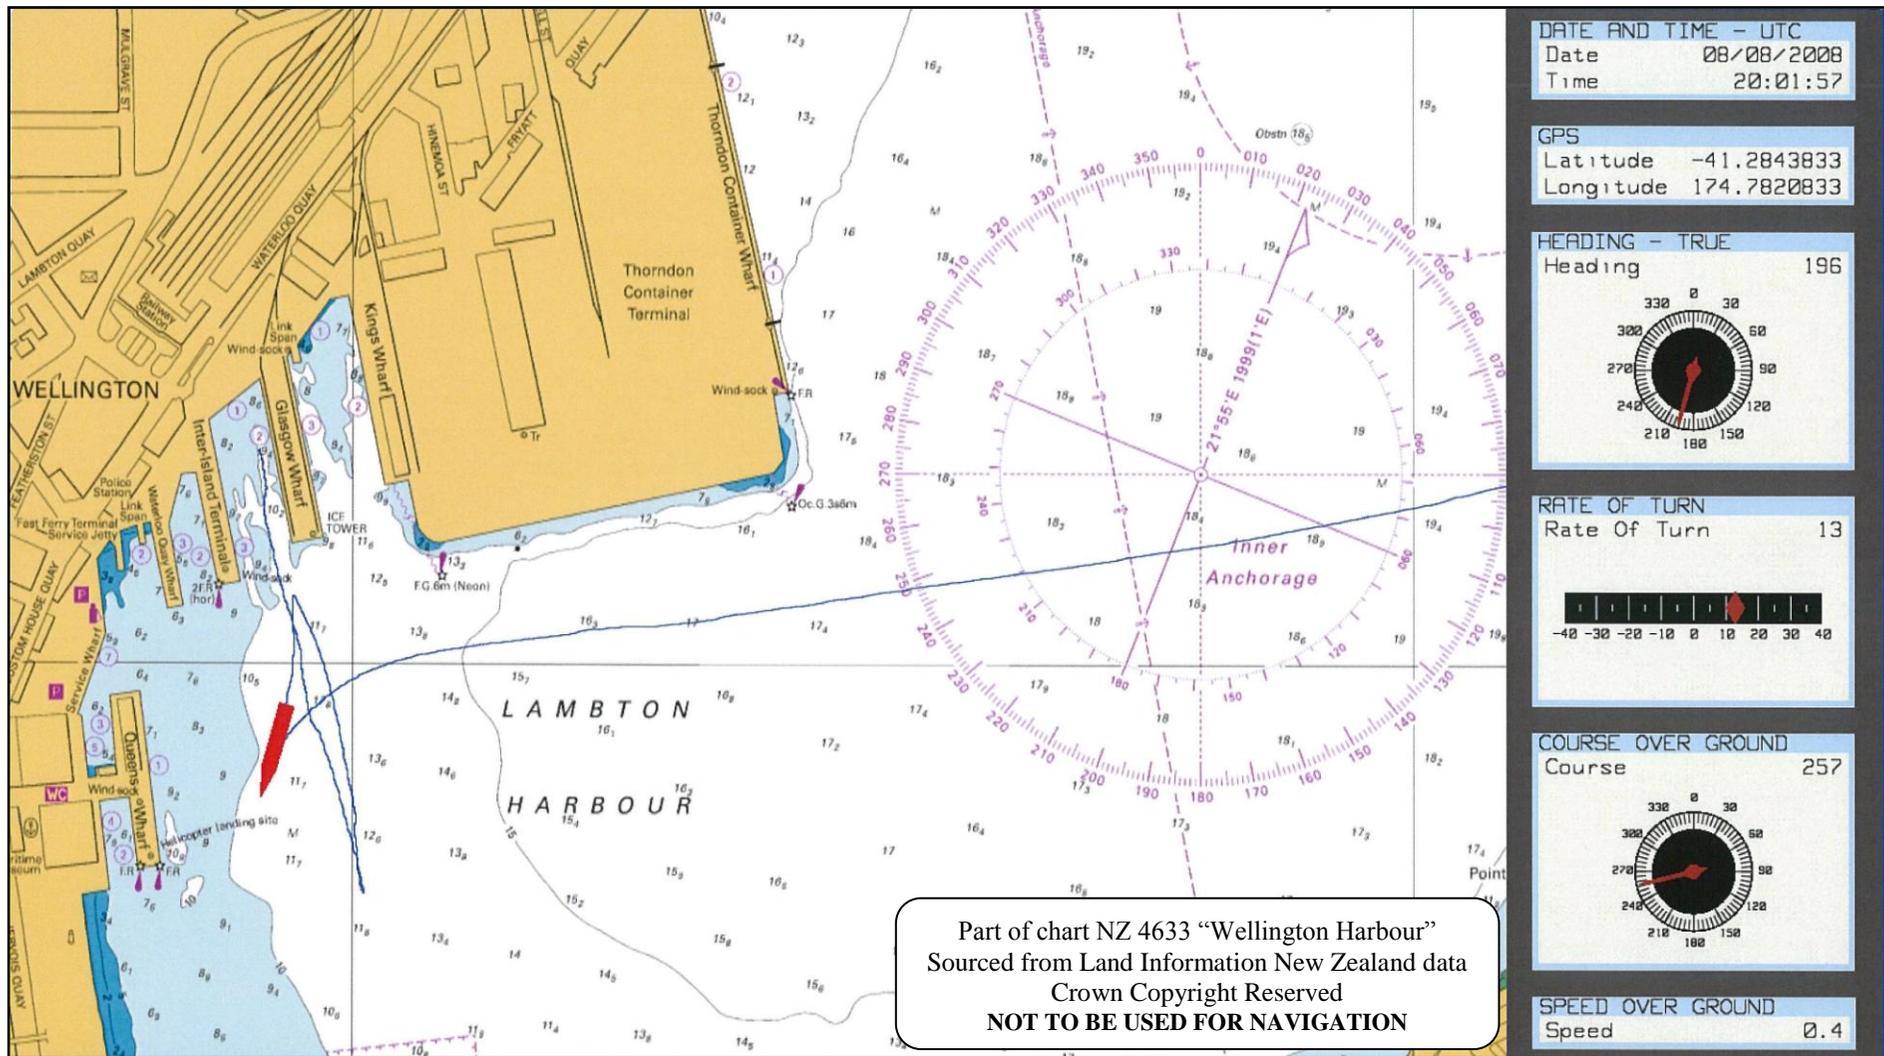
Monte Stello turn complete (about 210 m from knuckle of wharf)

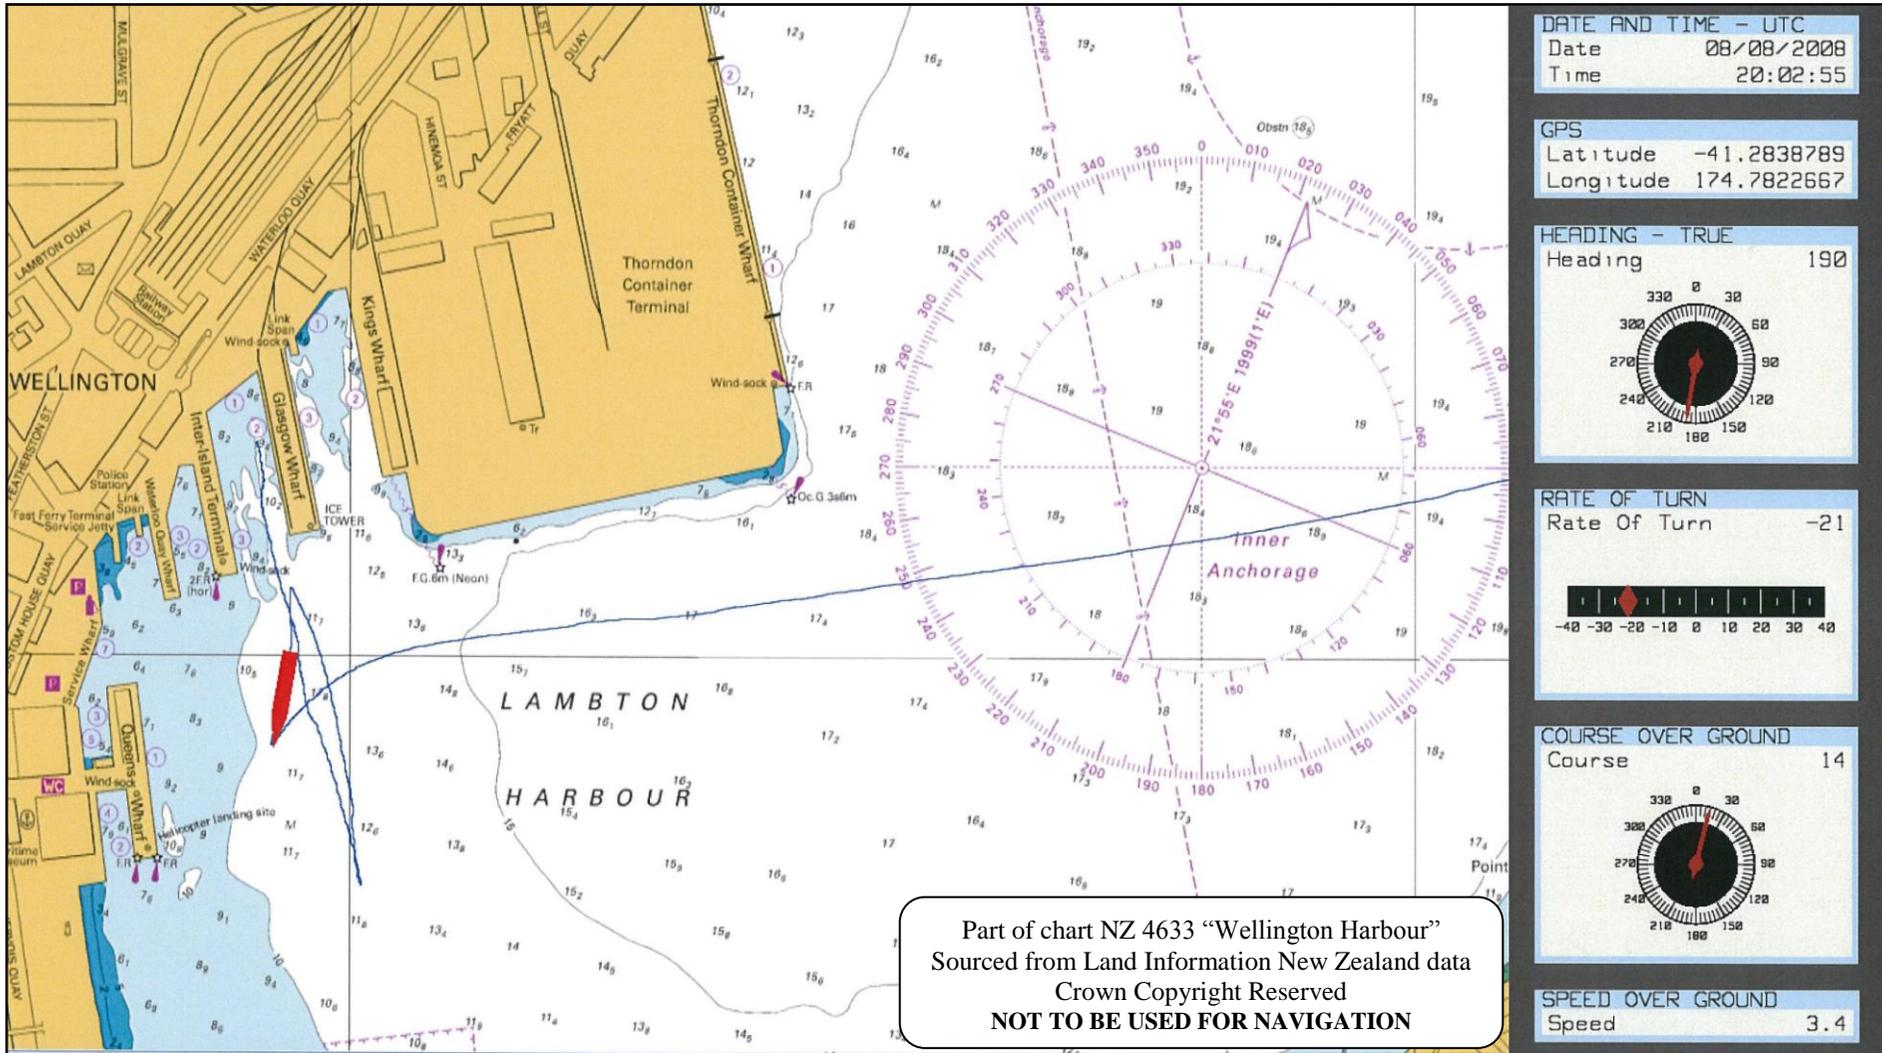
Monte Stello backing towards wharf (about 150 m from knuckle of wharf)

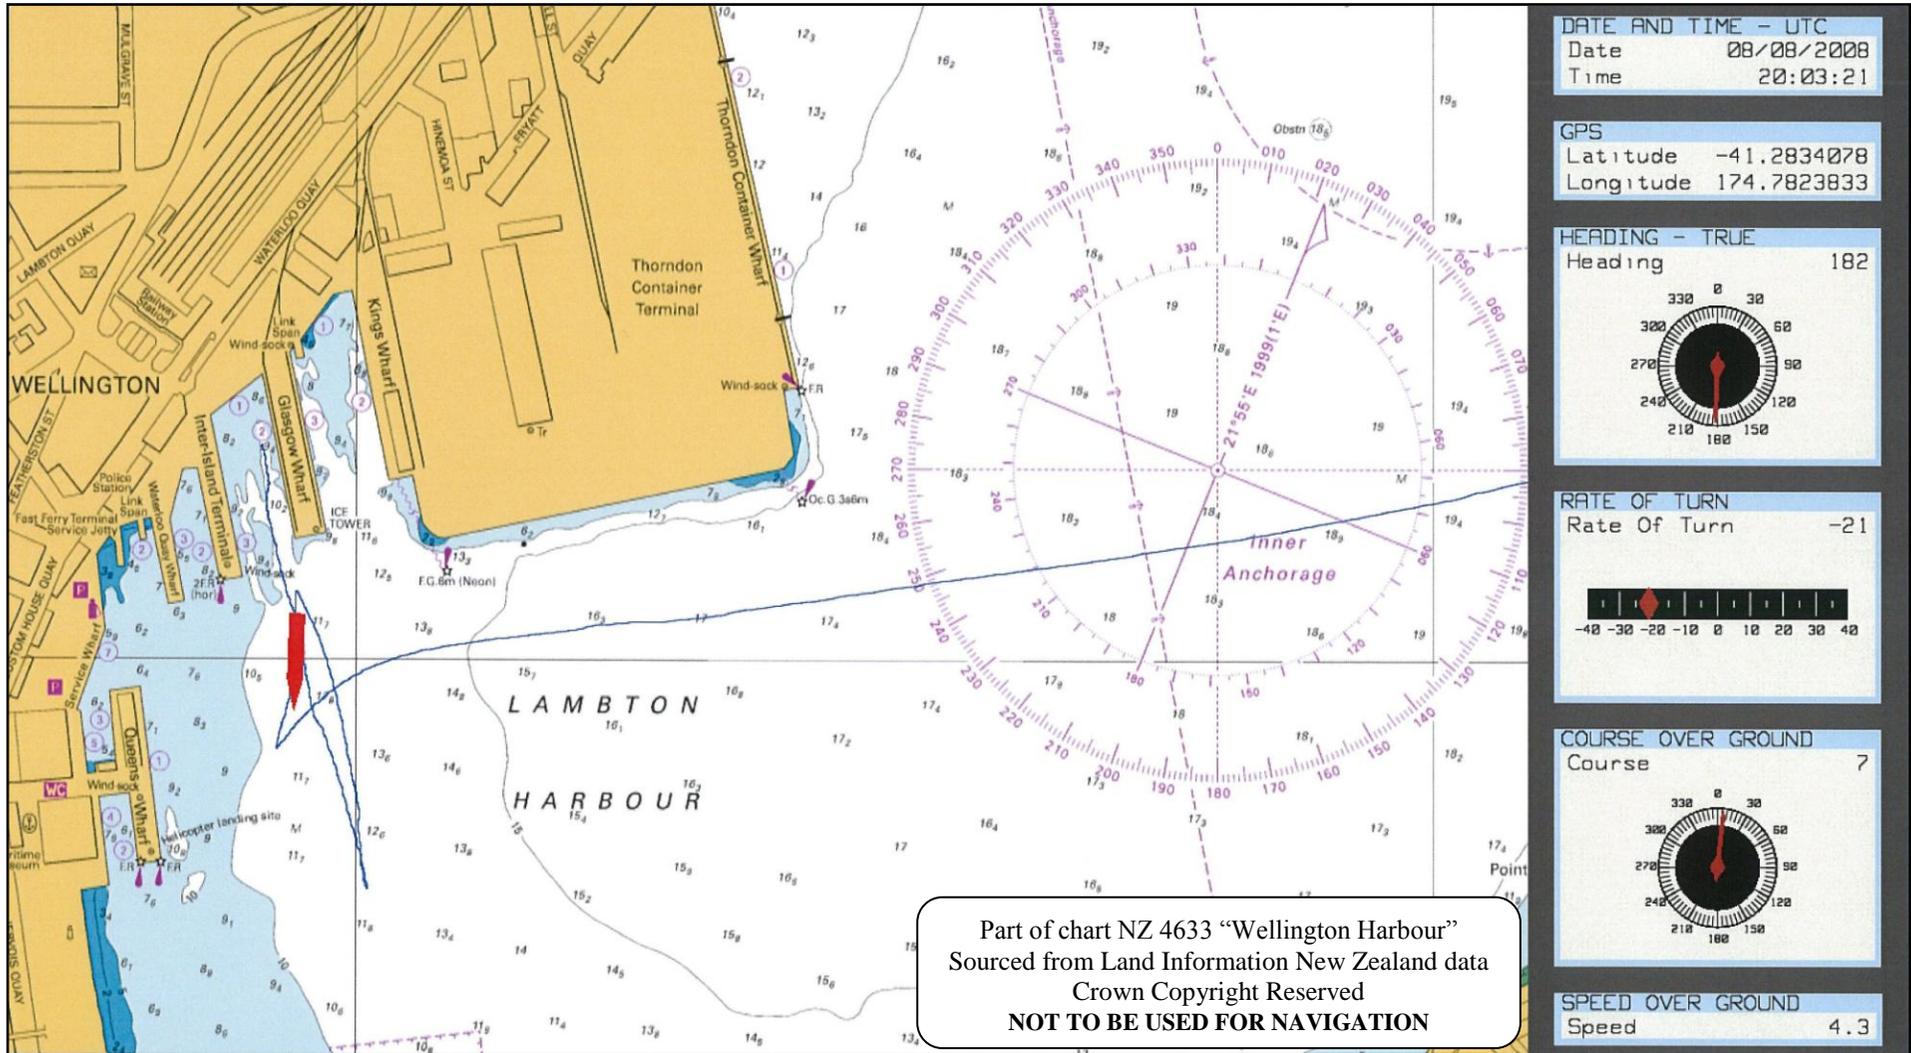
Monte Stello backing towards wharf (about 100 m from knuckle of wharf)

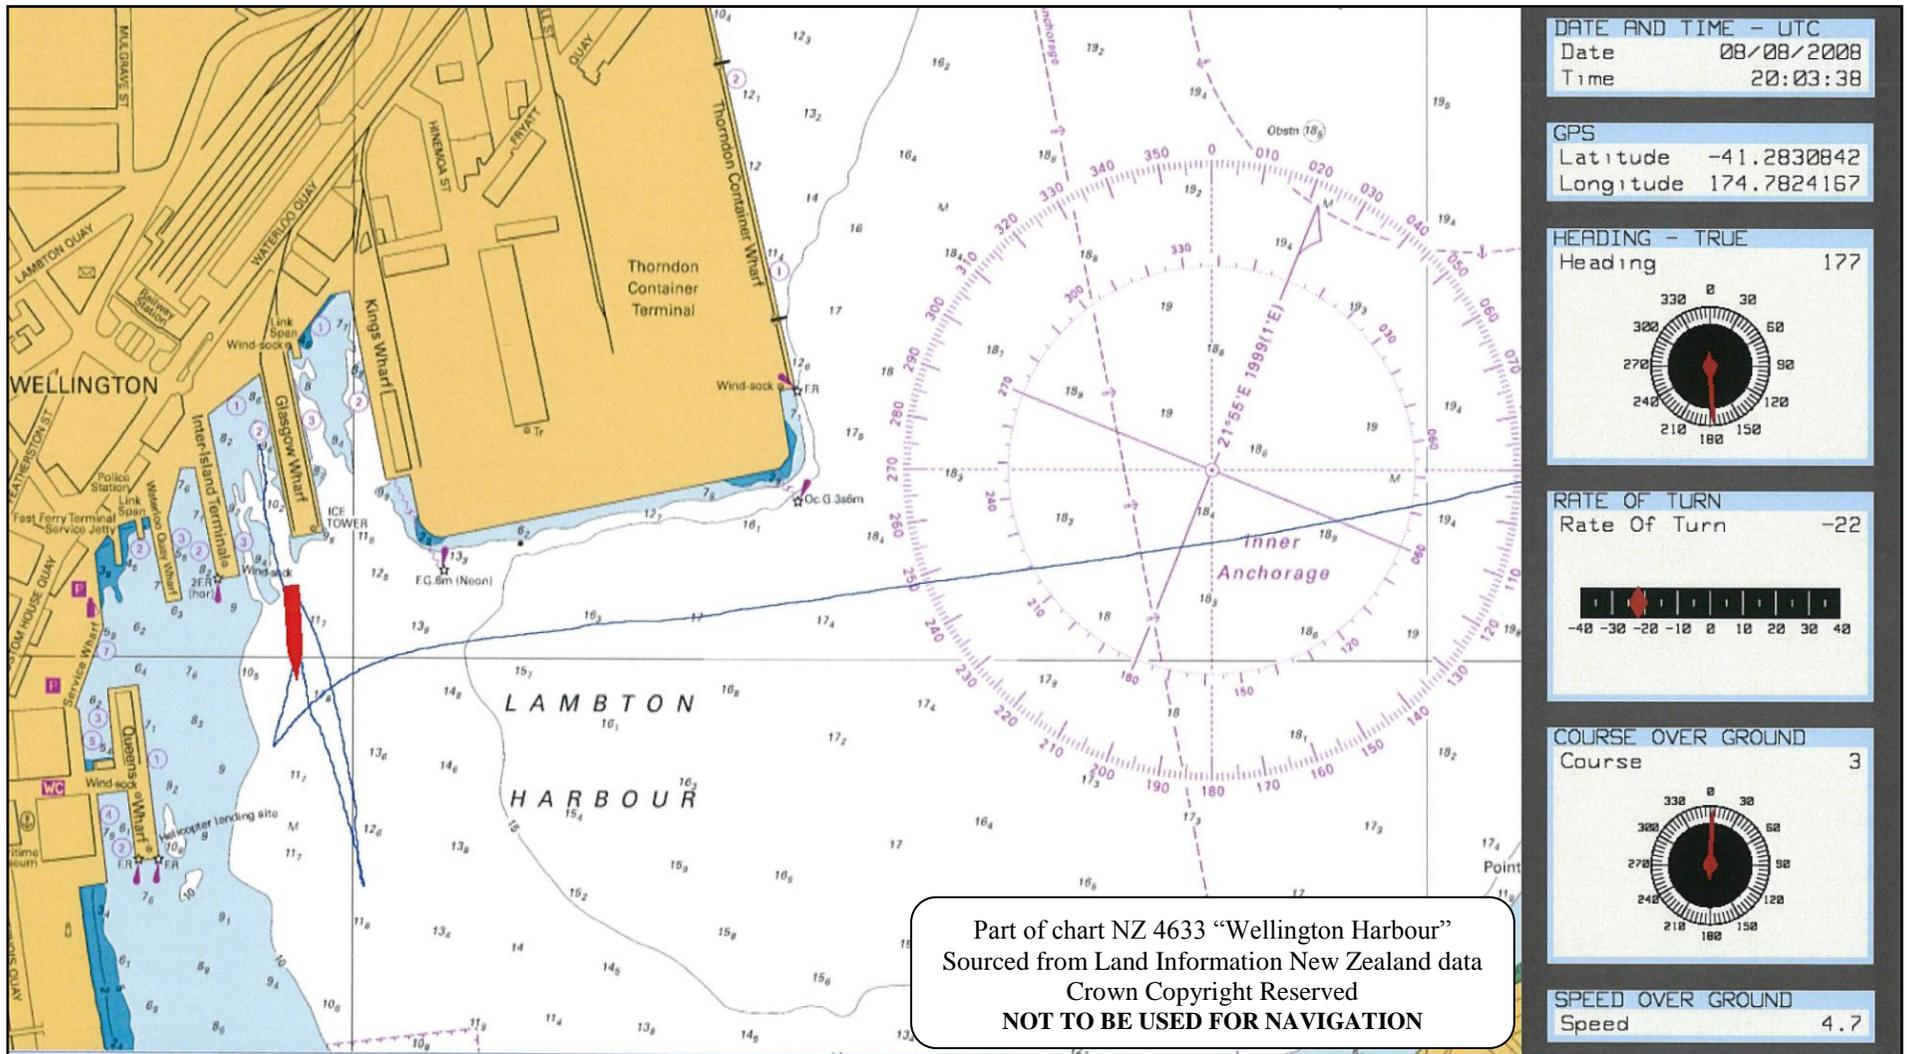
Monte Stello backing towards wharf (about 60 m from knuckle of wharf)
