**Report 08-206: passenger ferry *Monte Stello*, collisions with wharves,
Picton and Wellington, 8 and 9 August 2008**

Report 08-206

**passenger ferry
*Monte Stello***

collisions with wharves

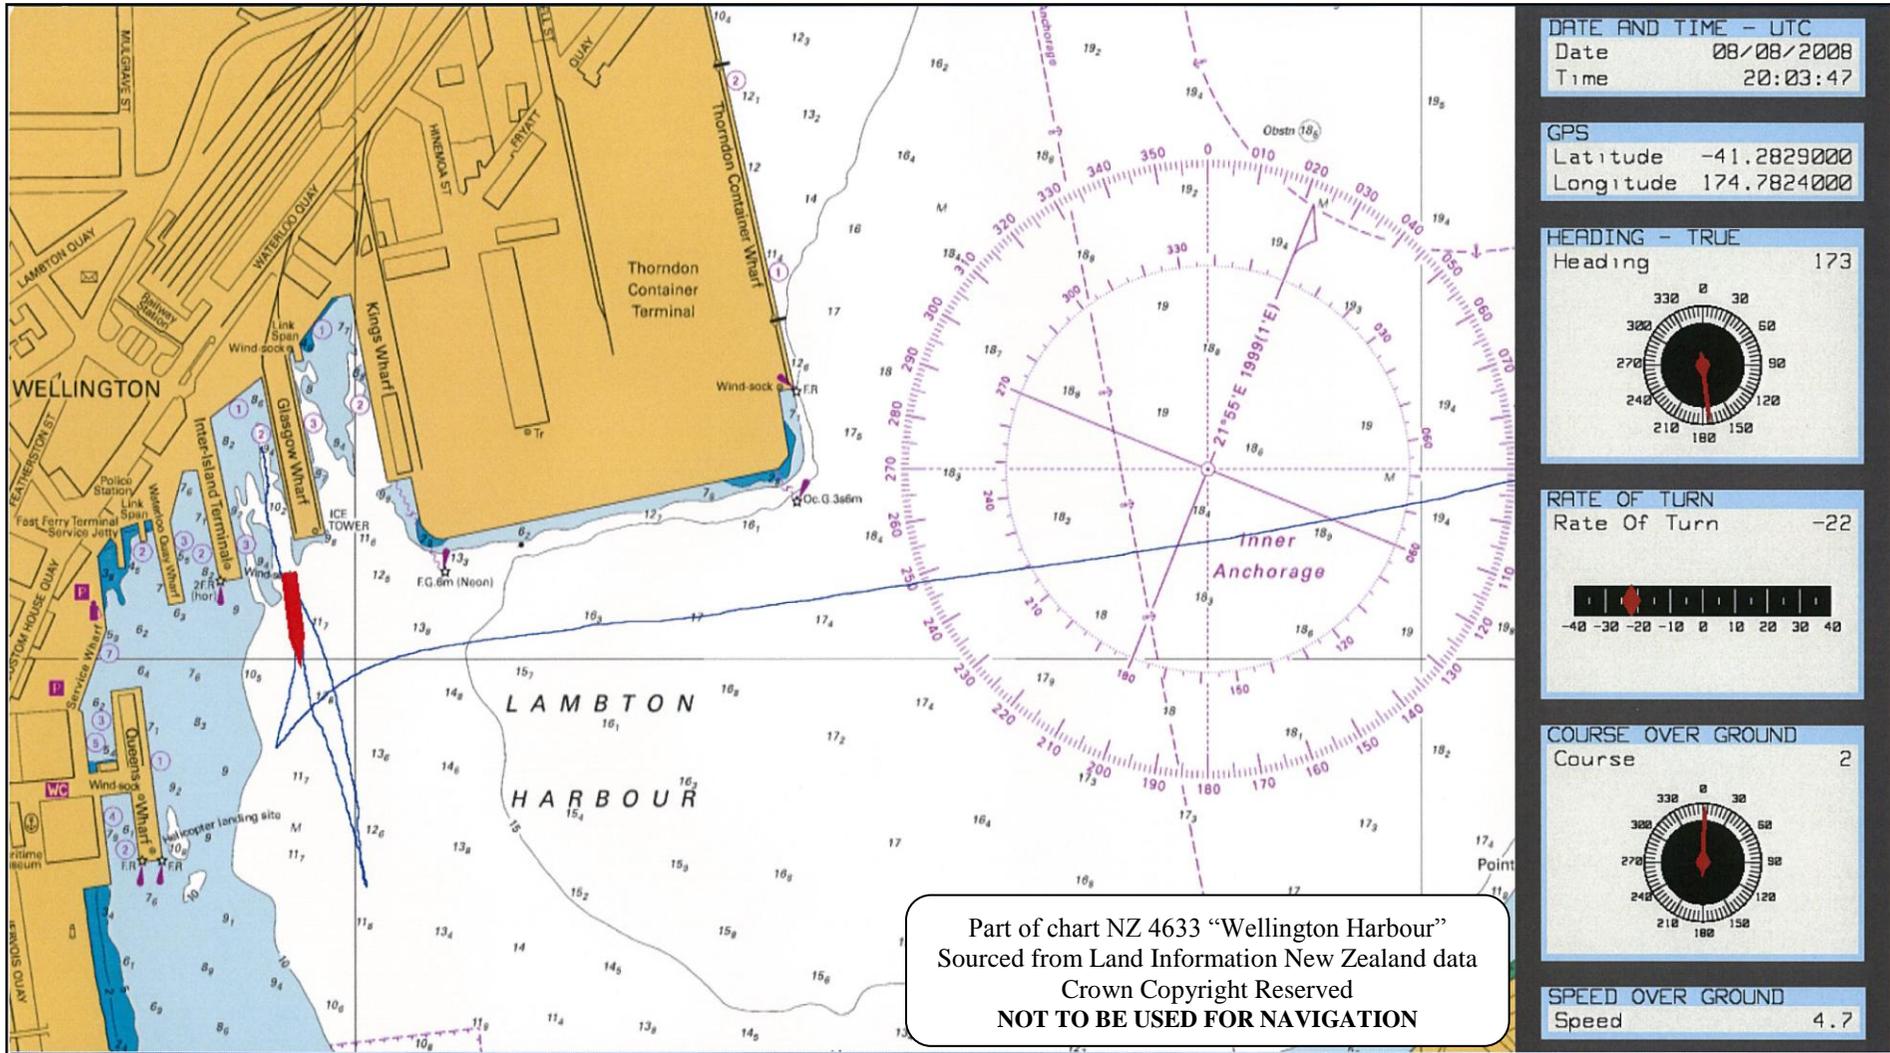
Monte Stello backing towards wharf (about 40 m from knuckle of wharf)

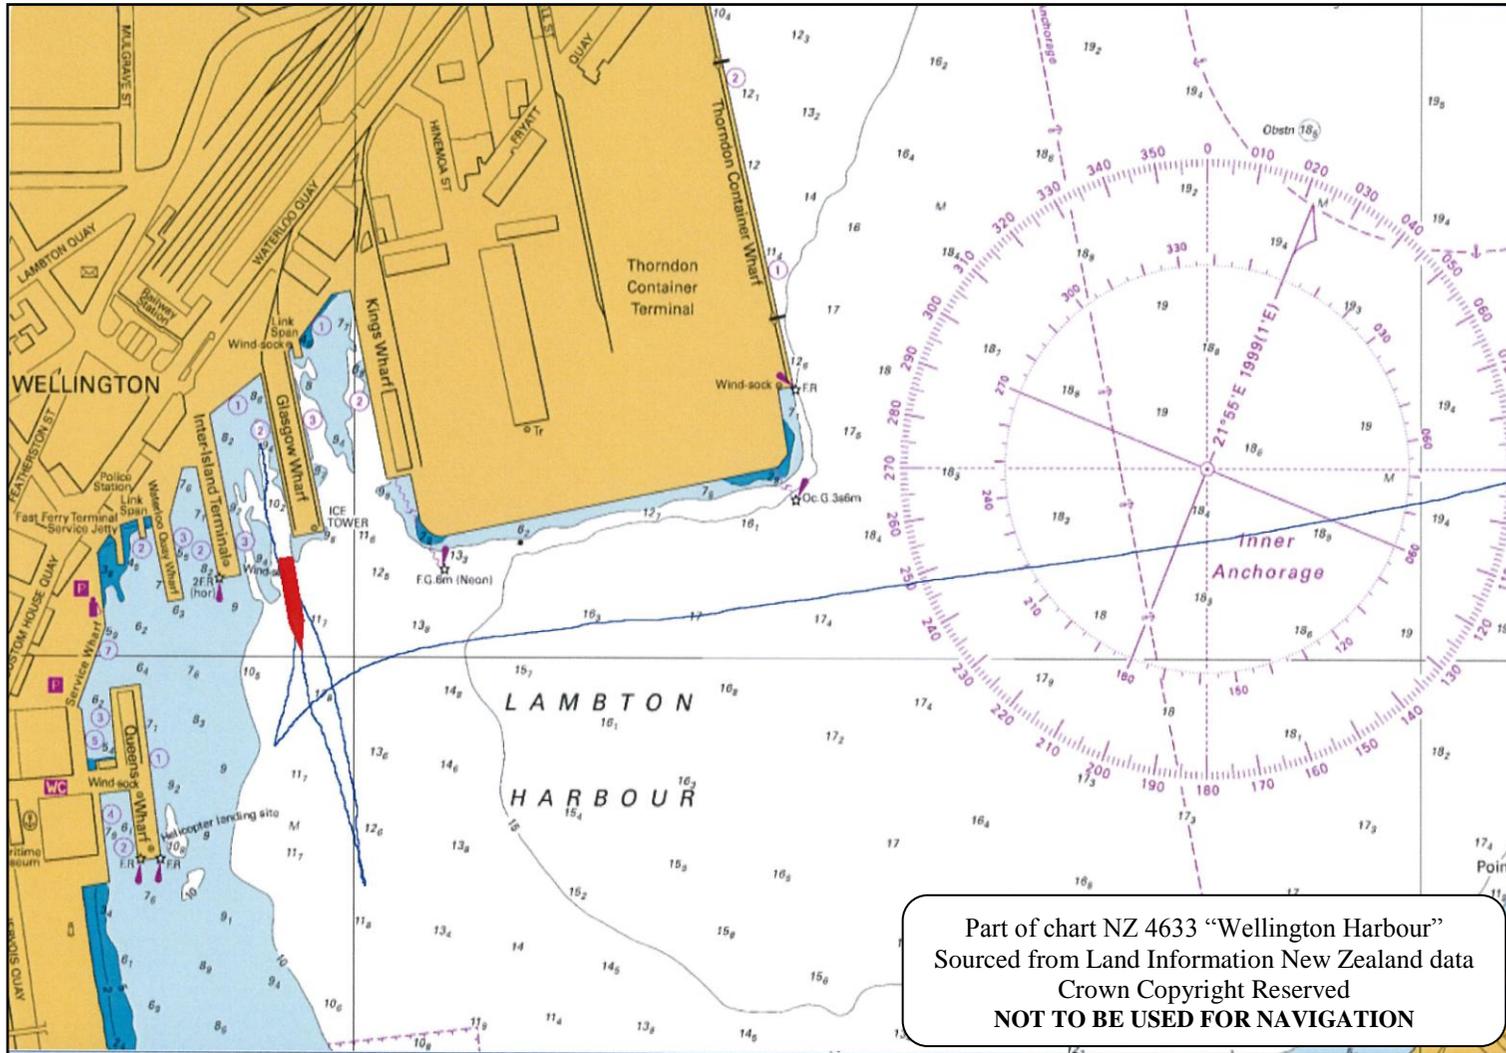
Monte Stello contacts knuckle of wharf
