Report 08-209: Loss of the rigid inflatable boat Mugwop,  
off the entrance to Lyttelton Harbour, 28 October 2008

Marine Inquiry 08-209

Loss of the rigid inflatable boat Mugwop,  
off the entrance to Lyttelton Harbour,  
28 October 2008

Approved for publication: February 2011

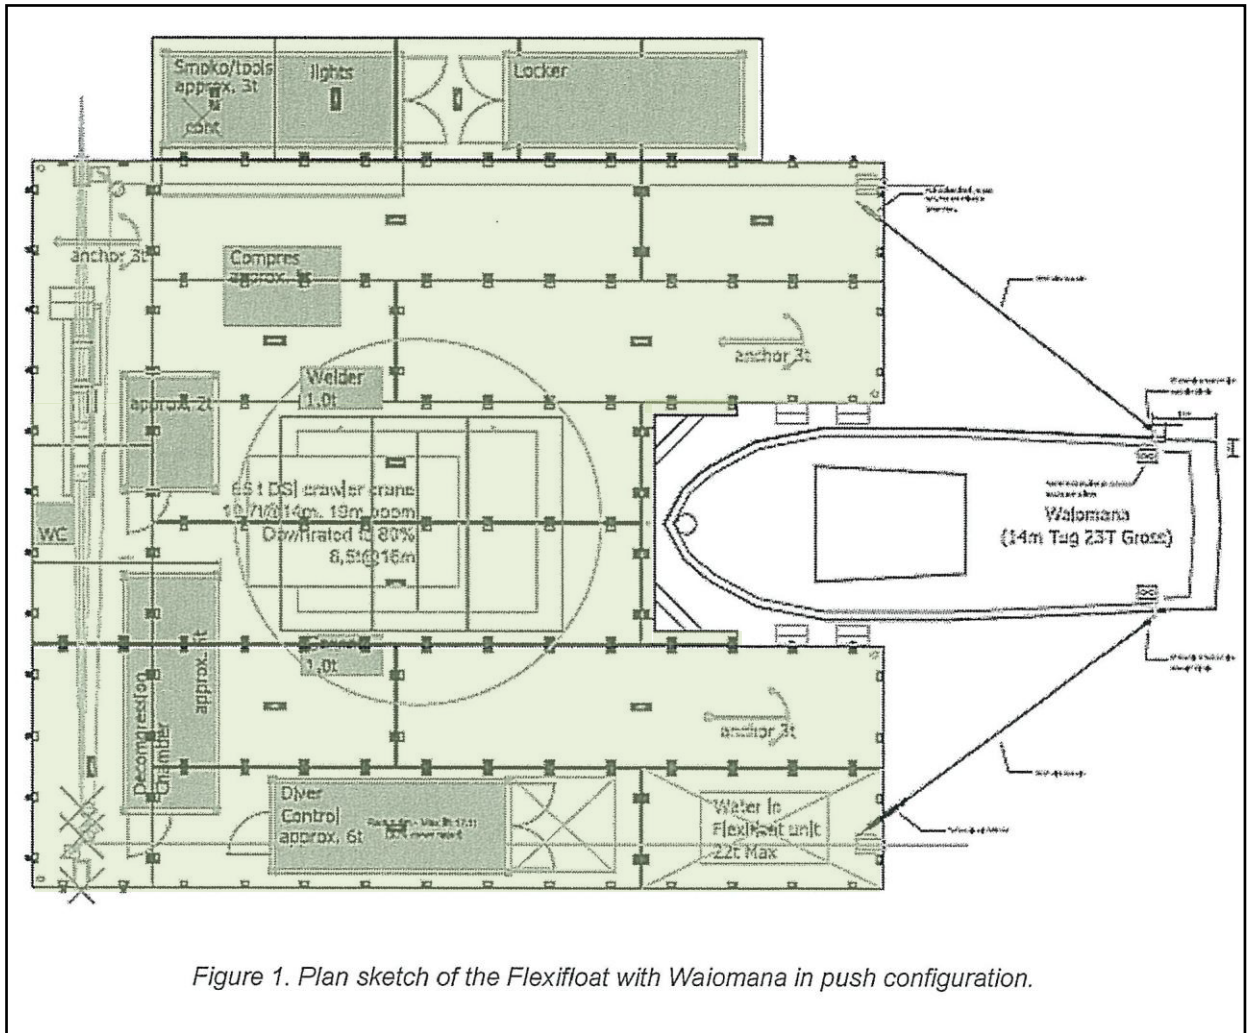
Figure 1. Plan sketch of the Flexifloat with Waiomana in push configuration.

3.3.24. During the morning of the day of the accident, the fixed-length wire strop had been lost overboard, so a black-and-yellow 100 mm plaited polypropylene rope had been used to secure the port quarter of the tug to the *Flexifloat*. During the voyage back into Lyttelton Harbour, that rope had chafed where it crossed the deck edge of the barge and had eventually parted. Another mooring rope had been quickly secured, but when the hand winch was tightened the securing hook on it straightened. It was after this that the tug master decided it was too rough to re-secure the tug into the barge, so arranged for the barge to anchor and called for assistance from the larger tug, the *Kurutai*.

3.3.25. In addition to the convenience of manoeuvring the tug and barge in the push mode, because the consist was less than 40 m in length and less than 500 t, it was not required to take a harbour pilot to transit the harbour. However, if the tug towed the barge in the conventional manner, the length would have been deemed to be the overall length from the bow of the tug to the stern of the barge, which would have been more than 40 m and therefore necessitated the employment of a pilot for each transit, a substantial cost over the period of the project.
