Marine Inquiry 09-202: Passenger vessel Oceanic Discoverer
Fatal injury, Port of Napier
19 February 2009

Final Report

Approved for Publication: November 2011

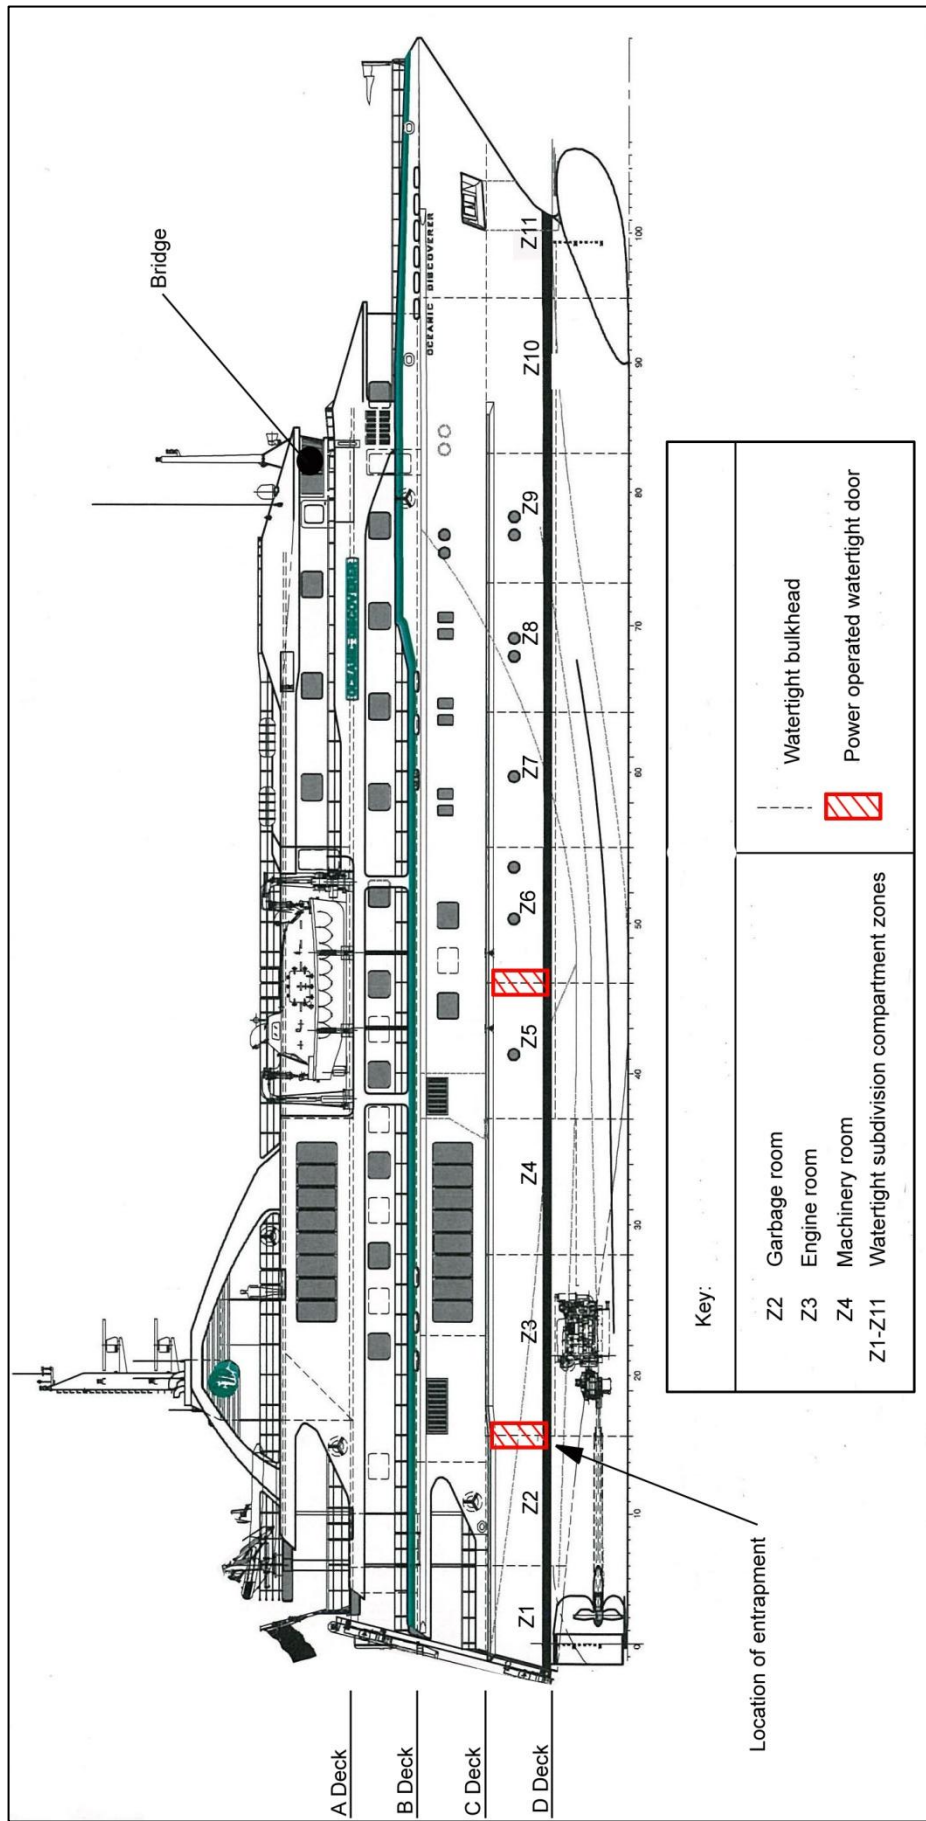
Figure 1
 General arrangement of the *Oceanic Discoverer*
 (adapted from NQEA Australia PTY Limited. Drawing O2 004-0002-F)

- 3.1.5. At 1006 the master made an announcement on the PA that he was about to close the power-operated watertight doors and that personnel should stand clear. He then operated the master switch on the bridge operating station and the doors closed (see Figure 1).

- 3.4.7. The power-operated watertight door where the accident occurred was one of 2 identical electro-hydraulic sliding doors on the ship, as shown in Figure 1. Designed by the Norwegian company IMS AS, the doors had been manufactured and supplied by a subsidiary of the company based in the United States of America. The doors had been constructed to SOLAS Part B Chapter II-1 Regulation 15.

- 3.4.20. The electro-hydraulic sliding watertight doors could be operated in one of 2 modes; the mode of operation was selected from an operating station located on the bridge of the ship, as seen in Figure 1. The 2 modes of operation were “local-control” and “remote-close”; their differences are shown in Table 1.

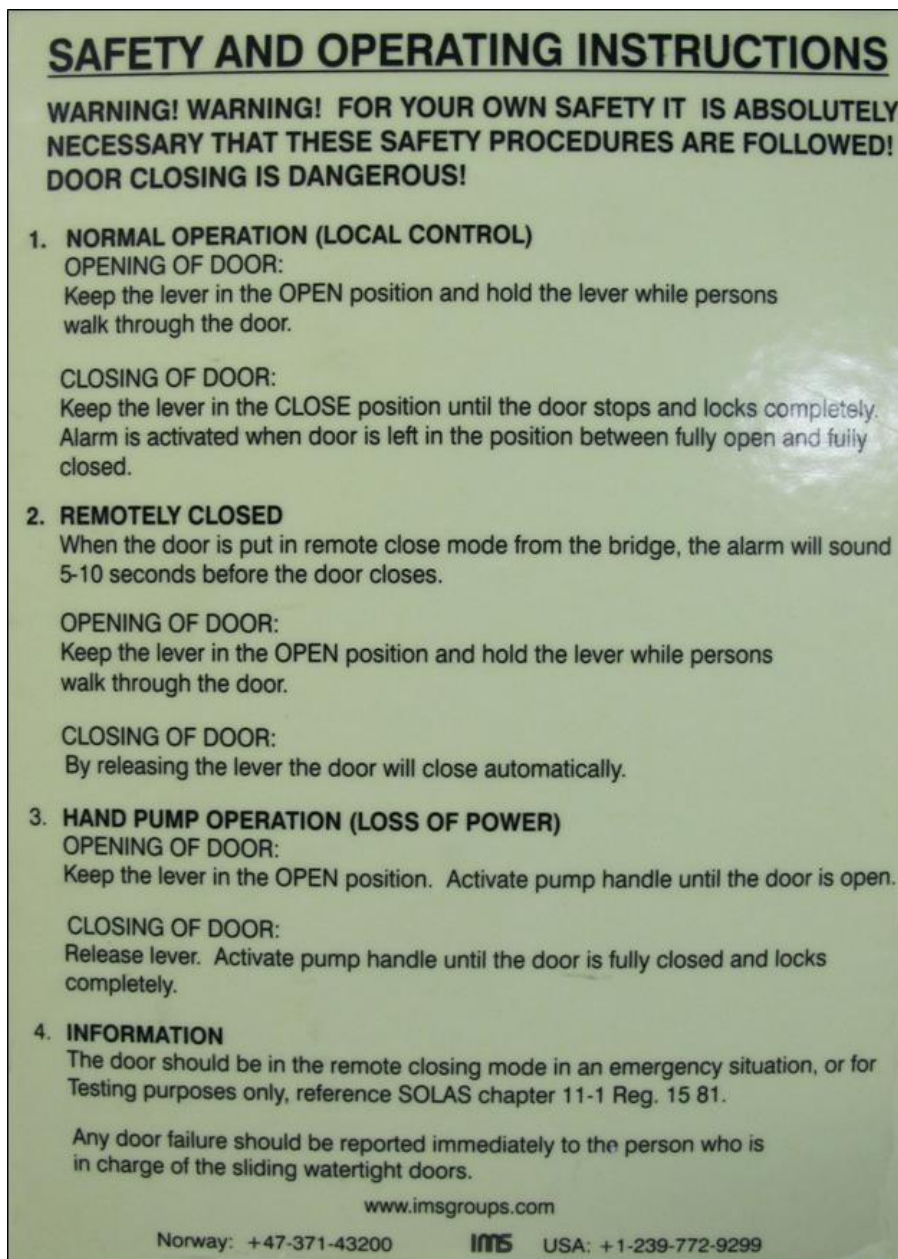
Figure 3
Safety and operating instructions attached to door jamb

- 3.4.14. Manufacturer-supplied operating instructions were posted at the door itself, as shown in Figure 3 and Figure 4.
- 3.4.15. The door was held closed by a mechanical lock. When the operating handle was rotated in the opening direction, approximately the first 70 degrees of rotation served to disengage the mechanical lock. The hydraulic pressure would be directed to open the door once the handle was rotated to 90 degrees.

4.5.2. The manufacturer's instructions were very clear that crew were to follow its instructions on how to operate the doors. It is worth quoting the introduction to the operating instructions posted at the door (see Figure 3):

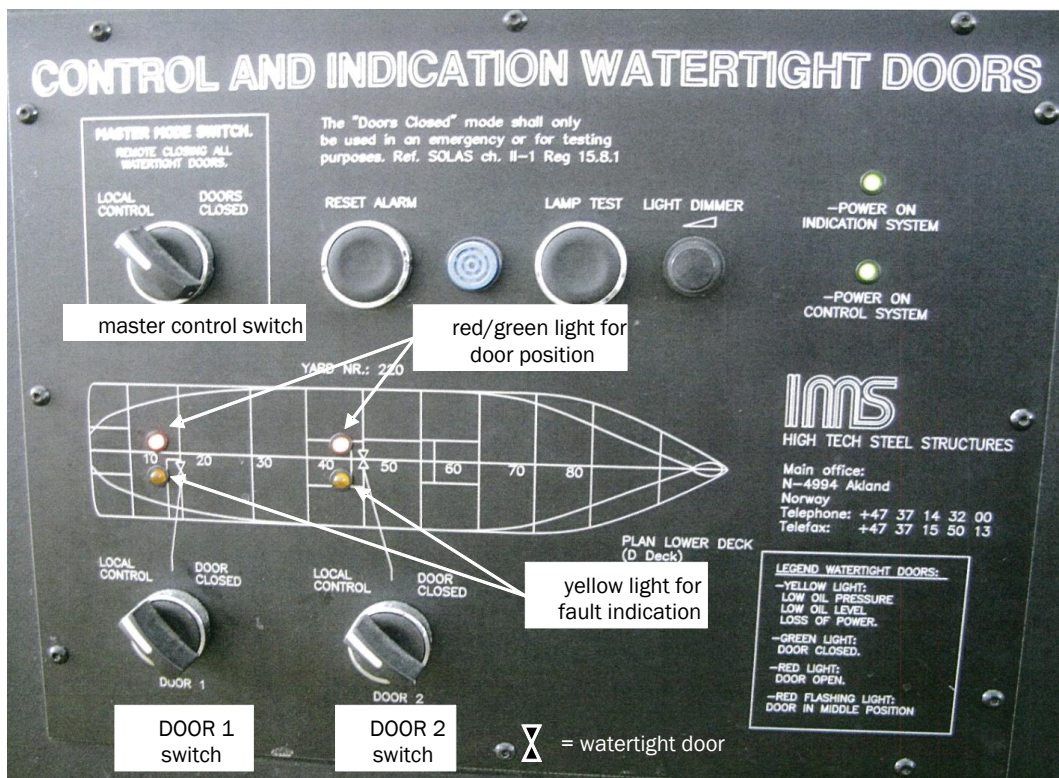
Figure 5
Power-operated watertight door control panel on bridge

- 3.4.21. The watertight door control panel located on the bridge is shown in Figure 5. A master control switch on the control panel could set both doors to local-control or remote-close mode. Alternatively the doors could be independently set to either mode by using the separate door switches (DOOR 1 and DOOR 2) shown in Figure 5.
