**Report 09-203, jet boat, *DRJS-11* grounding and subsequent rollover Dart River,  
near Glenorchy, 20 February 2009**

**Report 09-203**

**jet boat  
*DRJS-11***

**grounding and subsequent rollover**

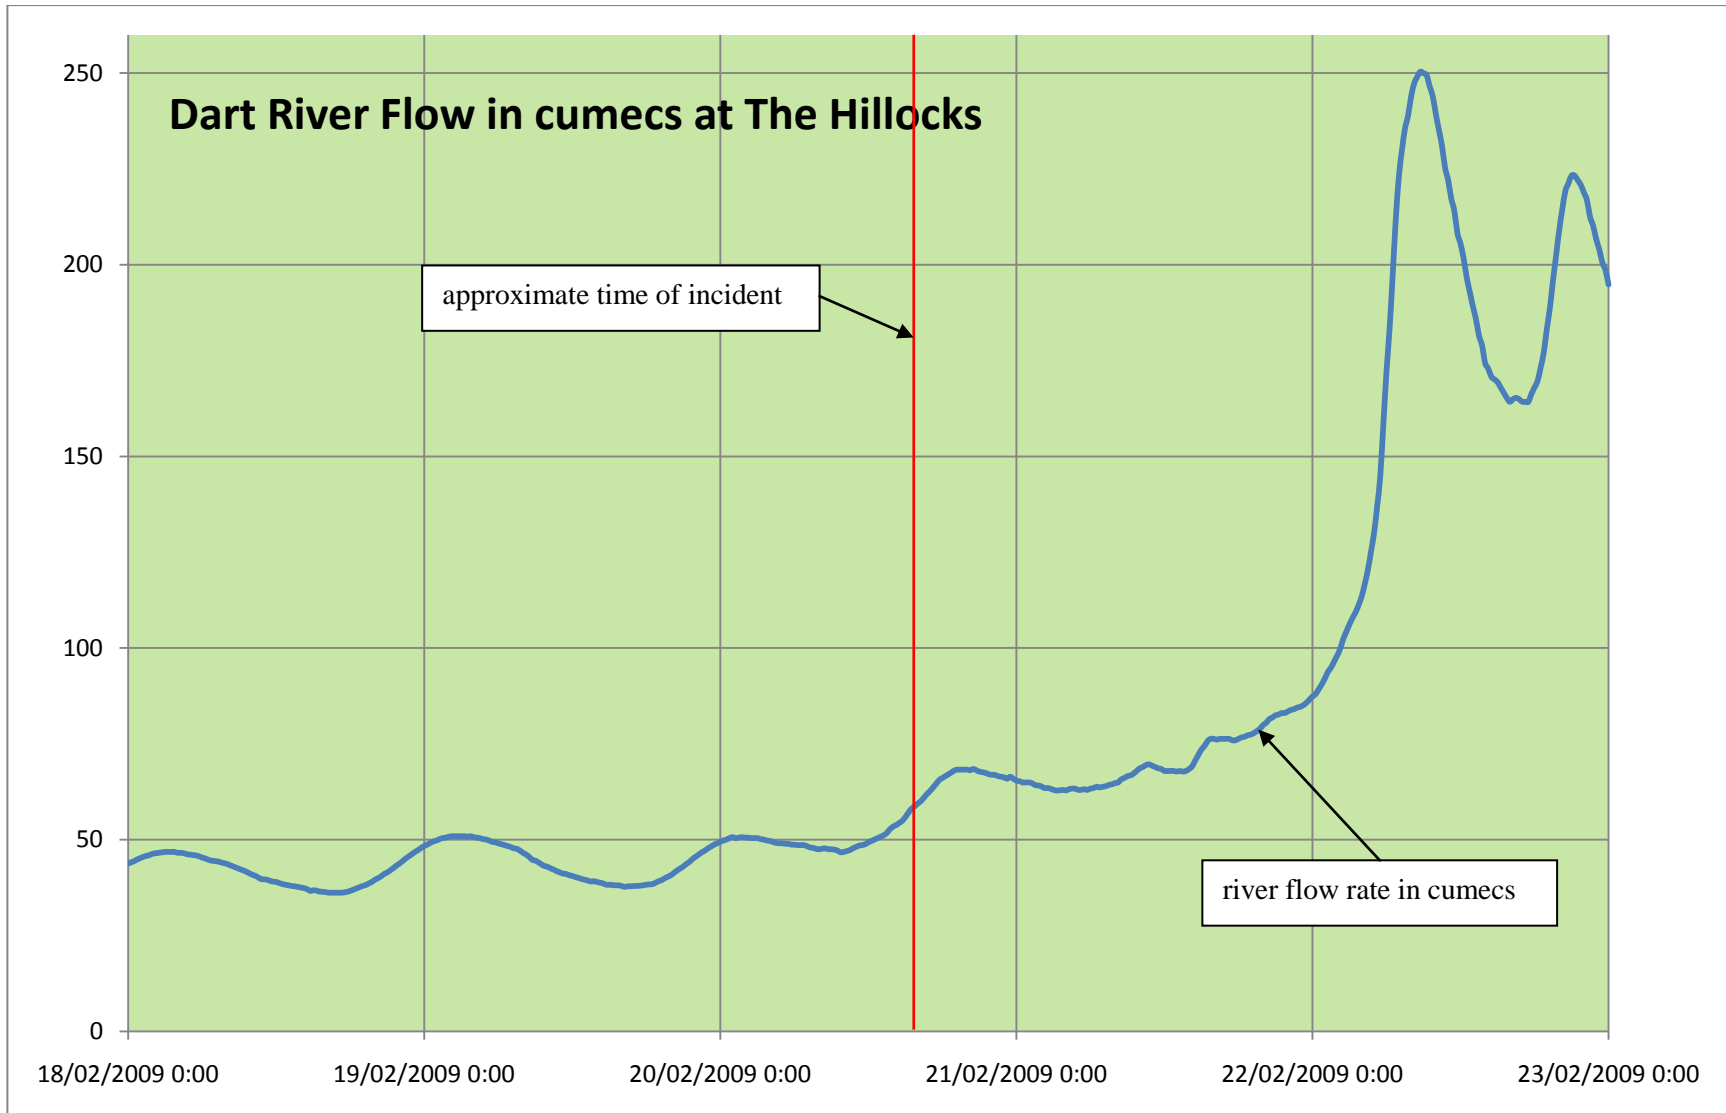
**Figure 7**  
**Dart River flow in cubic metres per second (cumecs) at The Hillocks**

- 1.5.4 As the river flow slows, much of the gravel and silt it carries in suspension is deposited on the river bed, forming new banks and changing the nature of the river. The main channel of flow can change dramatically in a short space of time. Drivers of jet boats operating on braided rivers such as the Dart River need constantly to “read” the water ahead to judge the best tributary to follow. Consequently the route a driver takes can vary from trip to trip or between going upstream and coming downstream, especially in the periods of rapidly changing flow after heavy rains.

- 1.5.5 Figure 7 shows the water flow of the Dart River as recorded by the Otago Regional Council at its monitoring station at “The Hillocks” (Otago Regional Council, 2010) close to the Dart River Bridge for the 5 day period encompassing the day of the accident.
