Report 09-204 : Coastguard rescue vessel *Dive! Tutukaka Rescue* collision with rocks,  
Taiharuru River entrance Northland, 4 March 2009; and  
Report 09-207:Coastguard rescue vessel *Trusts Rescue*, heavy weather encounter,  
Manukau Bar, 31 May 2009

## Final Report

Coastguard rescue vessel *Dive! Tutukaka Rescue* collision with  
rocks, Taiharuru River entrance Northland  
4 March 2009

Coastguard rescue vessel *Trusts Rescue*  
heavy weather encounter, Manukau Bar  
31 May 2009

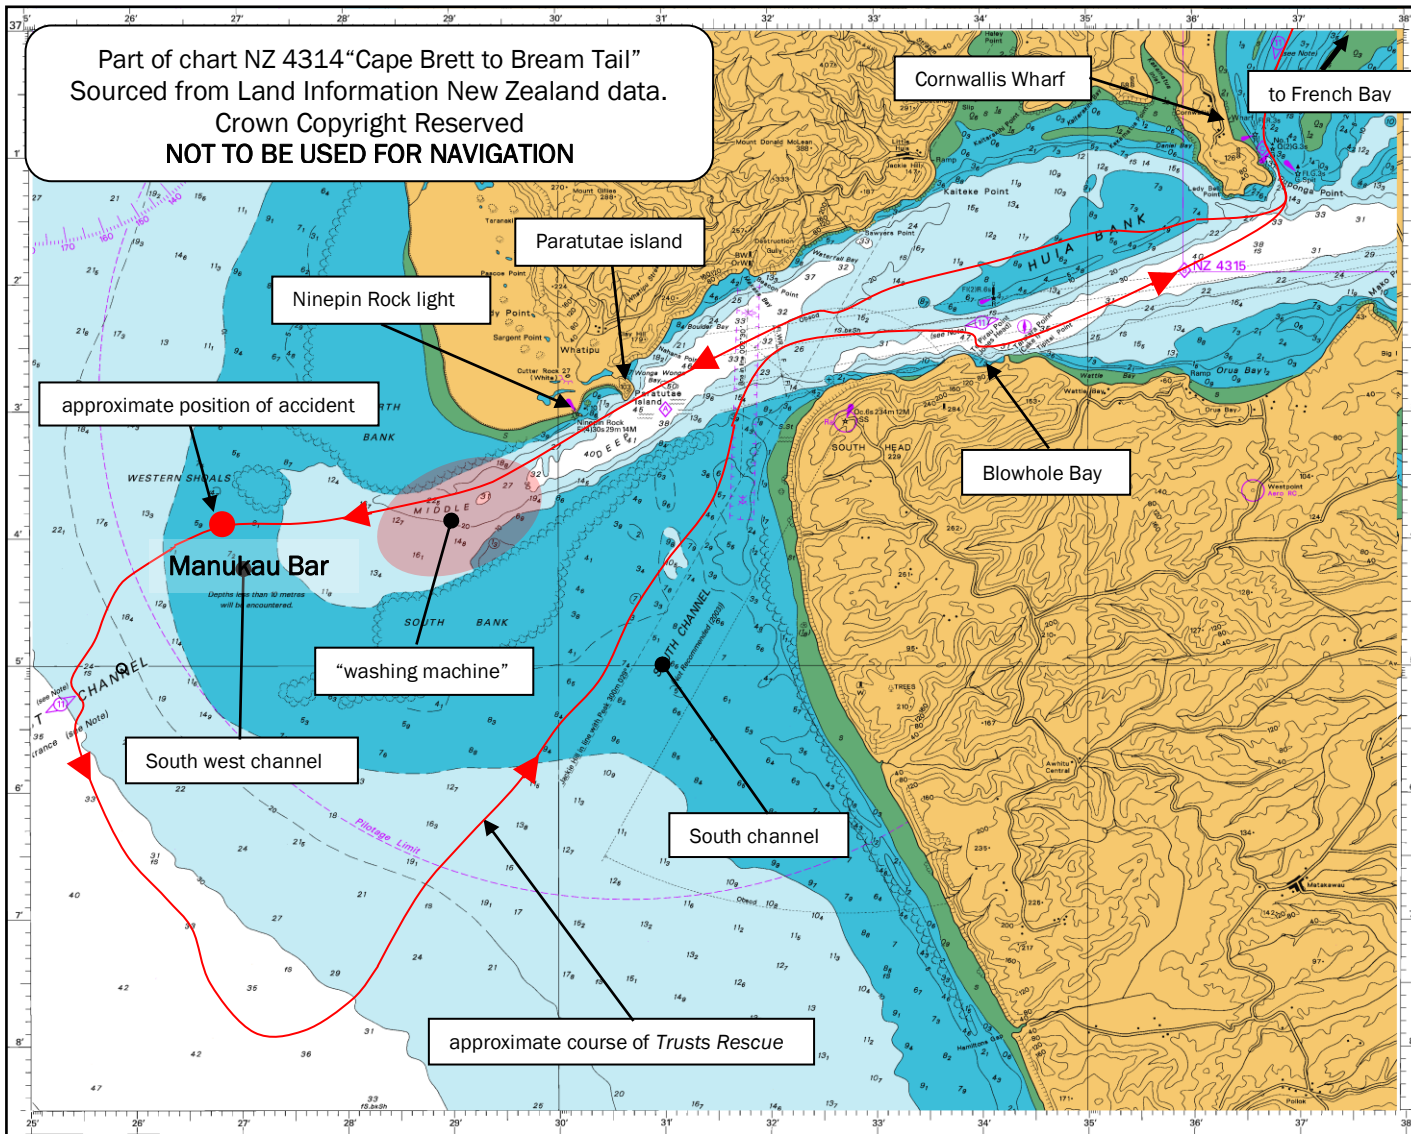
Figure 9  
General area of the incident showing Manukau Bar

4.2.5. As with all Coastguard NZ vessels the *Trusts Rescue* was fitted, with a Track-Plus system for monitoring the position of the vessel at any time. The positions downloaded from the CNR computer were used by the Commission to recreate the track of the *Trusts Rescue* after the incident (see Figure 9).
