Final Report
Into the capsizing and foundering of the
Single outrigger passenger ferry

Uean Te Raoi II

Off Maiana Island in the Republic of Kiribati

Prepared by the Transport Accident Investigation Commission

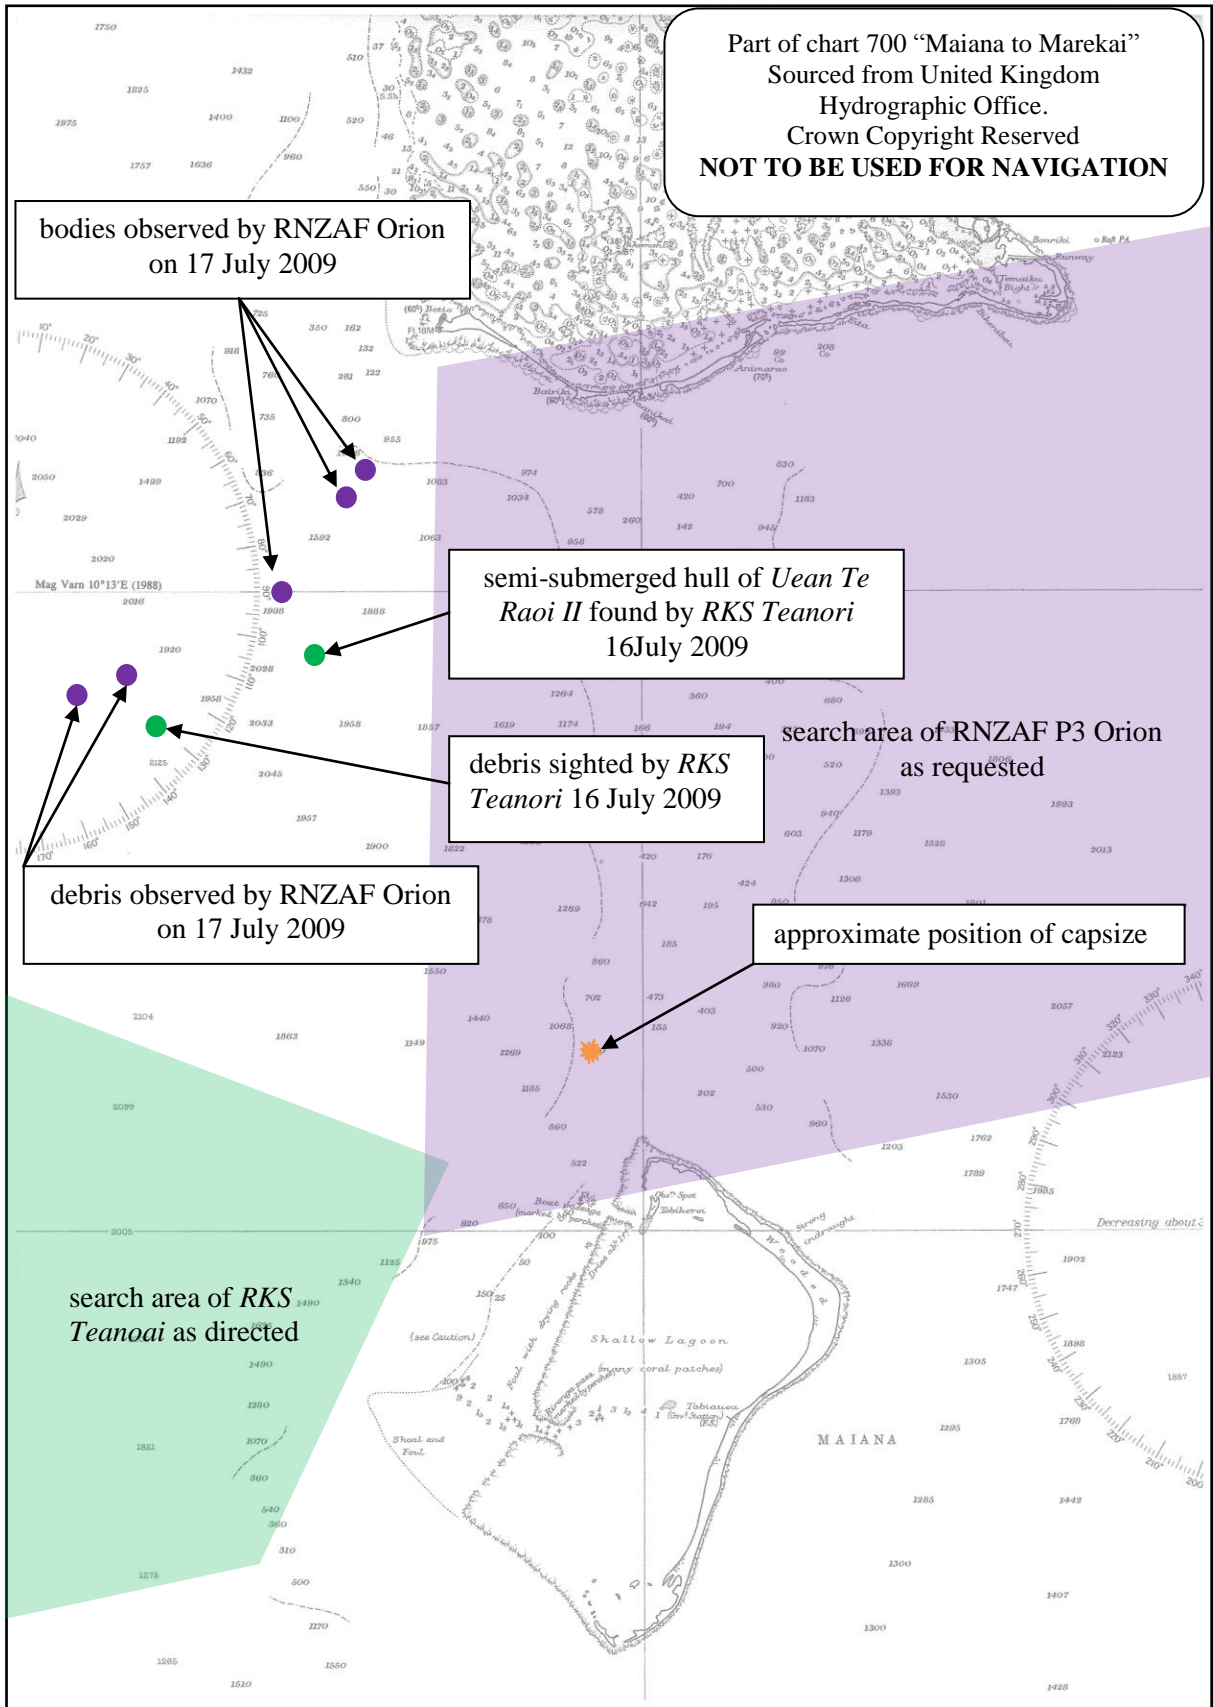
Figure 2
Search areas

- 2.21 As Figure 2 shows neither search area was entirely accurate. The area where survivors, victims and debris were recovered lay somewhere between the 2 areas. A successful search and rescue operation is reliant on good technical resources, local knowledge and good communications between those involved in the operation.

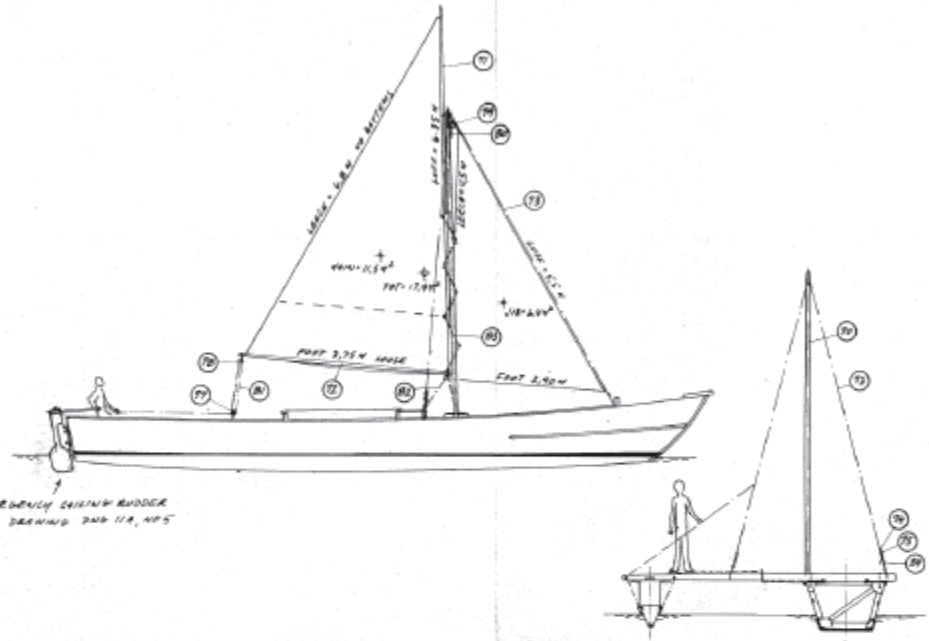
FIGURE 1
 The Outrigger Vessel
 JEAN TE RAOI II
 Plan view indicating relative
 positioning of main hull
 and outrigger

The builder reported draught measurements for the vessel loaded with 35 persons at 9 stations, and draught measurements for the vessel unloaded at 2 stations. The resulting waterlines are shown in Figure 1. The loaded draughts would be expected to give a straight waterline, and do so with reasonable accuracy (error margin +/- 15 mm) provided that the reported draught at the station 12m from the transom is taken to be actually at the station 10 m from the transom. This is likely to have been a simple experimental error on the day.
