Report 10-009: Walter Fletcher FU24, ZK-EUF,
loss of control on take-off and impact with terrain,
Fox Glacier aerodrome, South Westland, 4 September 2010

Final Report

Aviation inquiry 10-009
Walter Fletcher FU24, ZK-EUF
loss of control on take-off and impact with terrain
Fox Glacier aerodrome,
South Westland
4 September 2010

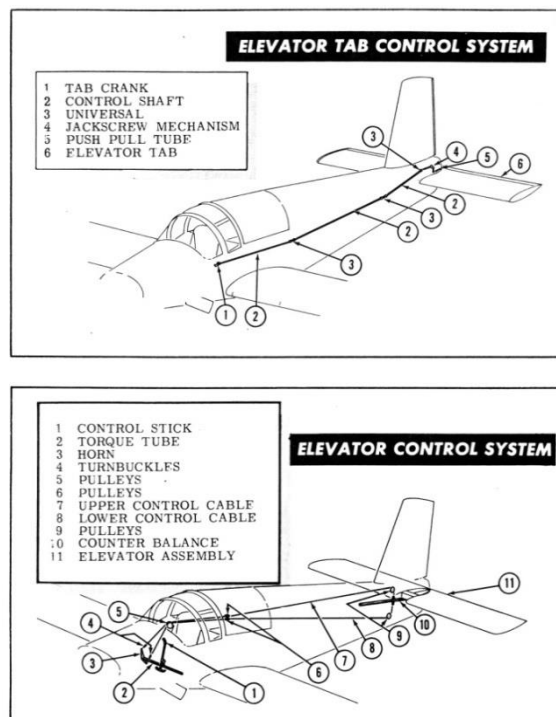
Figure 4
Fletcher flight control systems (Courtesy of Pacific Aerospace Limited)

3.5.2. The Fletcher aeroplane was equipped with conventional flight controls. Directional control on the ground was by a steerable nose wheel connected to the rudder pedals. Pitch control was achieved through elevators fitted to the empennage.⁶ The elevator was connected by cables running through a number of pulleys to the pilot's stick or control column (see Figure 4). Pulling back on the control column pitched the nose up and pushing forward on the control column pitched the nose down relative to the pilot. The amount and rate of any change in pitch were dependent on how much the pilot moved the control column or stick and the airspeed of the aeroplane. For a given amount of control input, the faster the aeroplane was flying, the greater would be the change in pitch attitude.

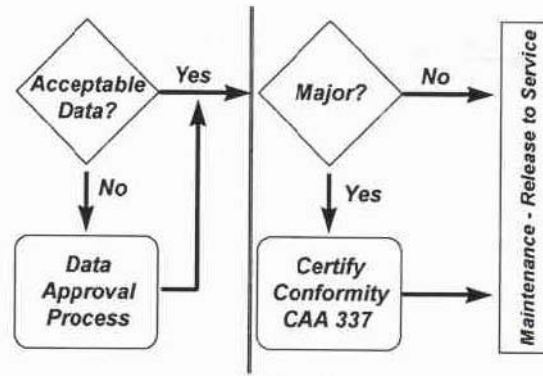
Figure 7
Modification process (CAA Advisory Circular AC43-9, Figure 1)

- e. The embodiment of the modification was then recorded in the maintenance records. The maintenance records included the form CAA 337, which was to be completed and a copy forwarded to the CAA (see Figure 7).
