Inquiry 10-010:
Bombardier DHC-8-311, ZK-NEB, landing without nose landing gear extended,
Woodbourne (Blenheim) Aerodrome, 30 September 2010

Final Report

Aviation inquiry 10-010
Bombardier DHC-8-311, ZK-NEB
Landing without nose landing gear extended
Woodbourne (Blenheim) Aerodrome
30 September 2010

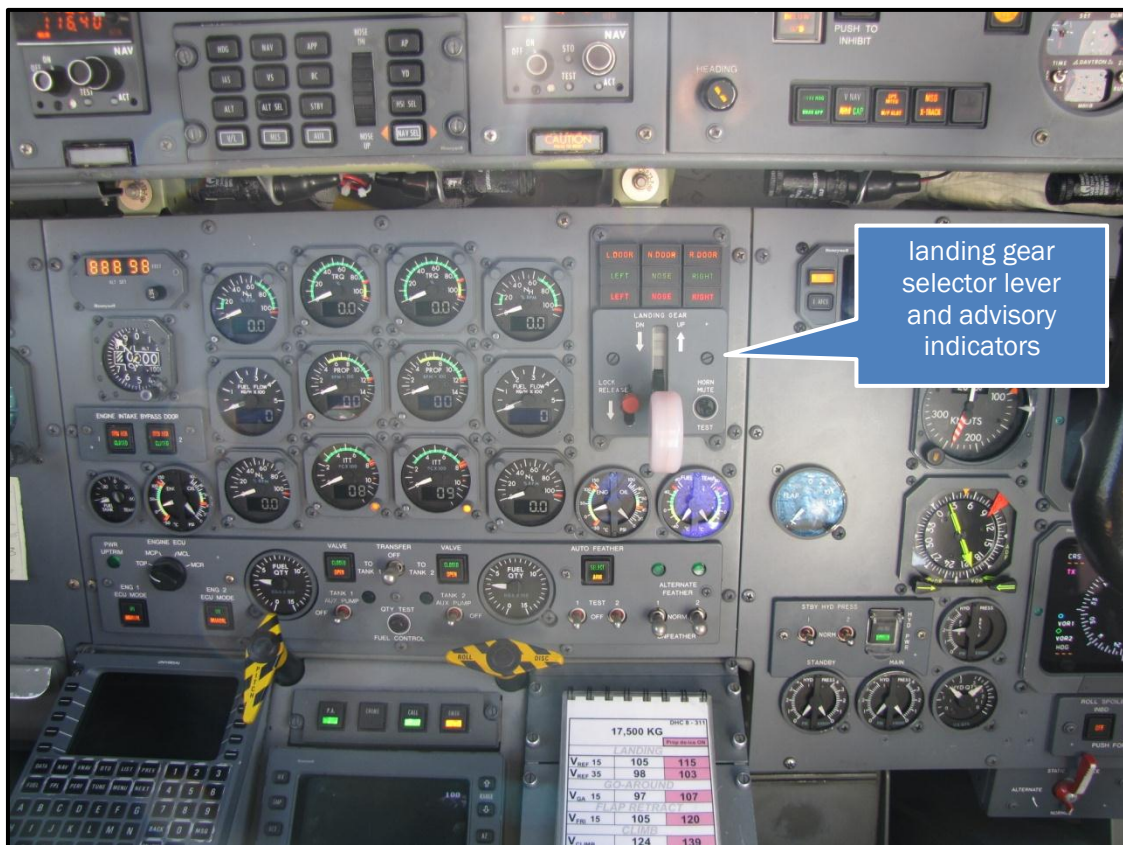
Figure 1
Q300 flight deck, centre instrument panel

- 3.1.3. At Woodbourne, a long, straight-in visual approach was flown to runway 24.⁴ After the landing gear had been selected DOWN, lights (advisory indicators) on the centre instrument panel indicated that only the main landing gear had locked down (see Figure 1). The red “gear unsafe” light and the amber “door open” light for the nose landing gear were illuminated. The amber light in the landing gear selector lever handle was also illuminated, indicating that not all of the landing gear was in the position selected. No other caution lights were illuminated.

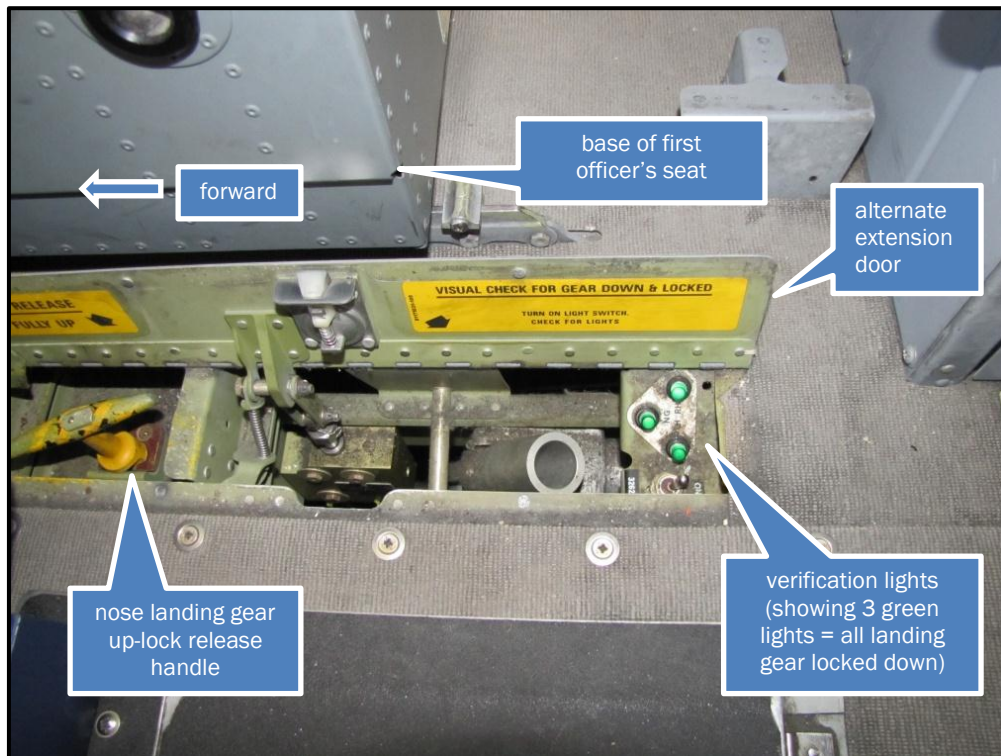
Figure 2
Nose landing gear up-lock release handle and verification lights

- 3.1.6. One item in the checklist was to check the verification lights that were located under the landing gear alternate extension door (flap) in the flight deck floor (see Figure 2). As the first officer was about to perform this step, the captain said to him, “You will find it’s not the problem”. The captain meant that he was not expecting the light for the nose landing gear to illuminate and that he expected that they would have to carry out the alternate landing gear extension procedure.

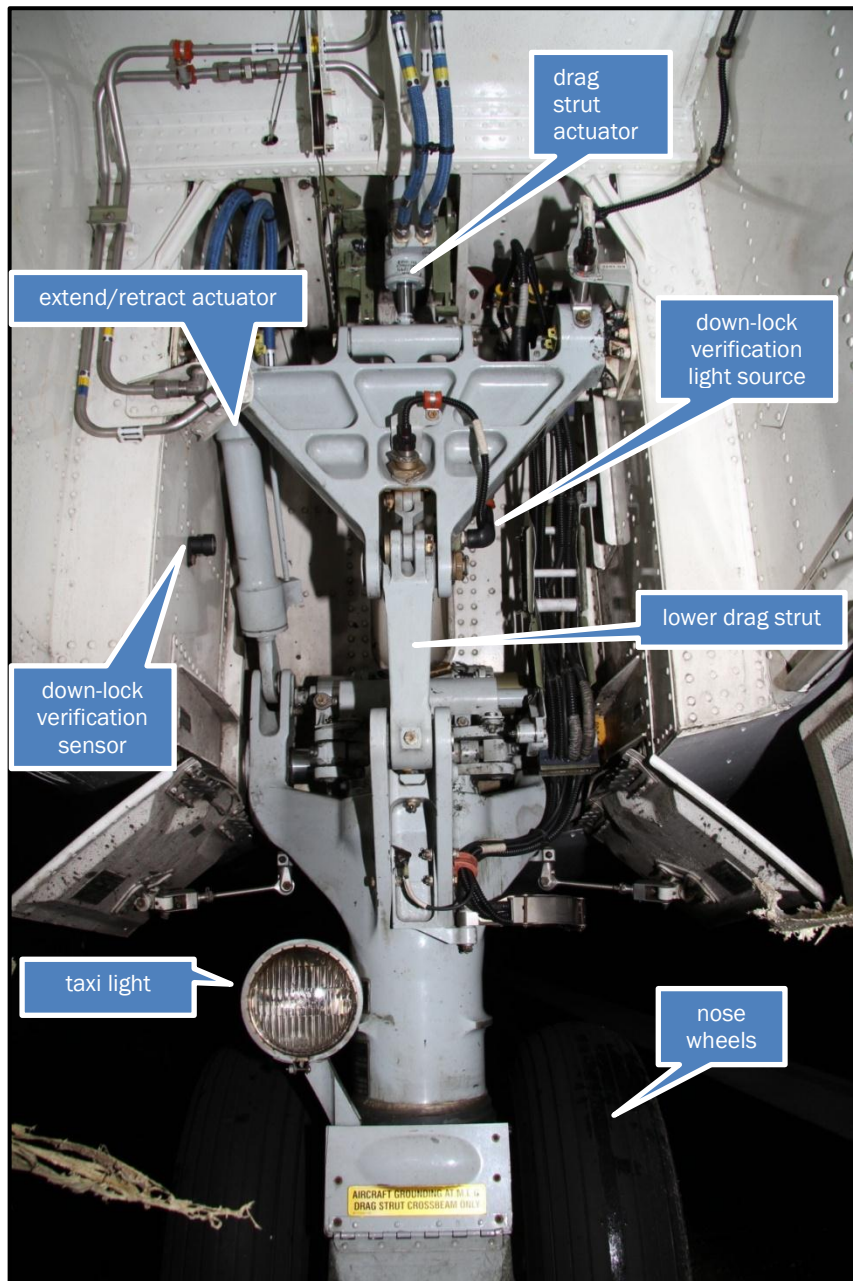
Figure 3
Q300 nose landing gear

- 3.2.8. The Q300 has a retractable, tricycle landing gear. The nose landing gear retracts forward into the fuselage nose. Figure 3 shows some of the nose landing gear components referred to in this report.

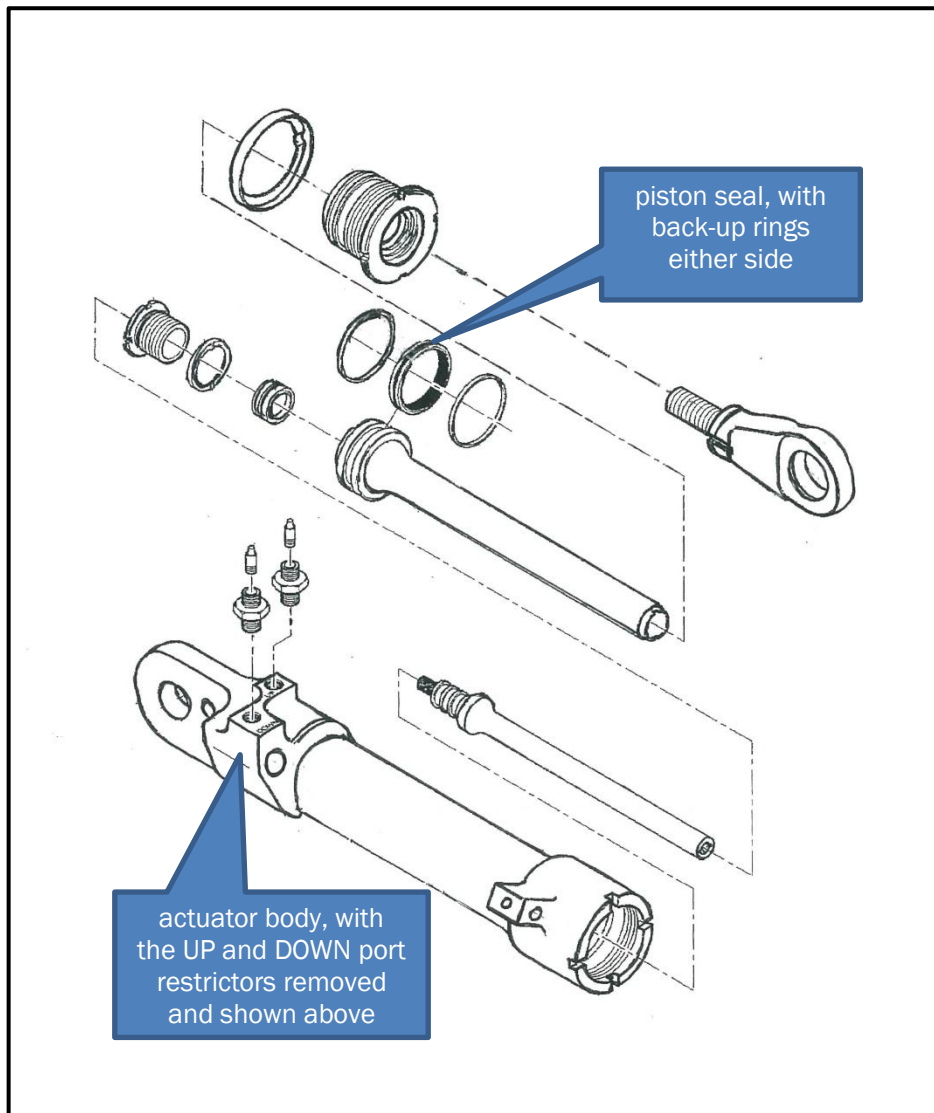
Figure 4
Nose landing gear actuator

- 3.2.12. The nose landing gear actuator has a dual-acting steel piston that slides inside an aluminium alloy cylinder. The piston head has a black elastomer inverted “T”- seal, with a black Teflon back-up ring on either side.^{13,14} Hydraulic fluid is directed through a restrictor to either the “up” or “down” port of the actuator. Figure 4 is a simplified “exploded” view of the nose landing gear extend/retract actuator.
