Report 10-101: wrong route setting, high-speed transit through turnout,
near miss and SPAD (signal passed at danger), Tamaki, 13 August 2010

Final Report

Rail inquiry 10-101
wrong route setting, high-speed transit through turnout, near miss
and SPAD (signal passed at danger),
Tamaki, 13 August 2010

Transport Accident Investigation Commission

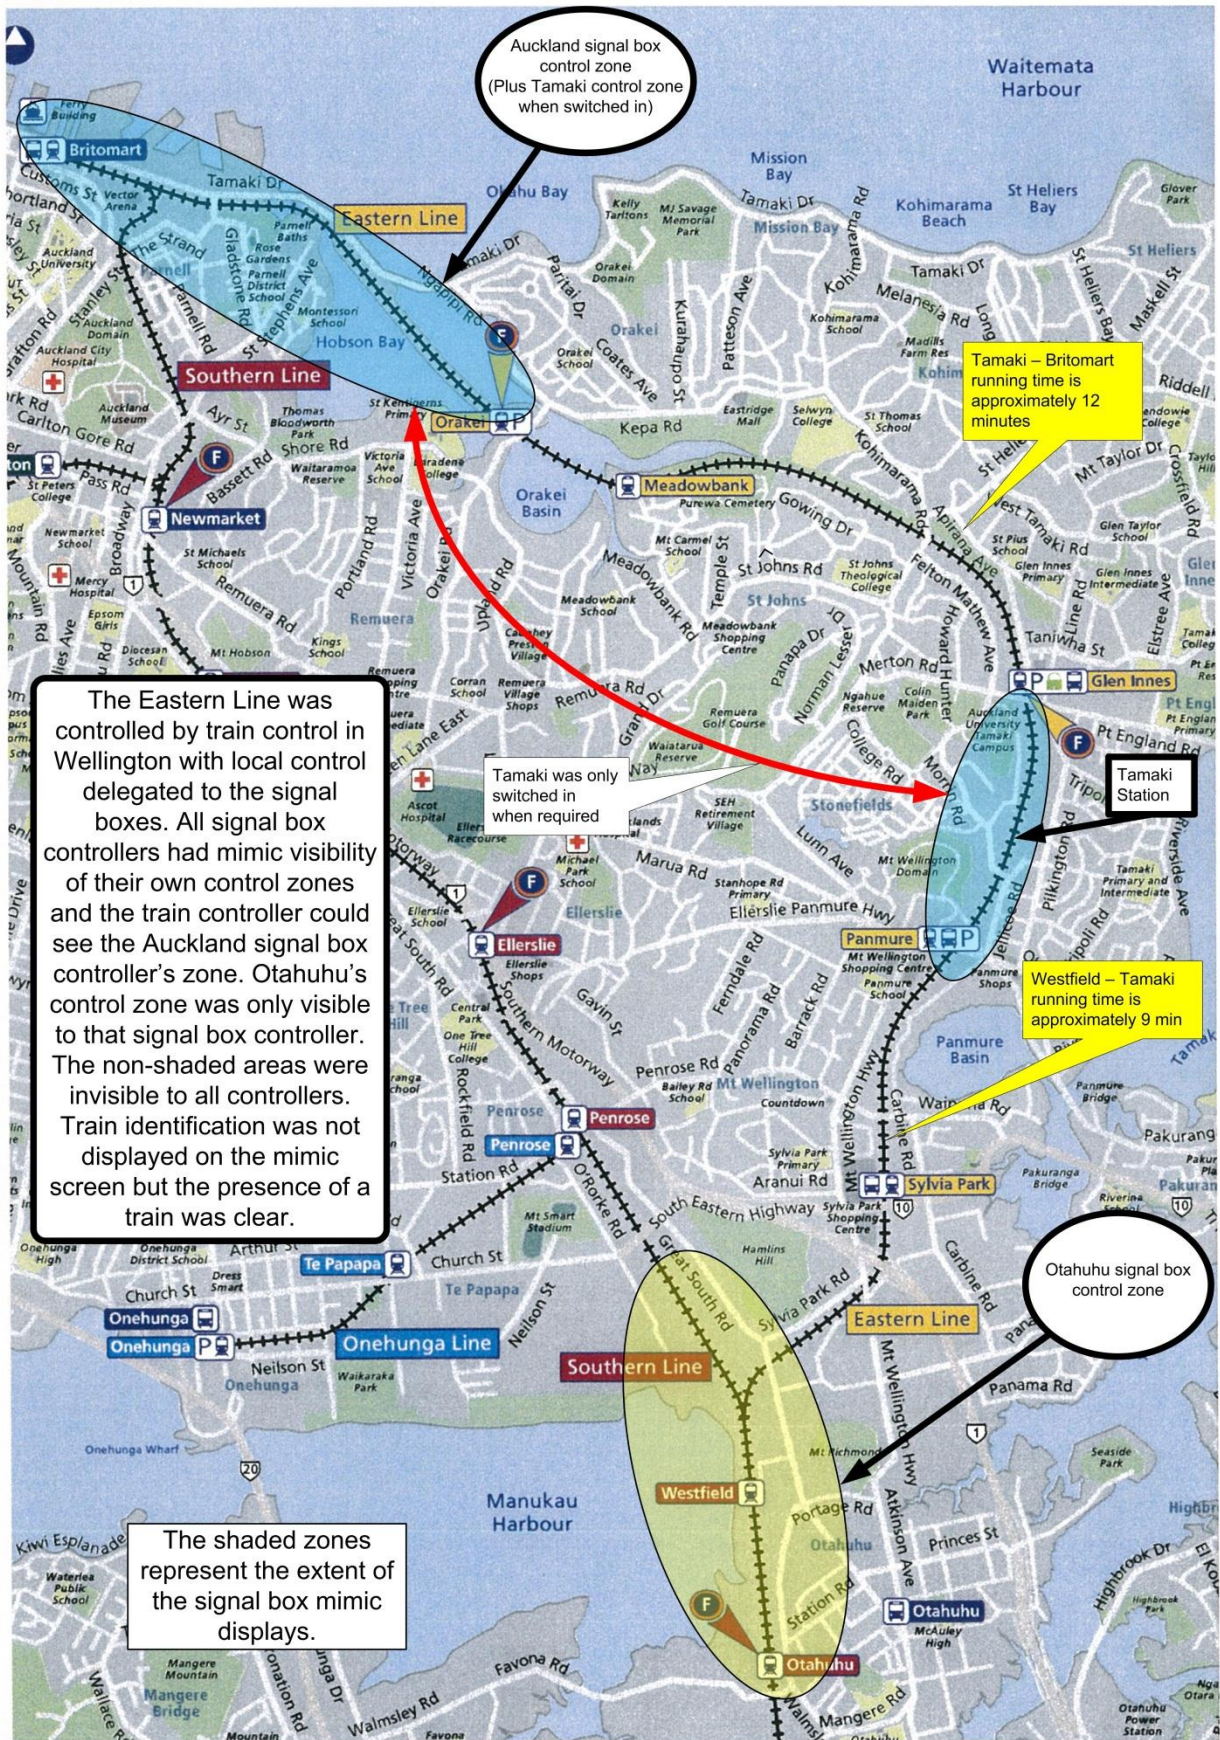
Figure 1
Auckland area signal box control zones

- 3.4.1. Train operations within the Auckland metro area were controlled by the Auckland train controller located in the Wellington National Train Control Centre. The operation of some high-activity zones within the area was delegated to local signal box controllers (see the shaded signal box control zones in Figure 1), but the train controller still retained overall responsibility for train movements through those zones. The signal box controllers provided a local interface with train drivers, but still required approval from train control before dispatching movements from a station or terminal other than scheduled passenger movements.

- 3.4.7. The Eastern Line, which runs between Westfield and Britomart via Tamaki, was usually controlled automatically, but the signal box control zones (as shown in Figure 1) could be manually controlled. The Wellington-based train controller and the Auckland signal box controller each had a mimic display that represented Tamaki Station (shown as one of the blue zones in Figure 1) to enable them to control the zone remotely. The rest of the Eastern Line was not represented on a mimic display for either controller.
