Inquiry 11-001: Bell Helicopter Textron 206L-3, ZK-ISF  
Ditching after engine power decrease, Bream Bay, Northland  
20 January 2011

Aviation inquiry 11-001  
Bell Helicopter Textron 206L-3, ZK-ISF  
Ditching after engine power decrease  
Bream Bay, Northland  
20 January 2011

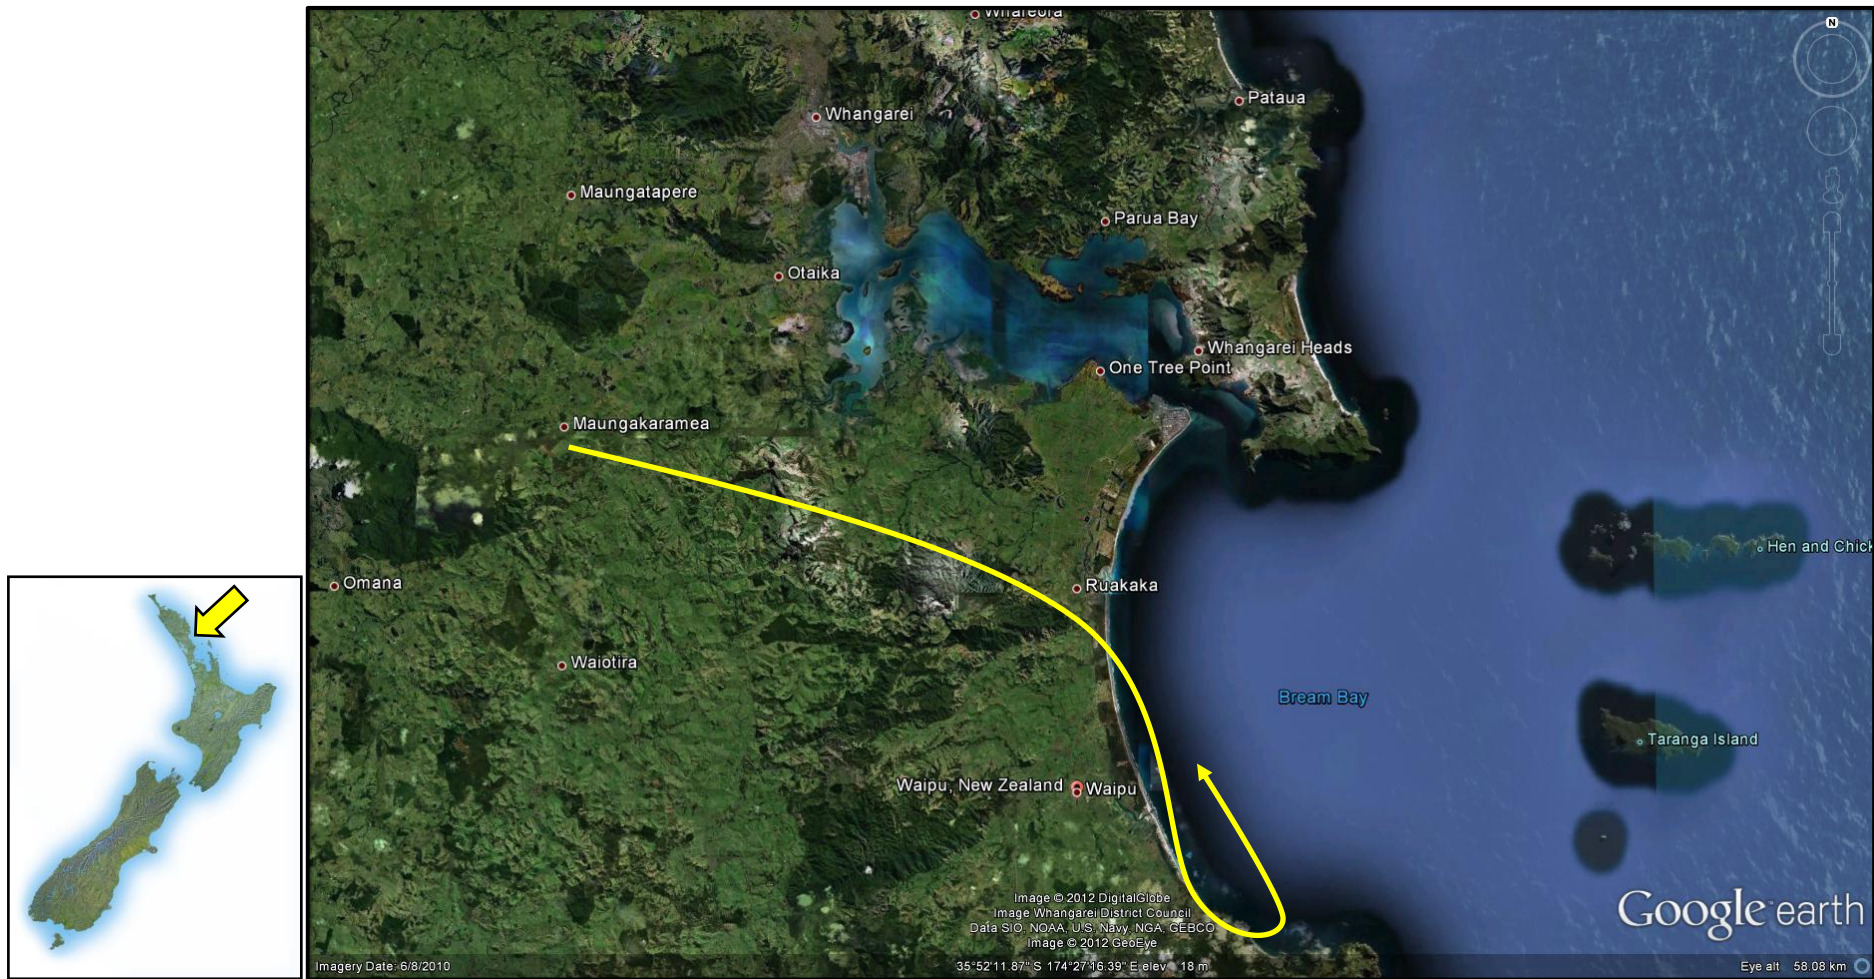
Bream Bay, and approximate flight path

- 3.1.2. The flight proceeded normally from the home base directly to Ruakaka and then south along the coast to Langs Beach, about 40 kilometres from the departure point, where the pilot turned to retrace his track (see Figure 2). He said he was cruising at about 1000 feet above the sea, at 110 knots. He noted the indicated engine torque was approximately 70%.<sup>4</sup> The engine then “surged”, and the indicated power turbine revolutions per minute (RPM) decreased.<sup>5</sup> Power turbine RPM is often referred to as N2. The pilot said that he used N2 as his primary reference for engine power.<sup>6</sup>

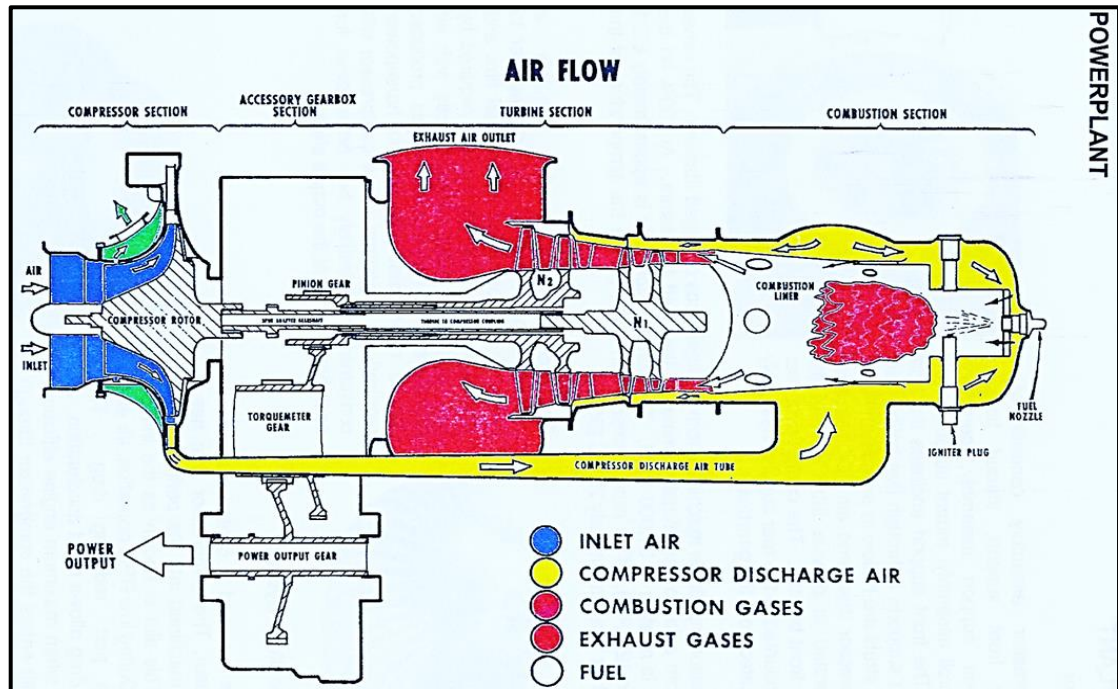
The Rolls-Royce model 250-C30P engine used on the Bell 206L-3 helicopter is a turbo-shaft engine with an output of 650 shaft horsepower. The engine consists of the usual turbine engine sections of compressor, combustion, turbine and accessory gearbox and the associated engine accessories.
