Inquiry 11-002:  
Bombardier DHC-8-311, ZK-NEQ, landing without nose landing gear extended  
Woodbourne (Blenheim) Aerodrome, 9 February 2011

Aviation inquiry 11-002  
Bombardier DHC-8-311, ZK-NEQ  
Landing without nose landing gear extended  
Woodbourne (Blenheim) Aerodrome  
9 February 2011

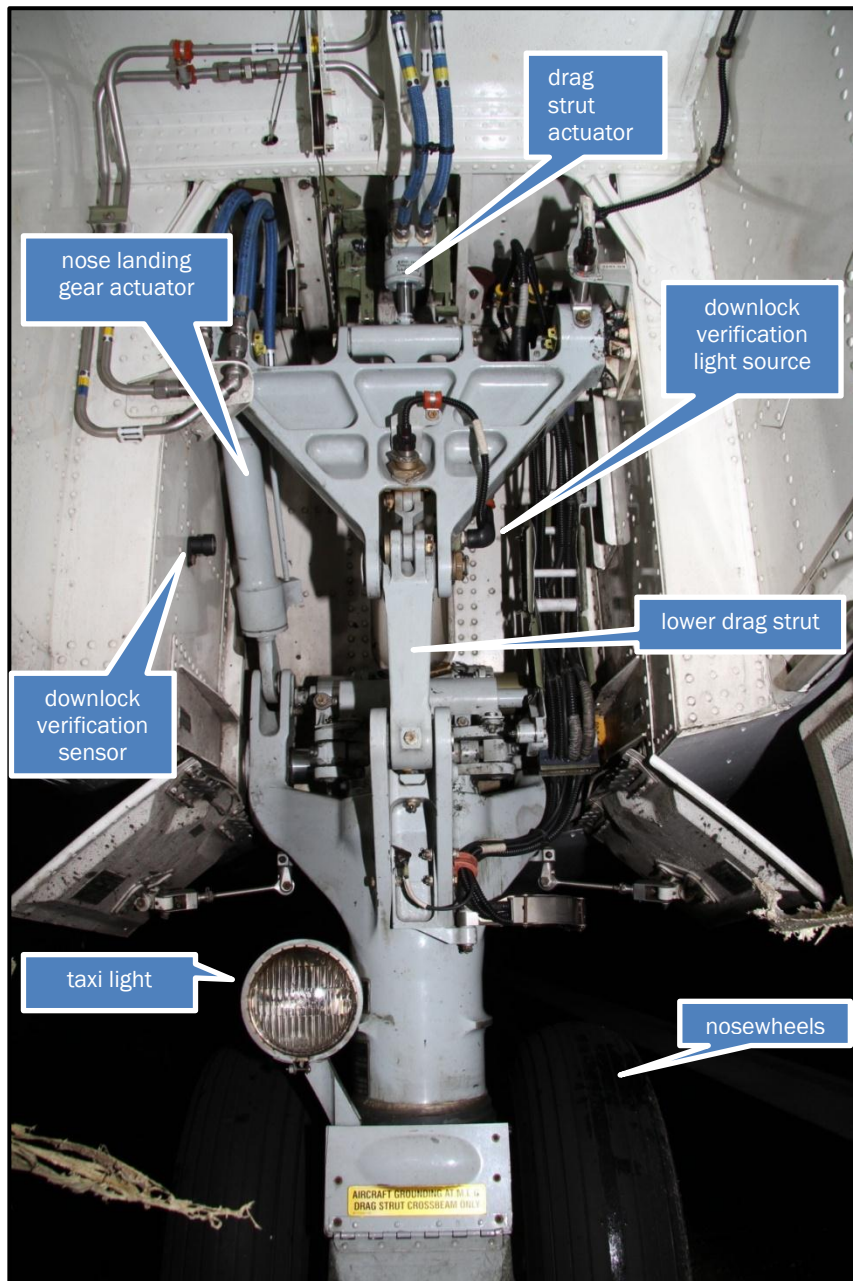
**Figure 4**  
Q300 nose landing gear

- 3.2.6. The Q300 has a retractable, tricycle landing gear. The nose landing gear retracts forward into the fuselage nose. Figure 4 shows some of the nose landing gear components referred to in this report.
