Inquiry 11-005: Boeing 747, engine compressor surges  
18 September 2011

# Final Report

Aviation inquiry 11-005:  
Engine compressor surges  
18 September 2011

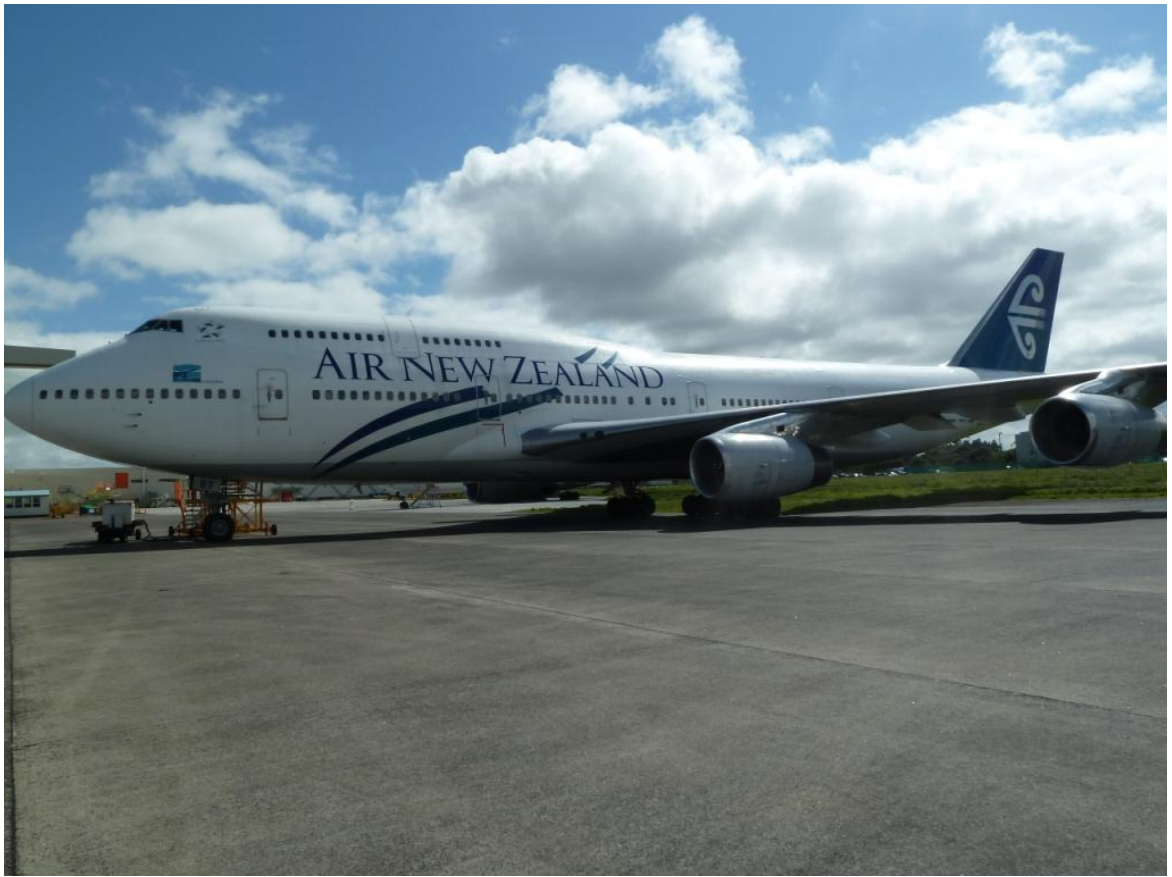
Boeing 747-419 ZK-NBT

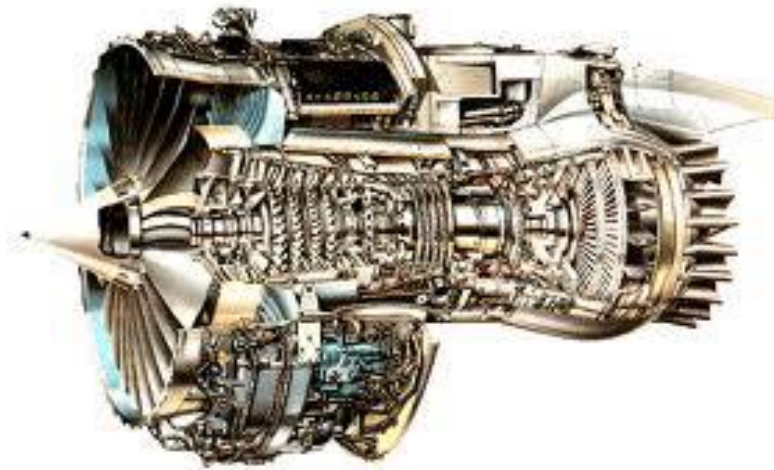
Figure 1  
Rolls-Royce RB211

- 3.2.1. ZK-NBT was a Boeing 747-419, serial number 24855, manufactured in the United States in 1990 and immediately leased by the operator. The aeroplane was powered by 4 Rolls-Royce RB211-524GT turbofan engines (see Figure 1). The incident engine, serial number 13261, was owned by the operator and had accrued 65 371 hours and 6988 cycles<sup>5</sup> since new, and 29 415 hours and 3926 cycles since its last overhaul.
