Inquiry 12-201:  
Fishing vessel Easy Rider, capsize and foundering,  
Foveaux Strait, 15 March 2012

Marine inquiry 12-201

Fishing vessel *Easy Rider*, capsized and foundering, Foveaux Strait,  
15 March 2012

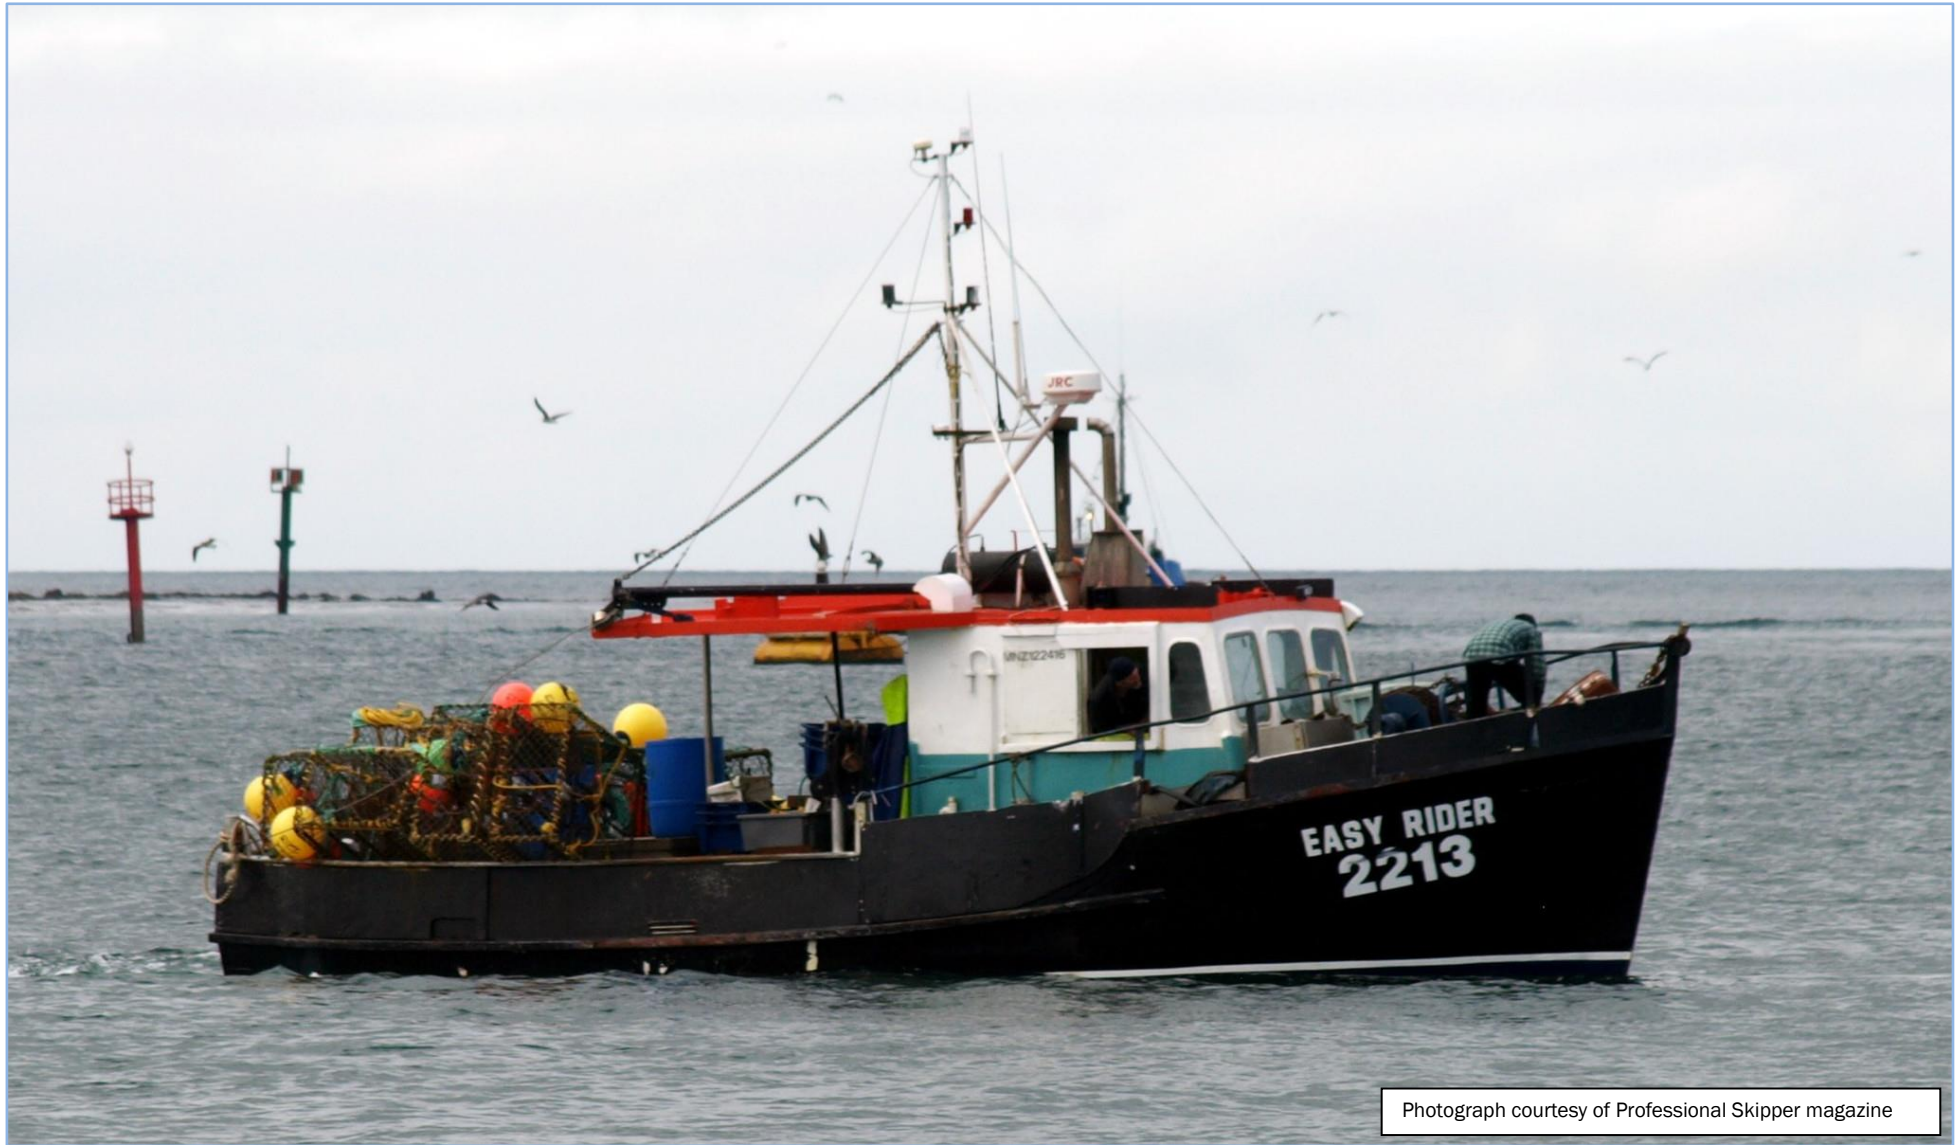
The Easy Rider in 2012

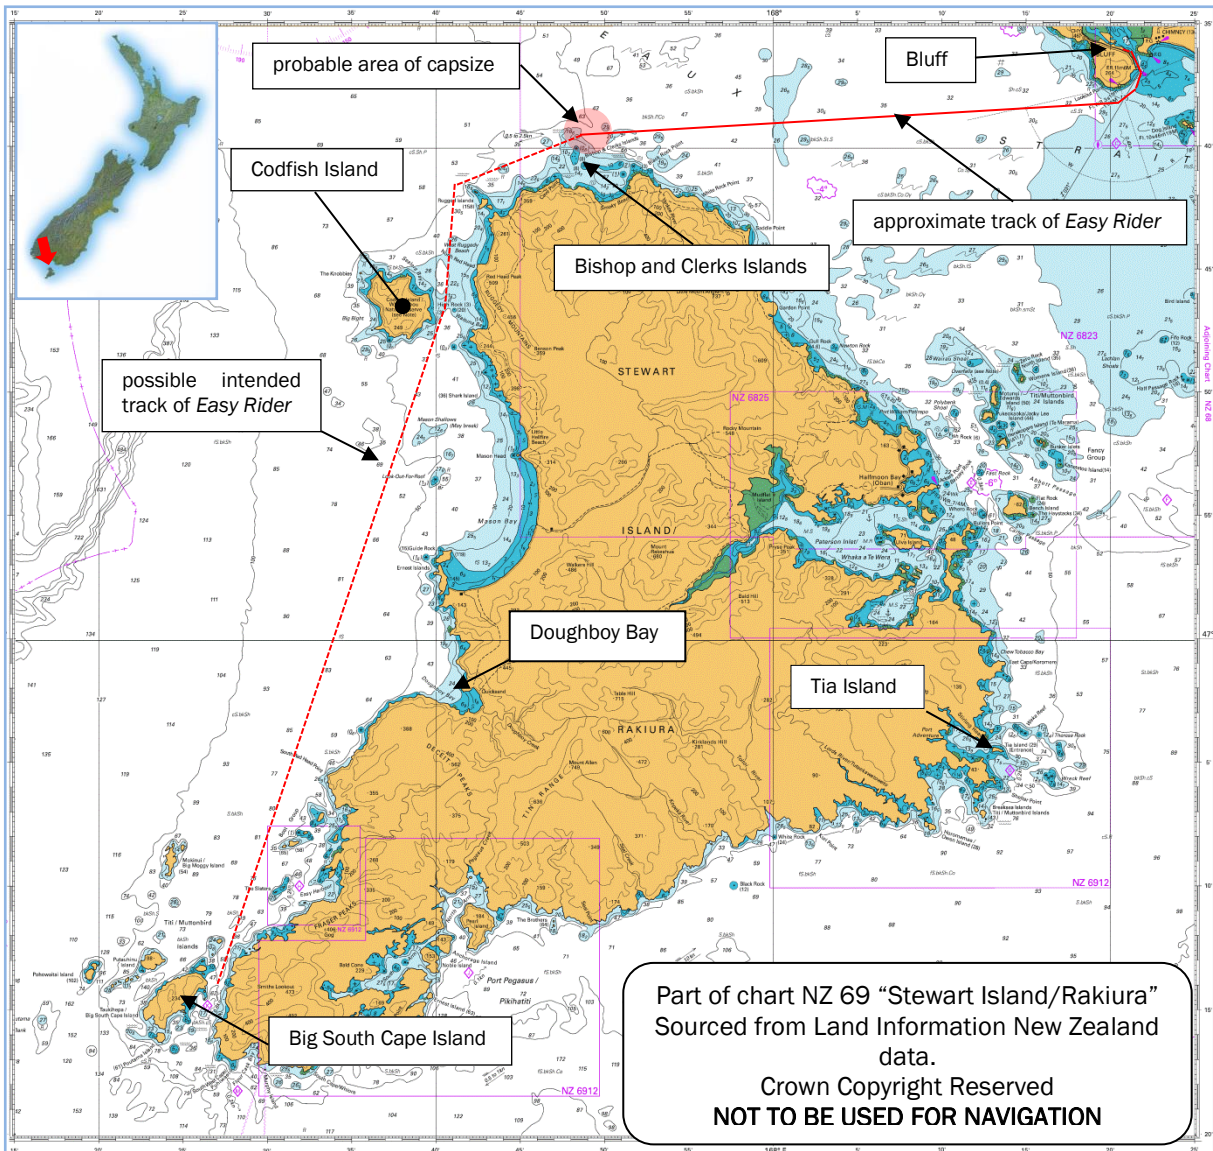
Figure 1  
Chart of the general area

- 3.1.1. The skipper of the *Easy Rider* had agreed to transport 2 members of his extended family along with their cargo to Big South Cape Island, one of the Titi (Muttonbird Islands), (see Figure 1) for 15 March so that they could prepare for the start of the muttonbirding season.

- 3.2.4. At about 1525 Bluff Fisherman's Radio informed the Police of the overdue vessel and a search was organised. The helicopter pilot was requested to search the coast of Big South Cape Island, after which he landed on the Island to refuel before commencing a coastline search along the west coast of Stewart Island northwards from Doughboy Bay (see Figure 1).

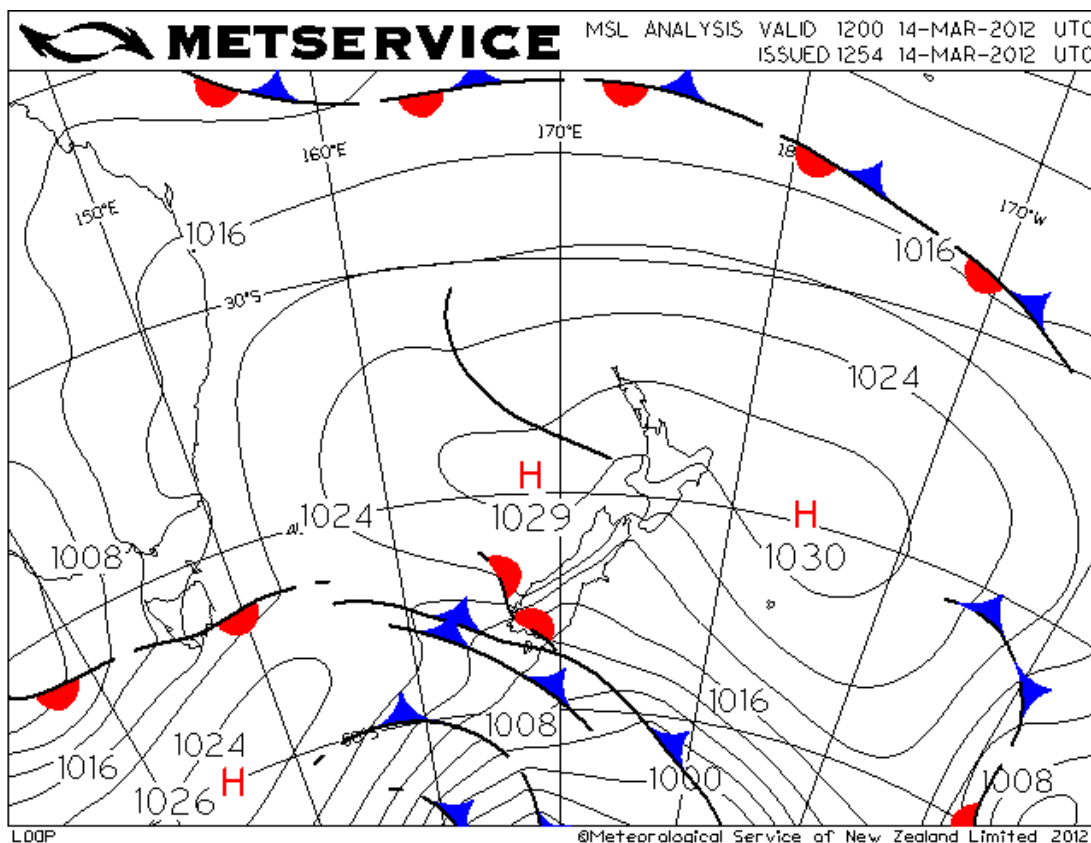
At midnight between 14 and 15 March (see analysis chart above for that time 1200 UTC 14 Mar 2012), a frontal system was moving north-eastwards over Stewart Island preceded by a strong west-northwest air stream. Further north, a ridge of high pressure lay west to east across the North Island and a westerly air stream covered central New Zealand and the South Island.

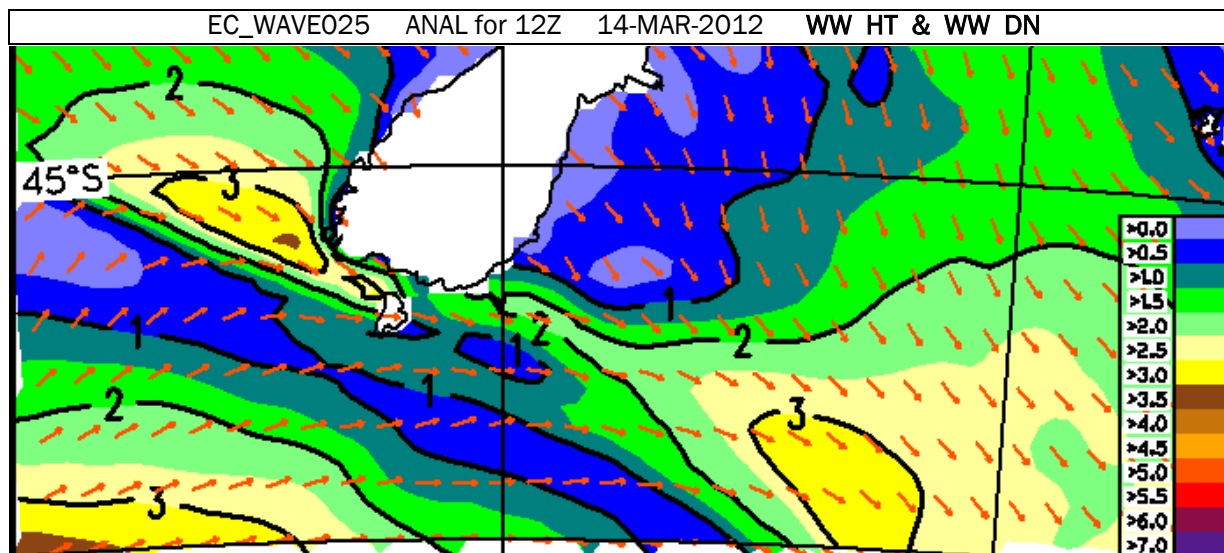
### Wind waves

Deep water wind wave (driven by the local wind) significant height in the vicinity of the north coast of Stewart Island was analysed at 1am 15 March 2012 to be about 3 metres near Codfish Island, and lower (about 2 metres) further east into Foveaux Strait.

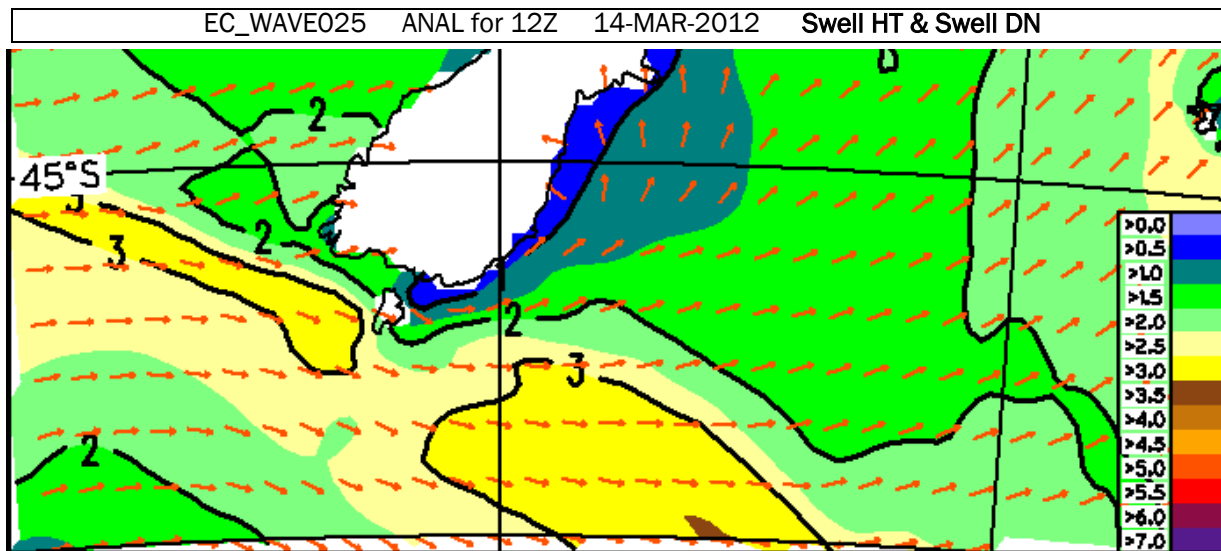
### Swell waves

Swell waves here were travelling from a generation area further to the west

Deep water swell wave significant height in the vicinity of the north coast of Stewart Island was analysed at 1am 15 March 2012 to be in a gradient from about 1.5 metres in Foveaux Strait to 2 metres further west about Codfish Island. The wave direction was from the west northwest.

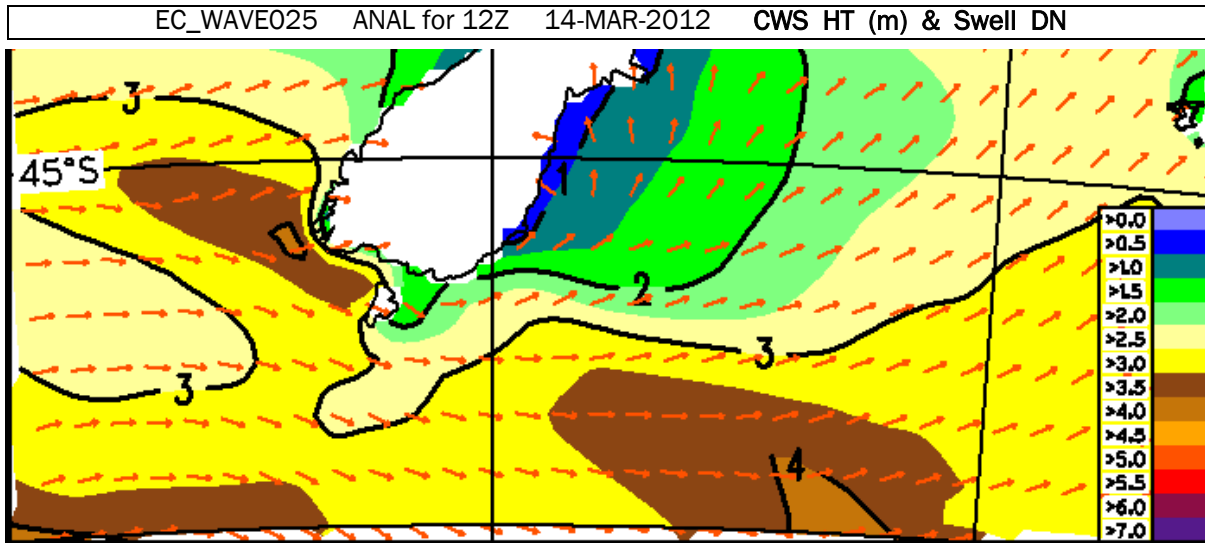
## Combined wind and swell waves.

The significant wave height of the combination of wind and swell waves in the vicinity of the north coast of Stewart Island was analysed at this time to be in a gradient from about 3 metres in Foveaux Strait to about 3.5 metres further west about Codfish Island. The wave direction was from the northwest.

Note that the significant wave height is a characteristic wave height and there would be occasional waves as much as 25% higher, and isolated waves up to 50% higher.

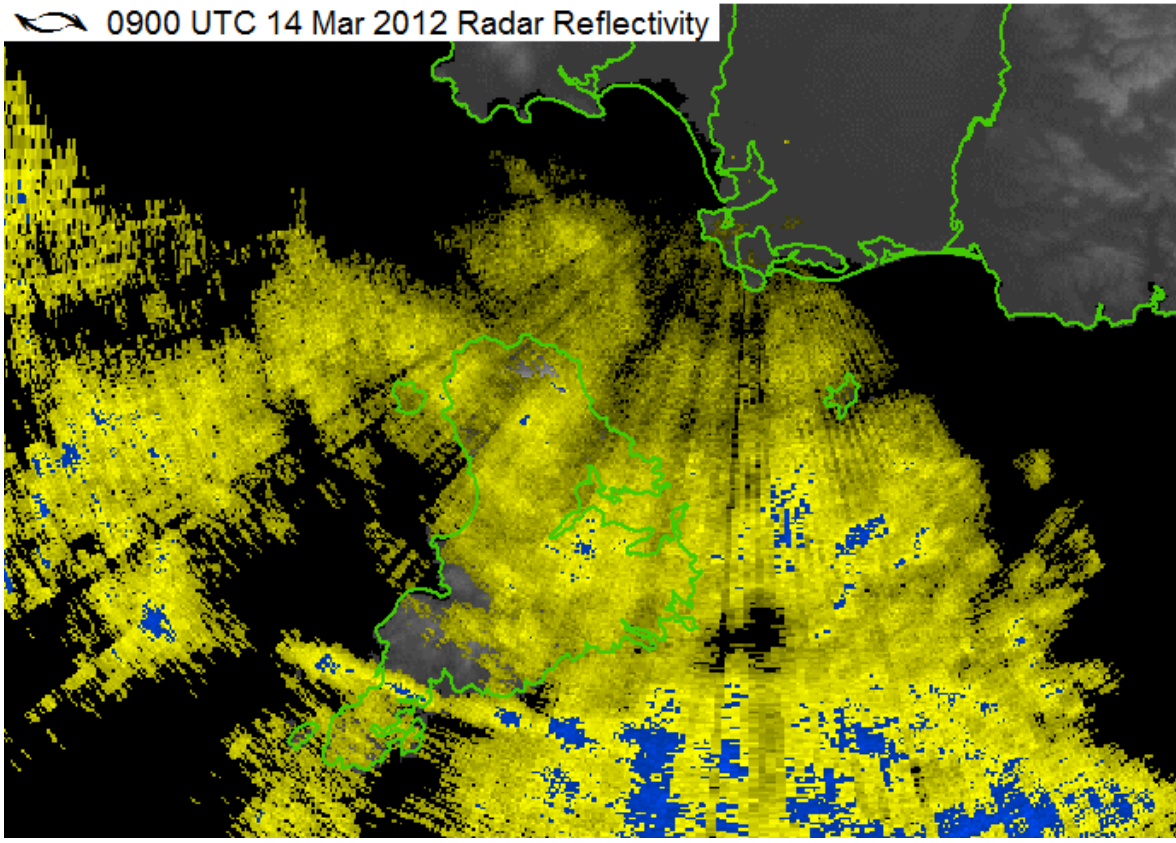
At 10pm 14 March, in the vicinity of the north coast of Stewart Island, the wind was blowing from the west to northwest at about 20 to 25 knots. There is more or less continuous rain which was reducing the visibility.

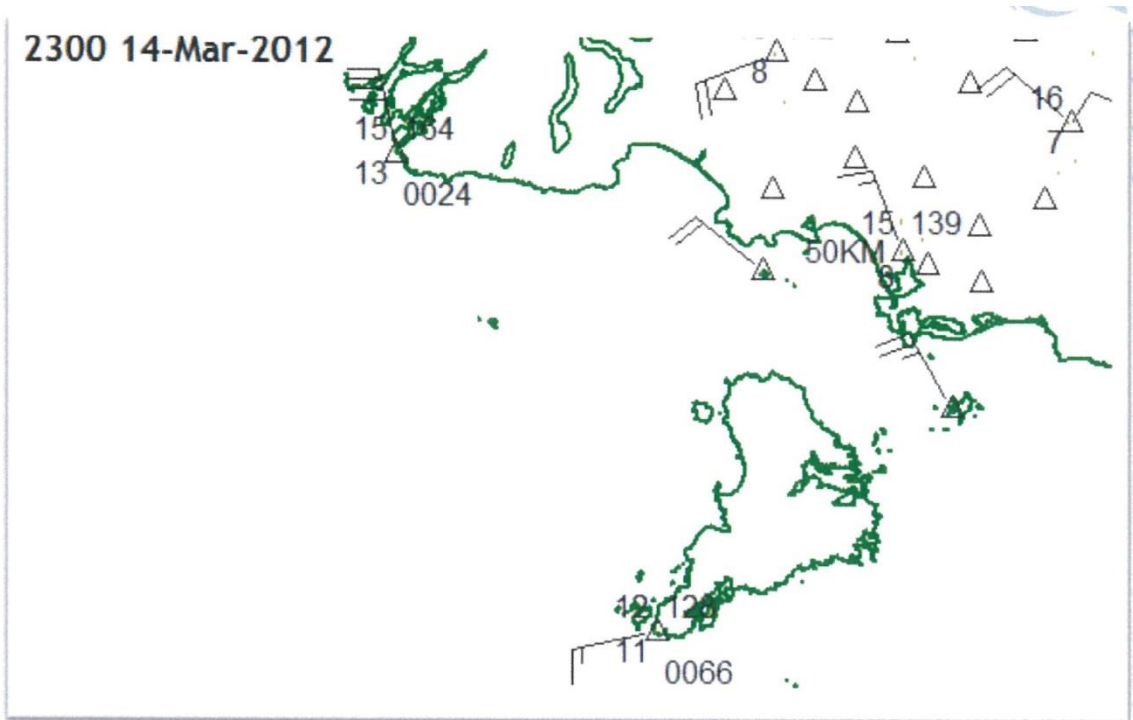
At 11pm 14 March, the cold front had passed to the north of Southwest Cape; the barometric pressure was rising, the wind direction had changed to south of westerly, and the temperature was lowering. The wind in the vicinity of the north coast of Stewart Island was blowing from the west- northwest at about 25 to 30 knots.

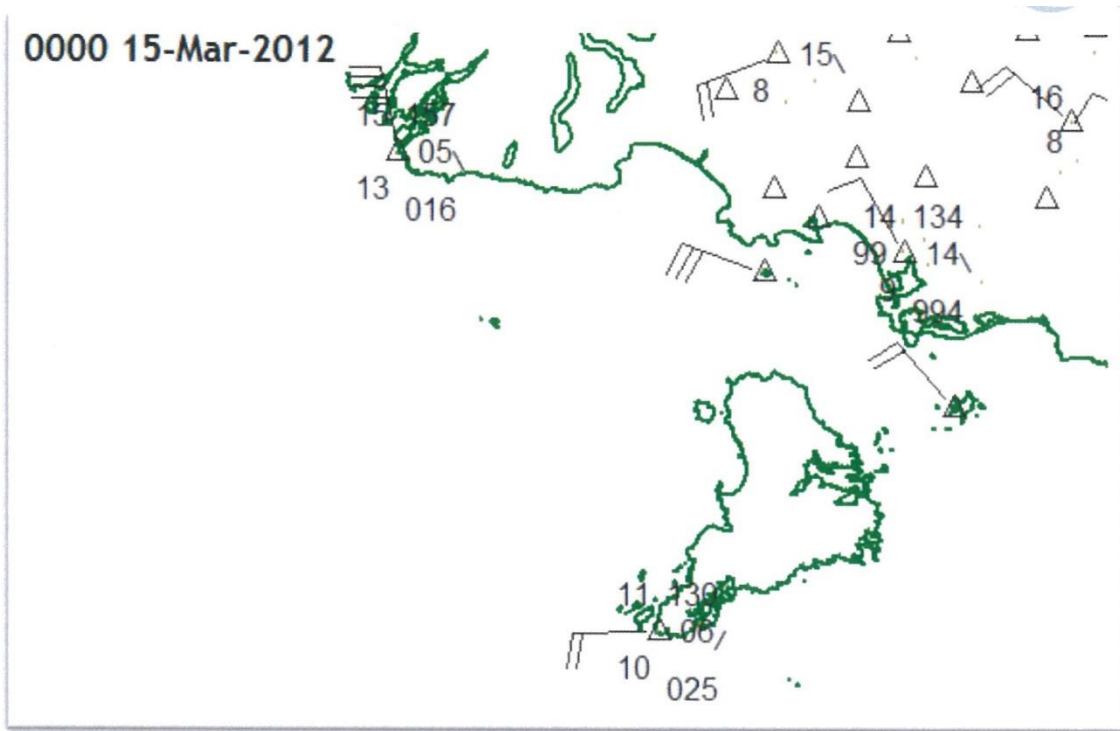
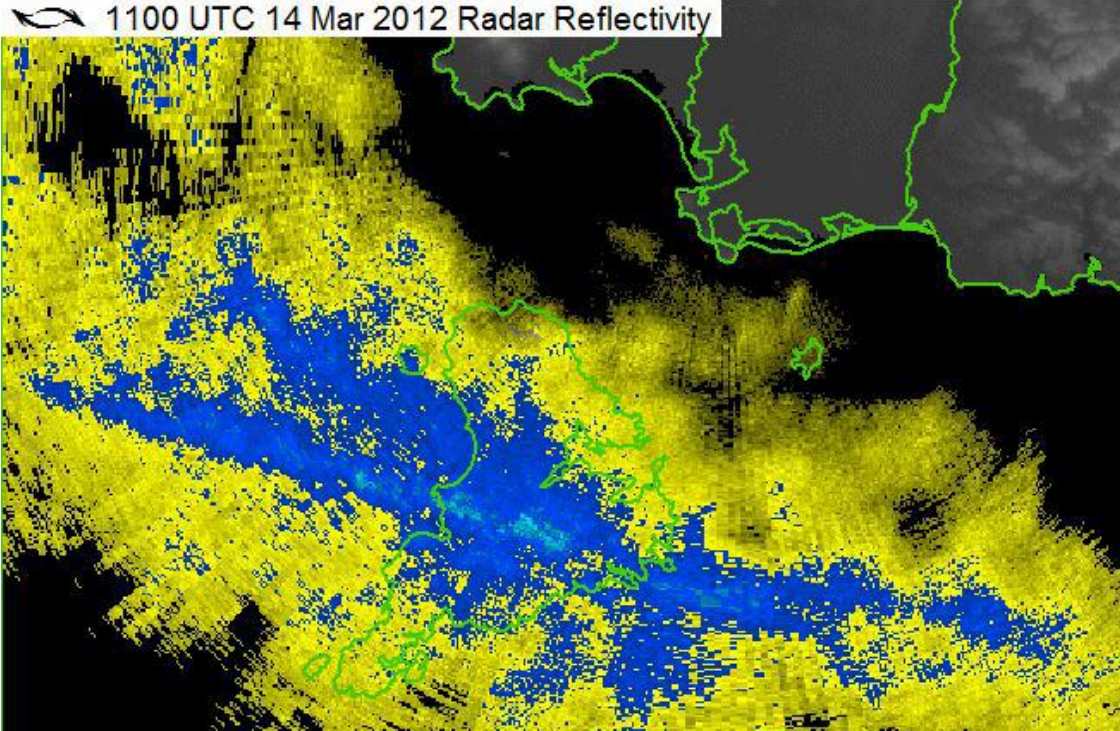
At midnight between 14 and 15 March, the cold front was moving northeast over Stewart Island. The wind in the vicinity of the north coast of Stewart Island was blowing from the west-northwest at about 25 to 30 knots. The significant wave height of the combination of wind and swell waves was in a gradient from about 3 metres in Foveaux Strait to about 3.5 metres further west near Codfish Island. There may have been isolated waves of 5 metres. The waves were travelling from the west-northwest.

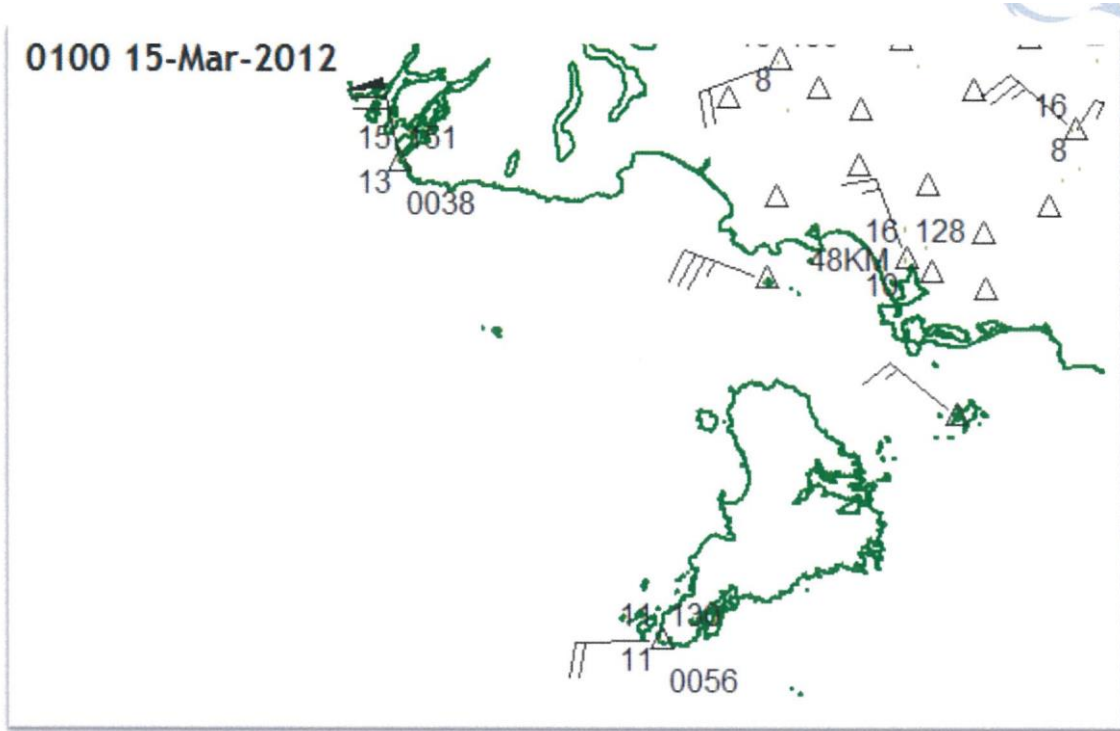
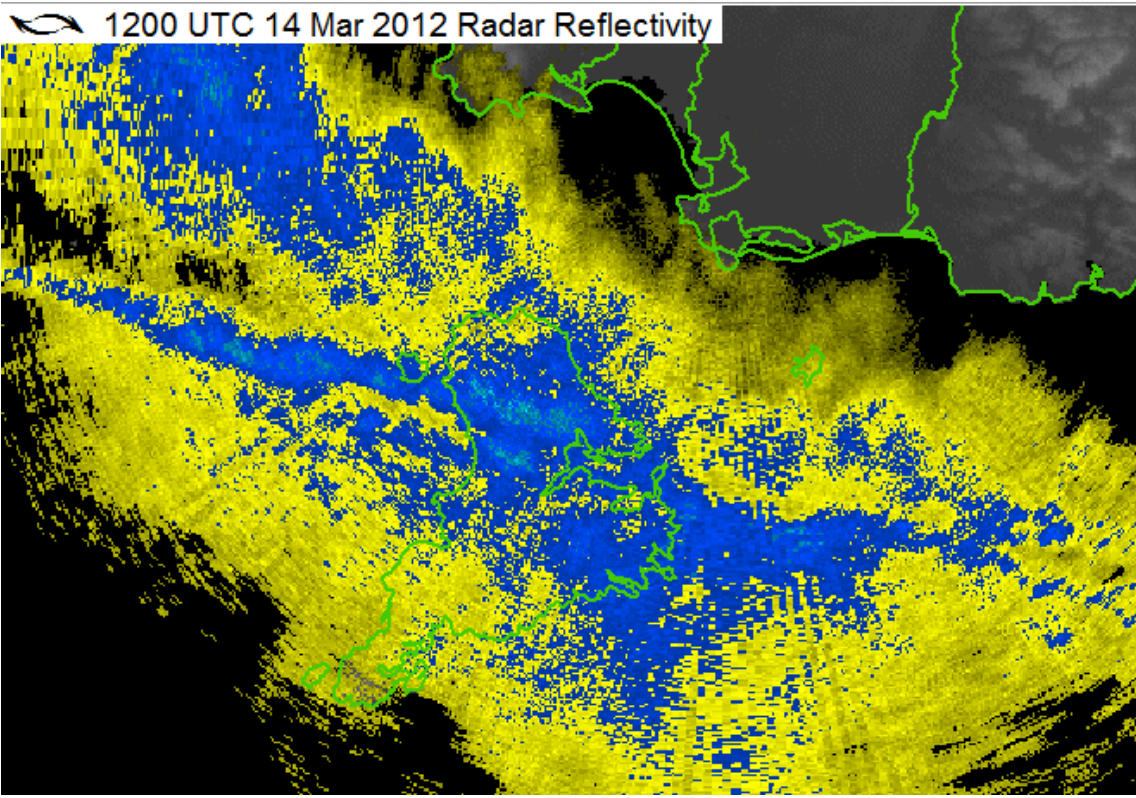
At 1am 15 March the cold front was near the north of Stewart Island. The wind in the vicinity of the north coast of Stewart Island was blowing from the west-northwest at about 25 to 30 knots. The significant wave height of waves was between 3 and 3.5 metres with higher waves near the west coast of Stewart Island, and isolated waves of 5 metres. Visibility would have been restricted by the moderate to heavy rain that was falling.

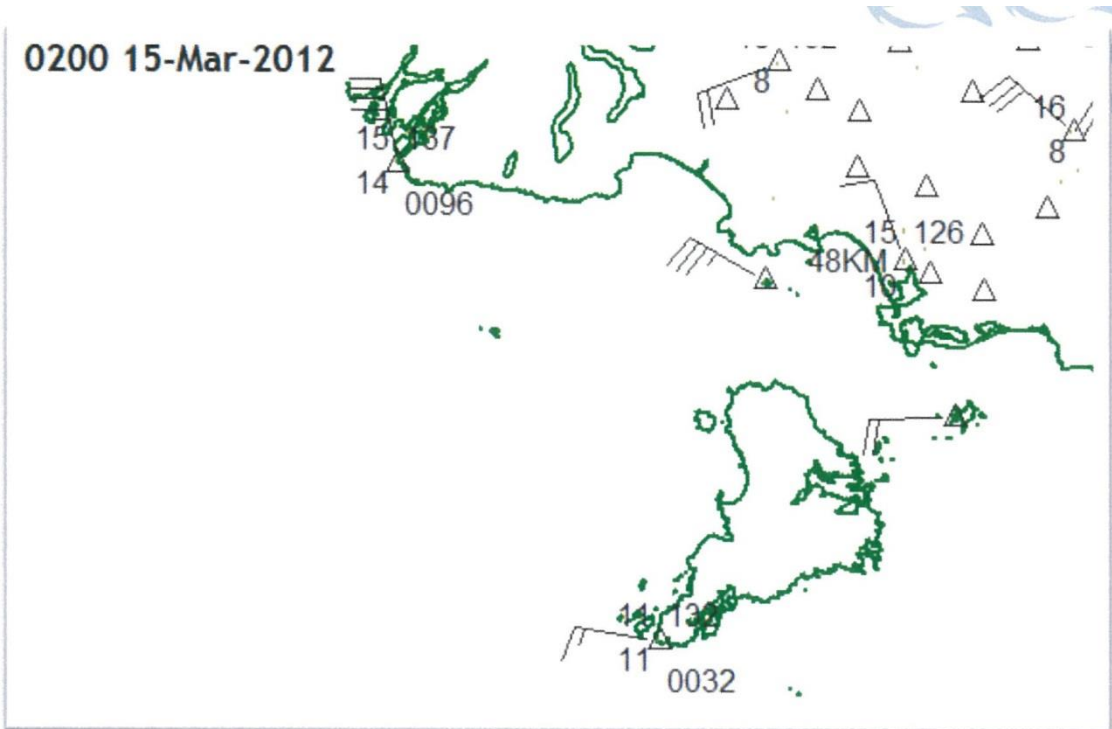
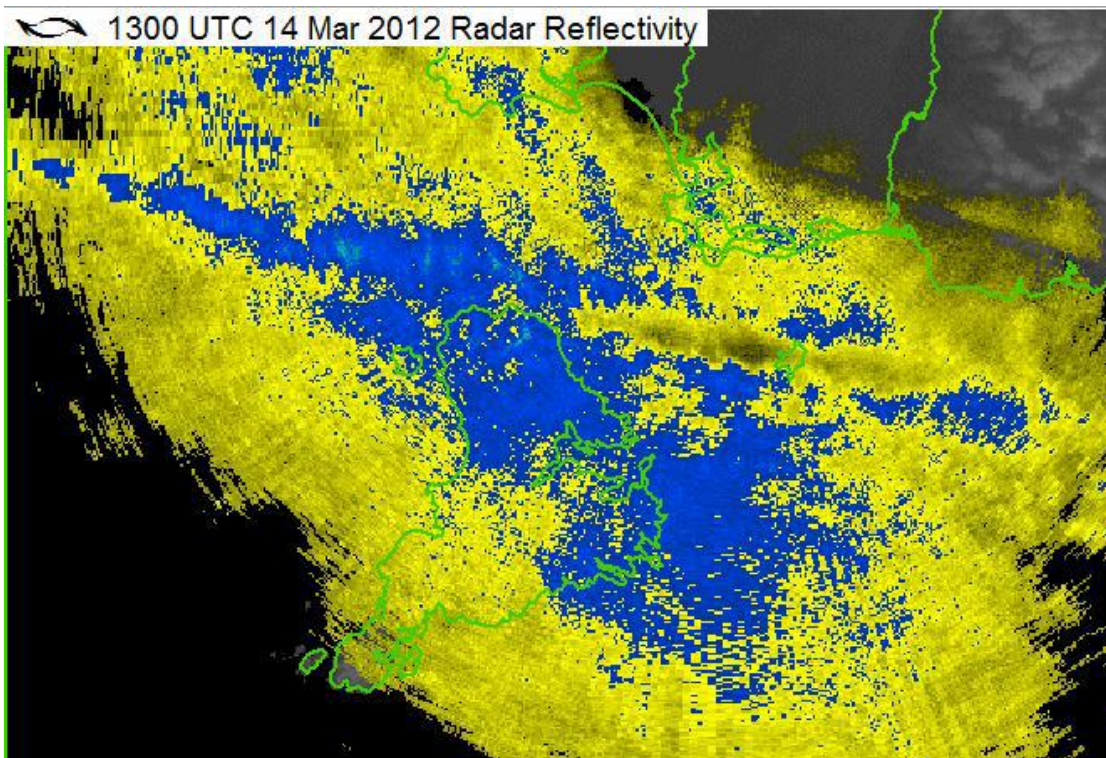
At 2am 15 March the cold front was close to Puysegur Point, over Ruapuke Island but not yet reached Centre Island which was recording 35 knots from the northwest. The wind had probably eased to 20 knots from west or southwest in the vicinity of the north coast of Stewart Island. Wave heights were probably still in the range 3 to 3.5 metres with isolated waves 5 metres high. Visibility was being reduced by the moderate rain that was still falling.
