Inquiry AO-2013-005: In-flight loss of control, Robinson R22,
ZK-HIE, near New Plymouth, 30 March 2013

Final Report

Aviation inquiry AO-2013-005
In-flight loss of control
Robinson R22, ZK-HIE
near New Plymouth
30 March 2013

Approved for circulation: May 2015

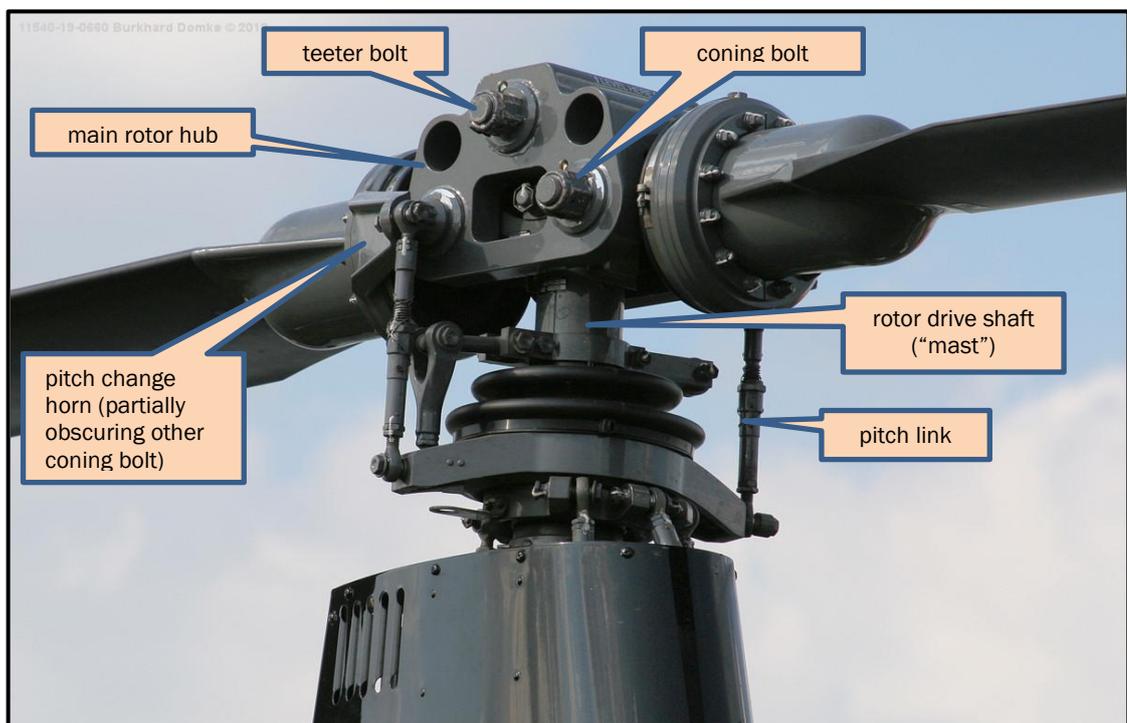
Figure 3
R22 main rotor head components
(Image used with permission of Burkhard Domke)

3.2.2. The manufacturer advised the engineer of the special inspections to be made after a mast bump. The main rotor blades did not require replacement, but the following major parts were replaced (see Figure 3):

- 3.4.1. The two-seat R22 light helicopter was manufactured by Robinson in the United States and was first certificated by the FAA in 1979. The two blades of the underslung, teetering main rotor can flap independently, a design feature that was unique to Robinson helicopters (see Figure 3).
