Final Report AO-2014-004: Piper PA32-300, ZK-DOJ,
Collision with terrain, Near Poolburn Reservoir, Central Otago, 5 August 2014

Aviation inquiry AO-2014-004

Piper PA32-300, ZK-DOJ
Collision with terrain
Near Poolburn Reservoir, Central Otago
5 August 2014

Approved for publication: August 2016

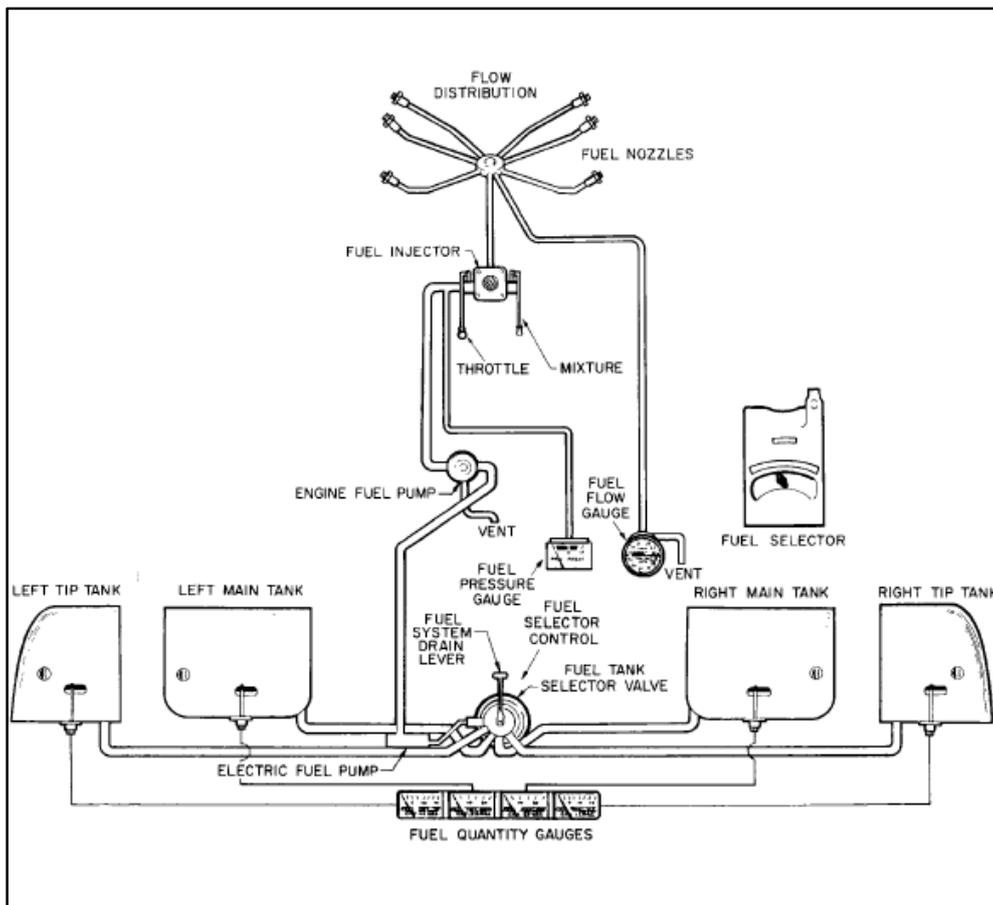
Figure 3
PA32-300 fuel system
 Source PA32 owner's manual

3.4.5. The fuel system consisted of two aluminium tanks contained in the inboard leading edge section of the wings, plus two fibreglass tanks, one located in each wing tip (see Figure 3). The main tanks had a maximum capacity of 95 litres each and the tip tanks had a maximum capacity of 64 litres each. Fuel was taken from each tank to a combination fuel selector valve and strainer located under the floor below the middle seats.
