Final report AO-2014-005: Eurocopter AS350-B2 (ZK-HYO), collision with terrain during heli-skiing flight, Mount Alta, near Mount Aspiring National Park, 16 August 2014

Aviation inquiry AO-2014-005
Eurocopter AS350-B2 (ZK-HYO)
collision with terrain during heli-skiing flight
Mount Alta, near Mount Aspiring National Park
16 August 2014

Approved for publication: November 2017

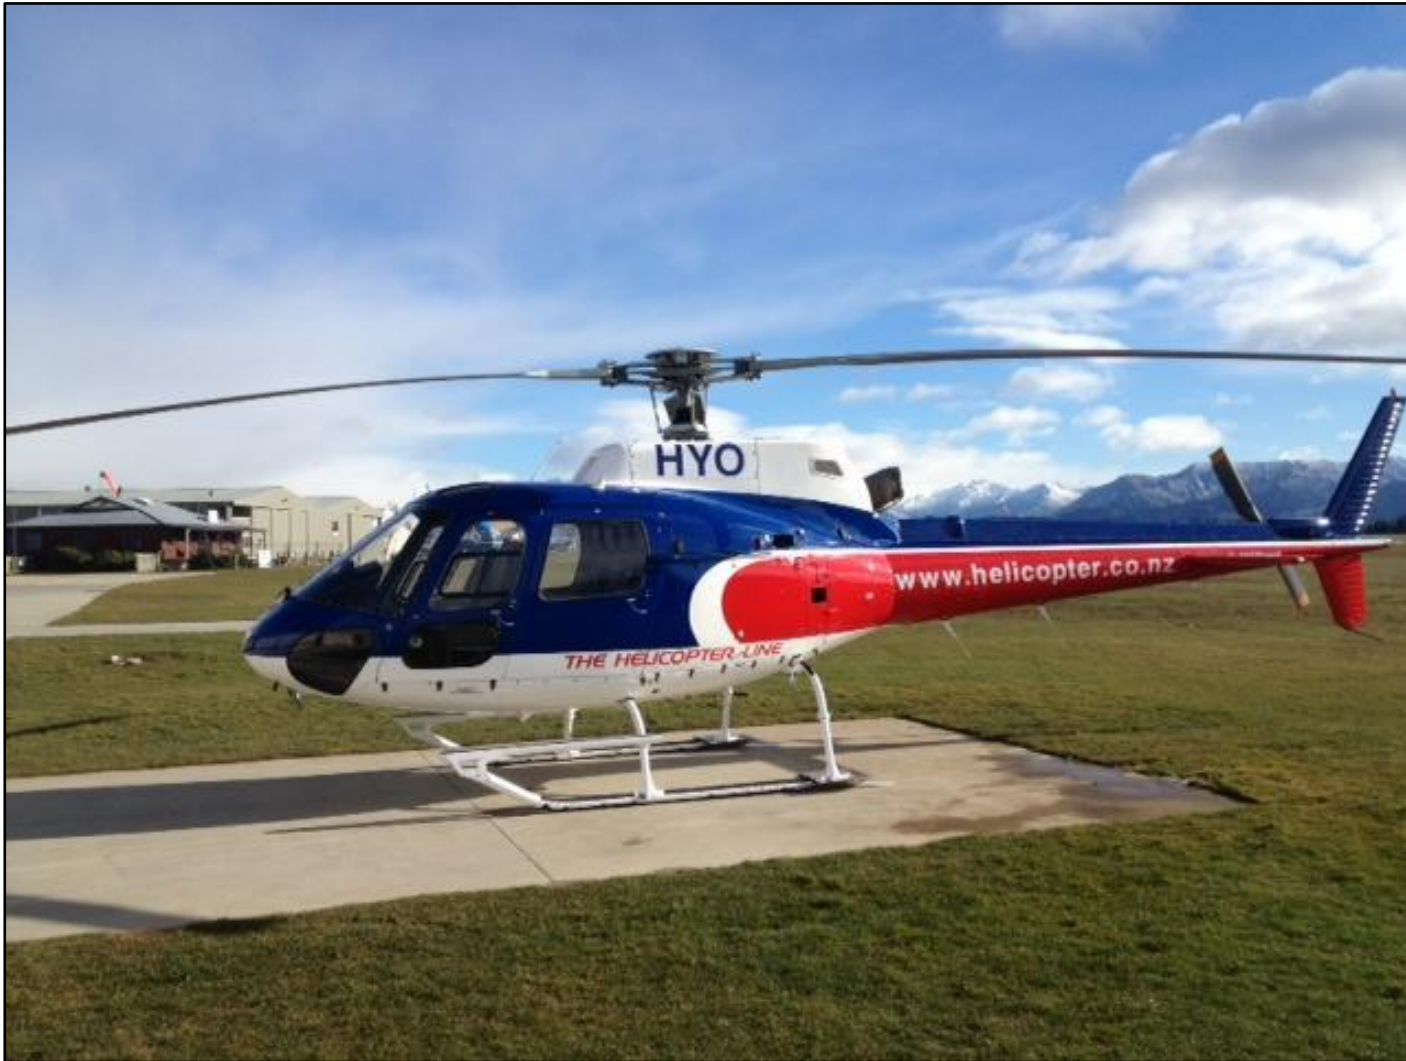
Eurocopter AS350-B2 (ZK-HYO)

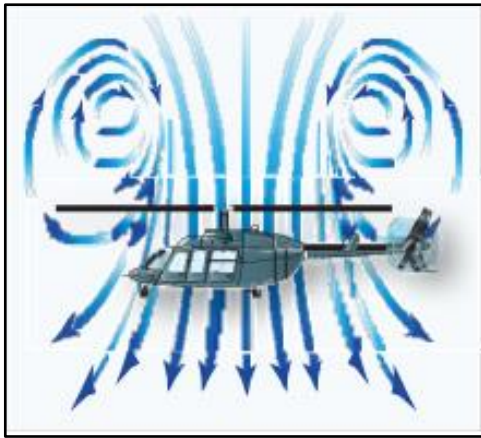
Figure 7
Typical rotor downwash flow
(Courtesy of Federal Aviation Administration)

When a helicopter is generating rotor thrust or lift, there will be some recirculation of air around the end of the blades or rotor disc.⁵⁵ The recirculation is most pronounced at high power and low airspeed, as in a hover, and reduces as the helicopter moves forward. Vortex ring state occurs when the tip vortex becomes more energised and a secondary inner vortex is established towards the centre of the rotor disc because the rate of descent exceeds the induced downward flow (see Figures 7 and 8).⁵⁶

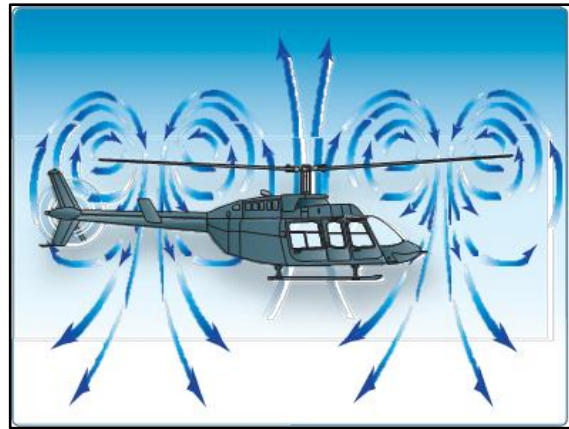
Figure 8
Vortex ring state
(Courtesy of Federal Aviation Administration)

The onset of vortex ring state can be sudden, resulting in the helicopter descending at a very high rate. Any increase in rotor thrust in an attempt to reduce the high rate of descent energises the vortices further and increases the rate of descent. Rates of descent of more than 3,000 feet per minute are not unusual. A United States National Transportation Safety Board report into an AS350-B2 accident cited rates of descent between 4,000 feet and 6,000 feet per minute (National Transportation Safety Board, 2001). This is significantly faster than the 1,500 to 2,000 feet per minute rate of descent experienced in an autorotation following a total power loss.
