Final report RO-2013-103 and RO-2014-103: Passenger train collisions with Melling Station stop block, 15 April 2013 and 27 May 2014

Rail inquiries RO-2013-103 and RO-2014-103

Passenger train collisions with Melling Station stop block, 15 April
2013 and 27 May 2014

Approved for publication: November 2016

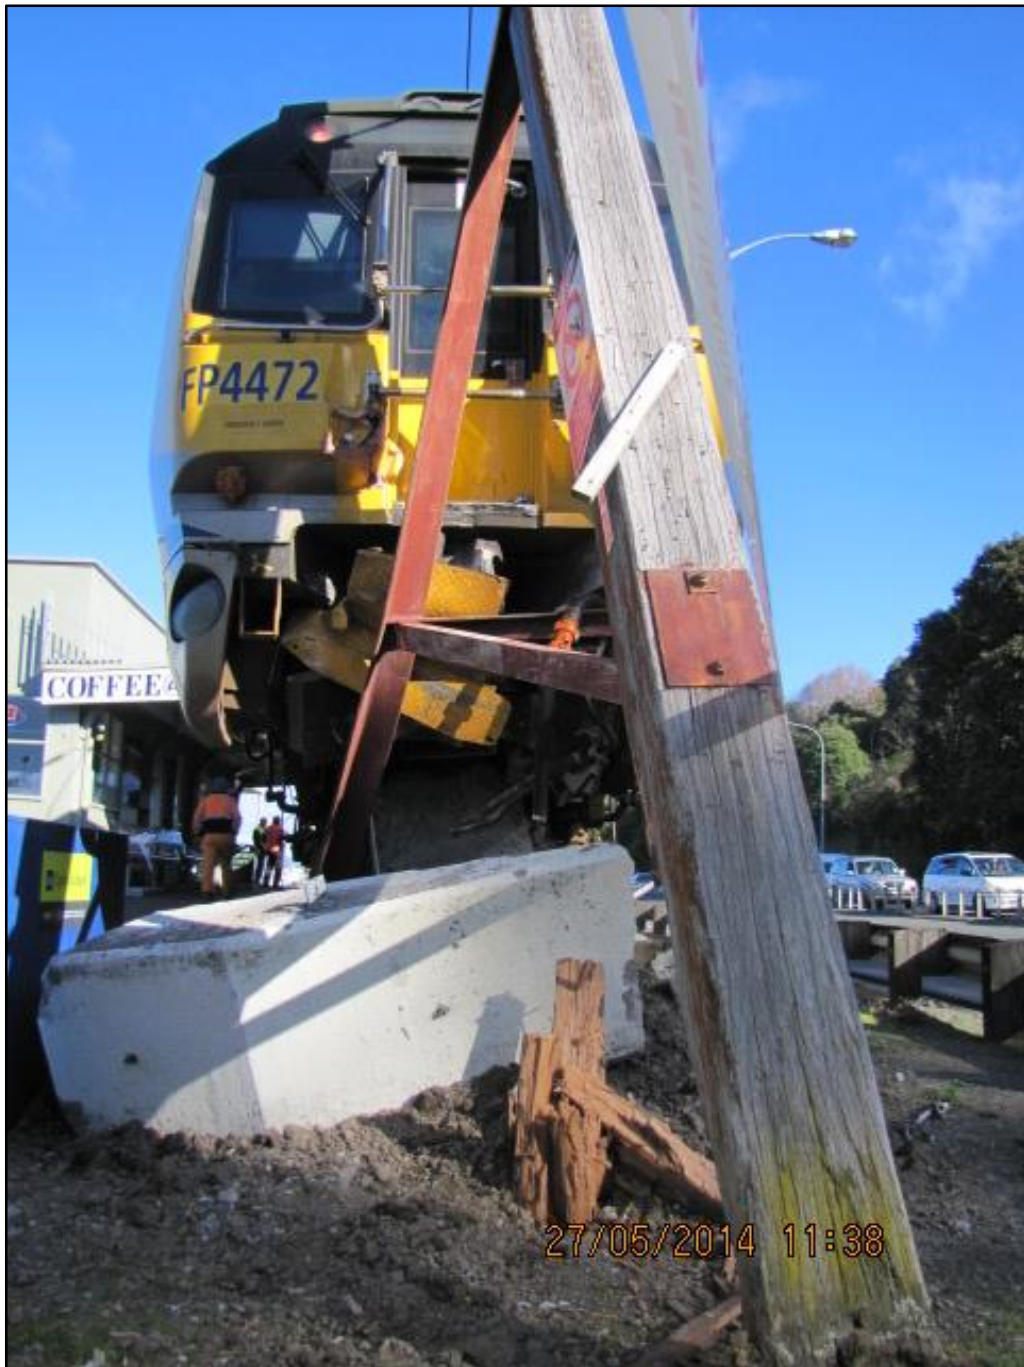
Melling 2 train

- 1.2. Just over one year later, on 27 May 2014, the same thing happened when another two-car Matangi passenger train collided with the stop block. This time the train came to rest on top of the stop block. The concrete block split and the terminal pole for the overhead power line, mounted directly behind the stop block, was severed at ground level. The overhead contact wire drooped and momentarily touched the roof of the train, causing the electrical circuit breaker to trip for the area. The train was extensively damaged and two passengers received minor injuries.

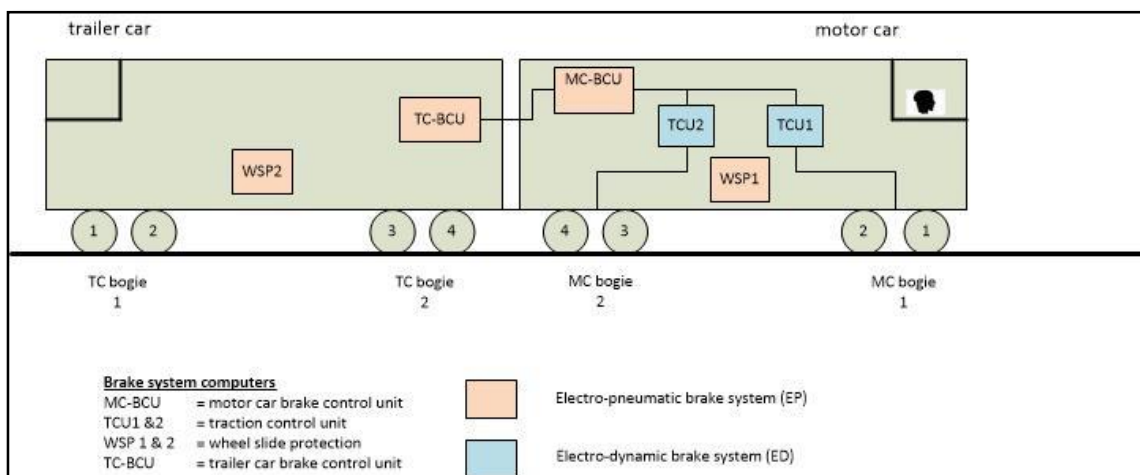
Figure 7
Brake computer control system

- 3.4.1. The Matangi brakes are controlled by computers (control units). The control units read a driver's brake demand signal and each activates an appropriate brake force depending on the speed and weight of the train at the time (see Figure 7). The control units each respond independently to the demand signal by calculating the required brake force. The control units then check how much brake force can be achieved using dynamic brakes and back off an equivalent friction brake force to ensure that dynamic is the preferred brake force.

3.6.2. One wheel-slide protection system is a software application within another controller. It resides in the two traction control units (see Figure 7) and is effective only when dynamic braking is in use. The other wheel-slide protection system is a dedicated, stand-alone, computerised control unit that only works with the pneumatic friction brakes. A system of this type is fitted to both the motor and the trailer cars. It continuously monitors for wheel slide and operates whenever wheel slide is detected while the friction brakes are in use. This wheel-slide protection system is disabled when the train speed drops below 5 km/h.
