Final report RO-2014-105: Near collision between train and hi-rail excavator,  
Wairarapa Line near Featherston, 11 August 2014

Rail inquiry RO-2014-105  
Near collision between train and hi-rail  
excavator,

Wairarapa Line near Featherston

11 August 2014

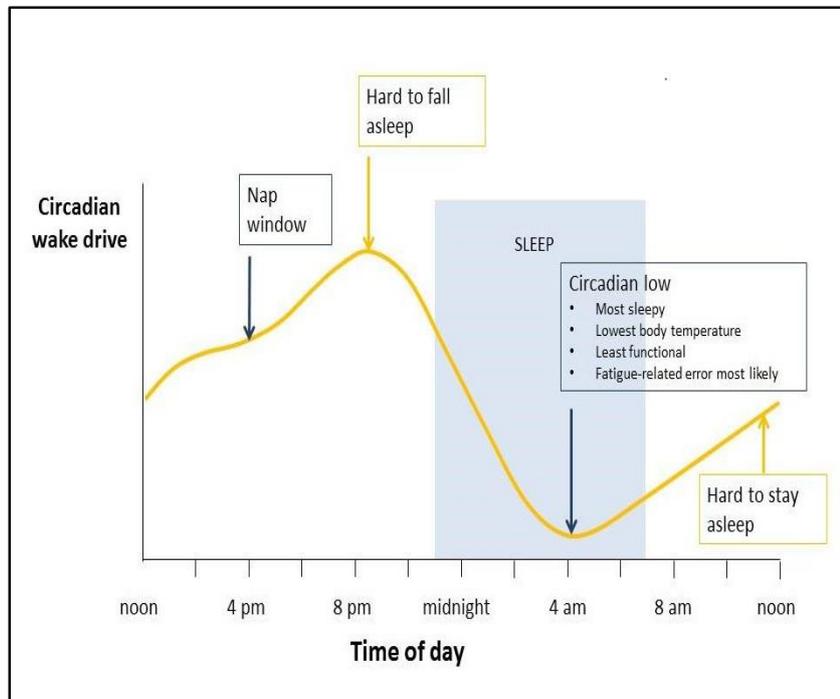
**Figure 5**  
**The influence of circadian body clock on sleep and alertness where an individual typically sleeps between 2300 and 0700**

Due to the circadian biological clock, sleepiness is maximal in the early hours of the morning (approximately 3-5am) with another, smaller peak in the middle of the afternoon (approximately 3-5pm) (see figure below). Although maximal sleepiness is in the early hours of the morning, performance and alertness can be affected throughout the night hours when a person would normally be asleep.
