Final report MO-2014-203: Fatal injury, Purse seine fishing vessel,
Captain M. J. Souza, 24 August 2014

Marine inquiry MO-2014-203
Fatal injury
Purse seine fishing vessel, *Captain M. J. Souza*
24 August 2014

Approved for publication: September 2016

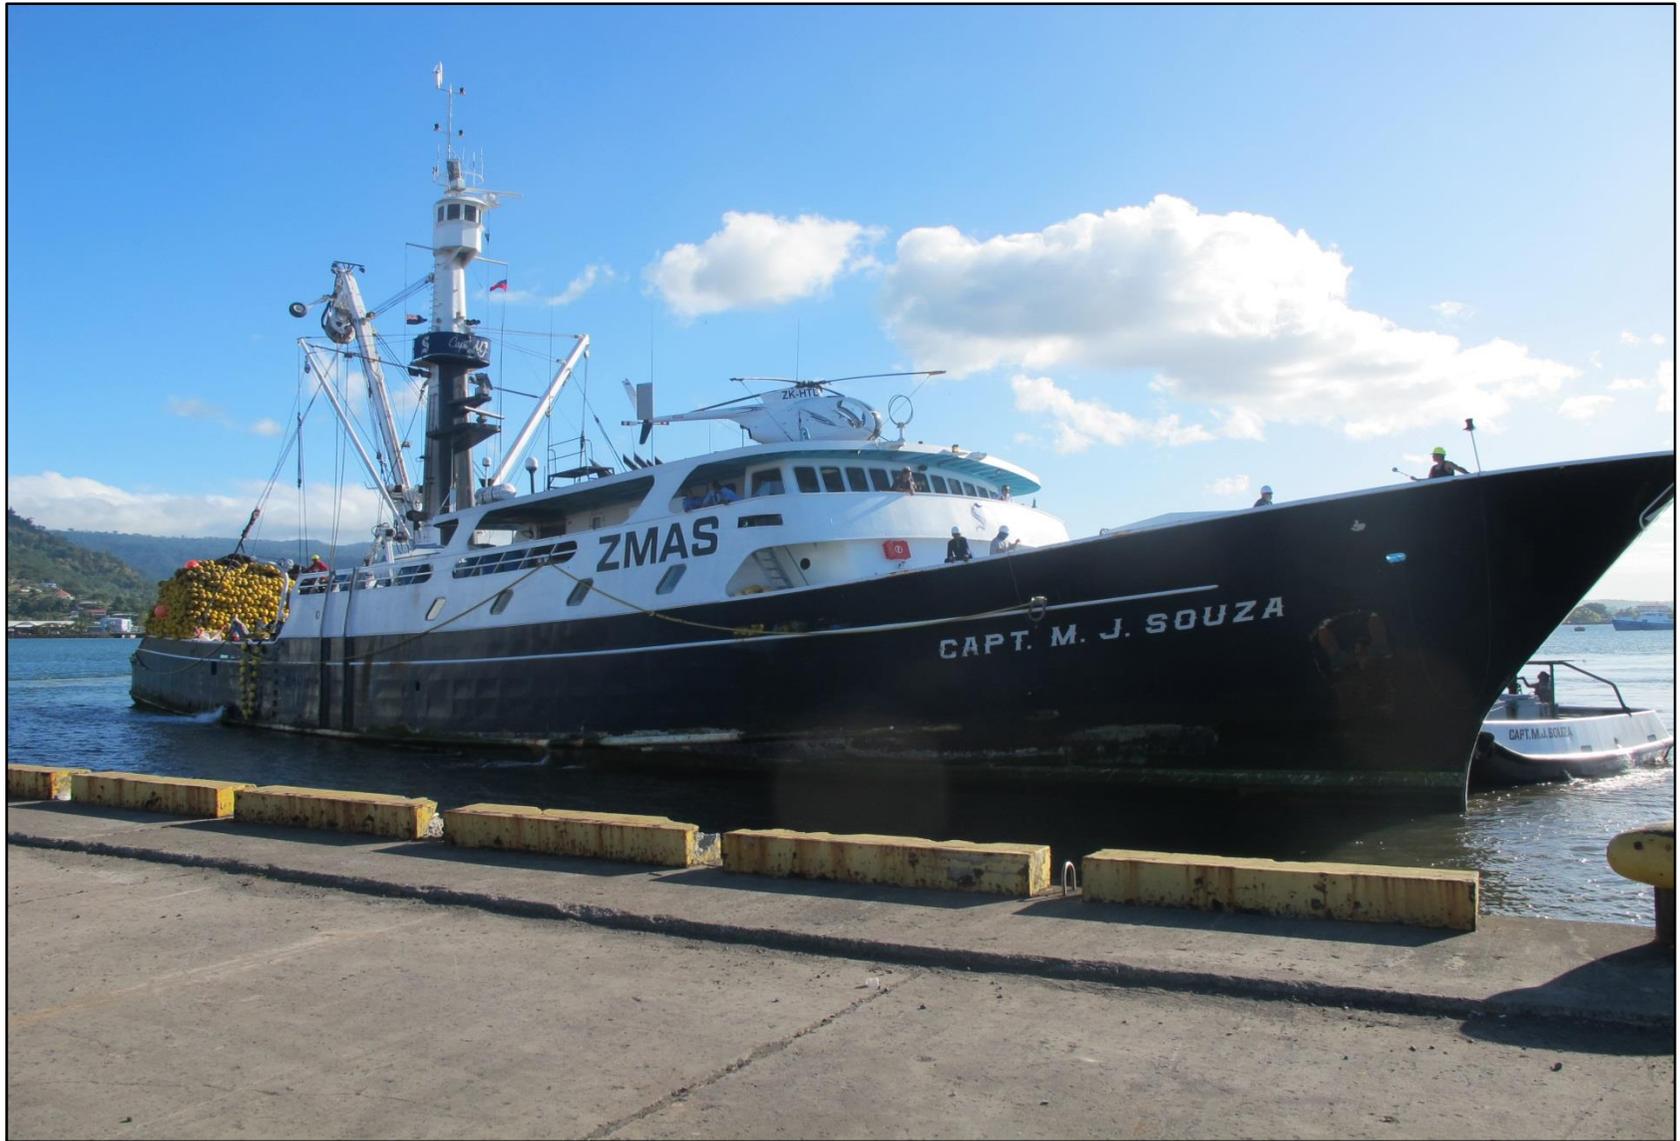
The Captain M. J. Souza at Apia, Samoa, August 2014

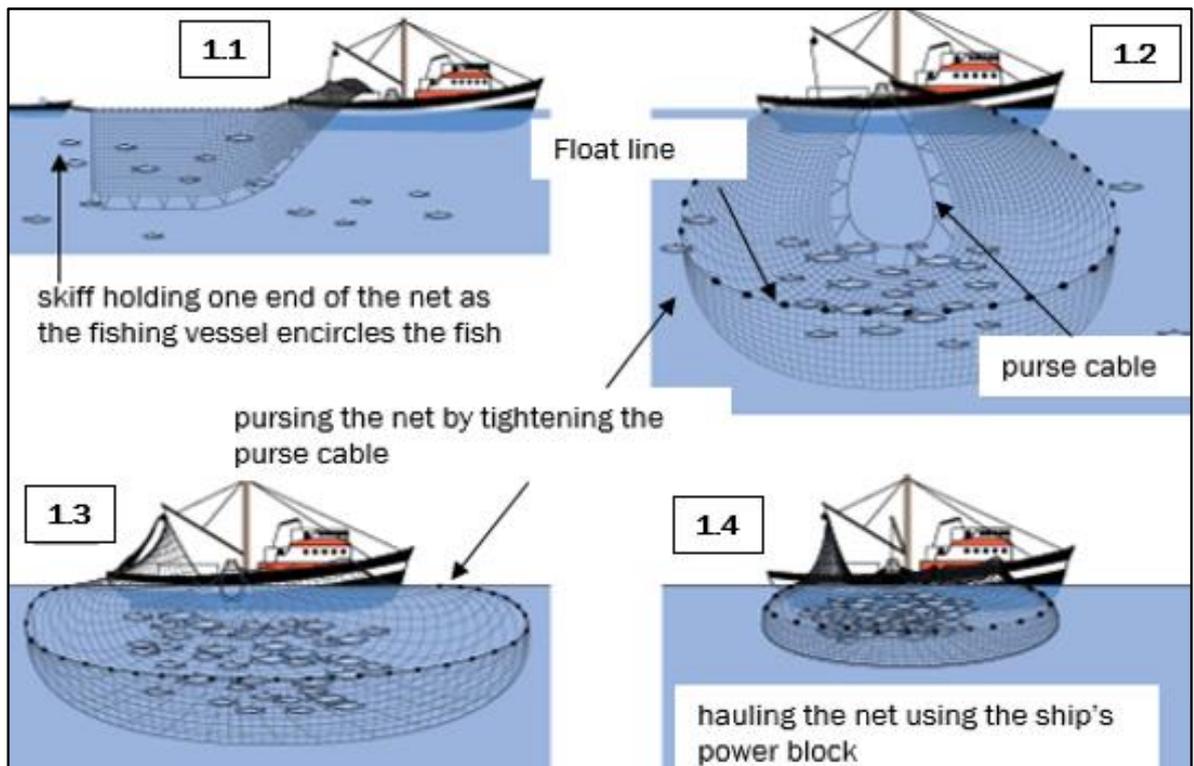
Figure 1
Purse seine operation
(Photo courtesy Encyclopaedia Britannica)

- 3.1.1. Purse seine fishing aims to surround a school of fish quickly by means of a large net, then impound the fish by closing the bottom of the net. The net is cast vertically (Figure 1, 1.1) and has buoys attached to a float line at the top to keep the net afloat. The remainder of the net is then dropped into the water using a weighted line (Figure 1, 1.2). A steel cable⁴ running through a series of purse rings at the lower end of the net is tightened or pursed to close the bottom of the net and prevent the fish escaping (Figure 1, 1.3).

- 3.2.8. Once the sling had been secured to the post and the choker line attached to the ortza, the winch operator started pursing in the cables to close the bottom of the net (Figure 1, 1.4).
- 3.2.9. About one minute into the pursing operation the sling parted and the weight of the net pulled the ortza outboard until the choker line took up the weight of the net. The ortza was at that point close to the sea surface.
