Final report AO-2015-003: Robinson R44, Main rotor blade failure,  
Waikaia, Southland, 23 January 2015

Aviation inquiry AO-2015-003  
Robinson R44  
Main rotor blade failure  
Waikaia, Southland  
23 January 2015

Approved for publication: December 2017

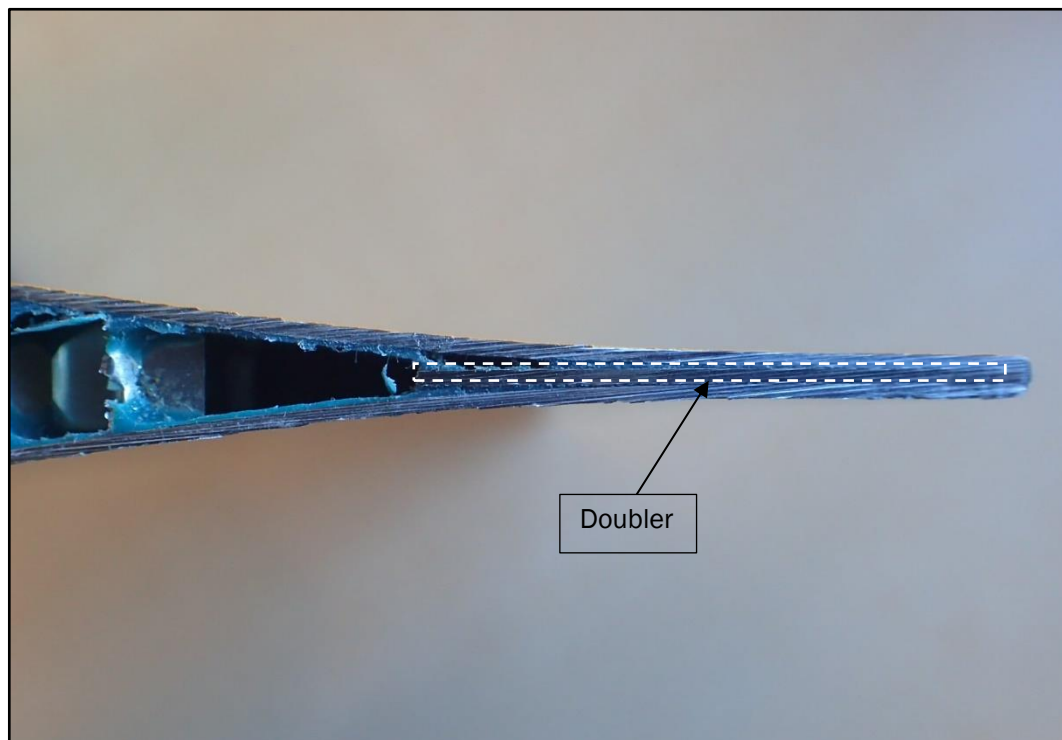
Figure 4  
Cross-section of blade trailing edge, with doubler highlighted

- 3.3.3. The main rotor blades were part number C016-7 'Revision AD' blades with aluminium top and bottom skins and an internal aluminium 'honeycomb' bonded to a load-bearing stainless steel 'D spar'. The blade's trailing edge was formed by bonding the upper and lower skins with structural epoxy adhesive. A stainless steel doubler was bonded between the upper and lower skins at the trailing edge (see Figures 4 and 5). The doubler terminated about two-thirds of the length of the trailing edge from the blade root. A fillet of flexible epoxy sealant along the rear edge of the bond line provided protection from corrosion.

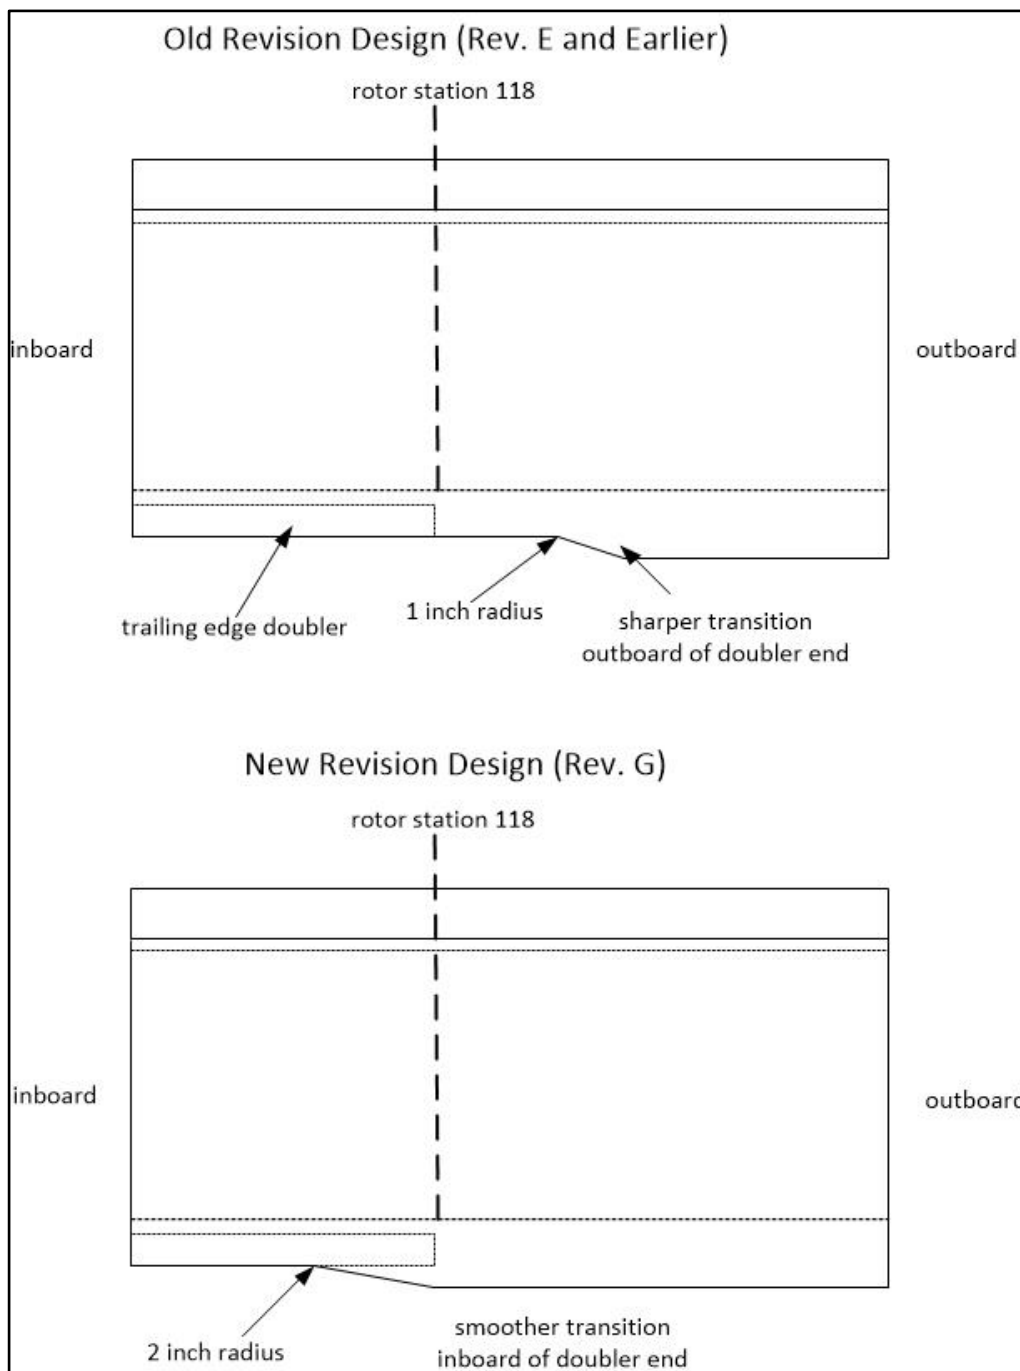
**Figure 6**  
Design changes between C016-7 'Revision AE' and 'Revision AG' blades

- 4.5.2. Blade 'Revision AG' also moved the chord length transition inboard of the doubler termination. Robinson advised that this change was to provide a strength margin in case of corrosion or damage at or near the transition radius (see Figure 6).
