Final report AO-2016-006: Eurocopter AS350-B2, ZK-HYY, Collision with terrain during scenic flight  
Mount Sale, near Arrowtown, 12 September 2016

Aviation Inquiry AO-2016-006:  
Eurocopter AS350-B2, ZK-HYY  
Collision with terrain during scenic flight  
Mount Sale, near Arrowtown  
12 September 2016

Approved for publication: February 2018

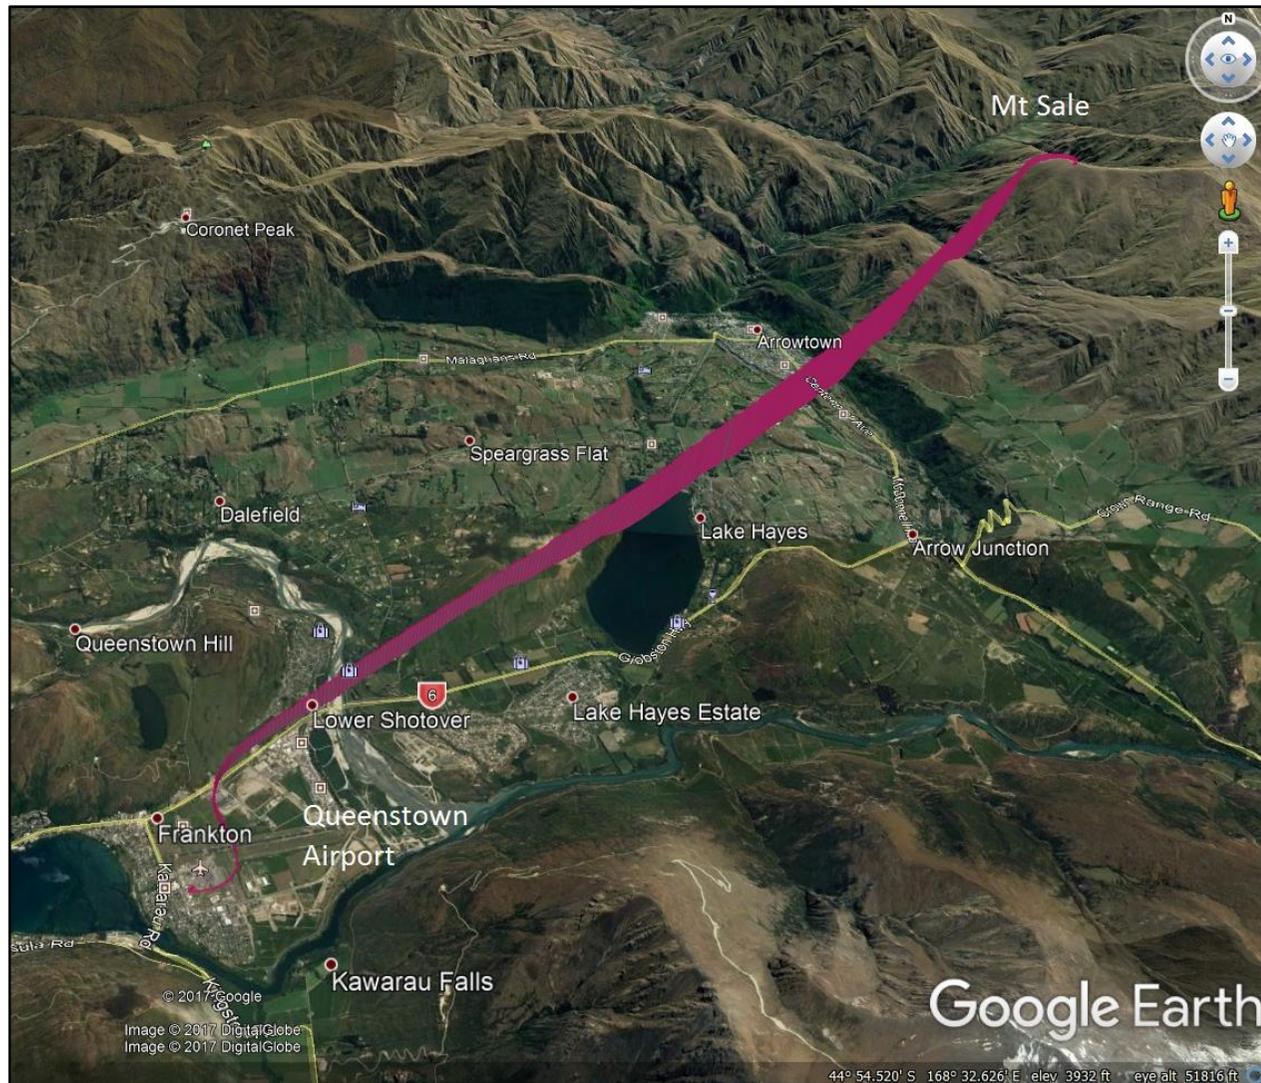
Figure 1  
Flight track to Mount Sale from Queenstown (source: Airways New Zealand surveillance data)

- 3.1.3. At 1437 the pilot was cleared by Queenstown air traffic control to depart to the north towards Mount Vanguard, the intended destination. Shortly after take-off the pilot could see that the weather towards Mount Vanguard was "a bit messy", so he changed the destination to Mount Sale to the northeast of Arrowtown and advised Queenstown air traffic control (see Figure 1). En route the pilot estimated that the wind was from the west to southwest.
