Final report MO-2016-204: Bulk carrier, *Molly Manx*, grounding,  
Otago Harbour, 19 August 2016

Marine inquiry M0-2016-204  
Bulk carrier, *Molly Manx*, grounding,  
Otago Harbour, 19 August 2016

Approved for publication: October 2017

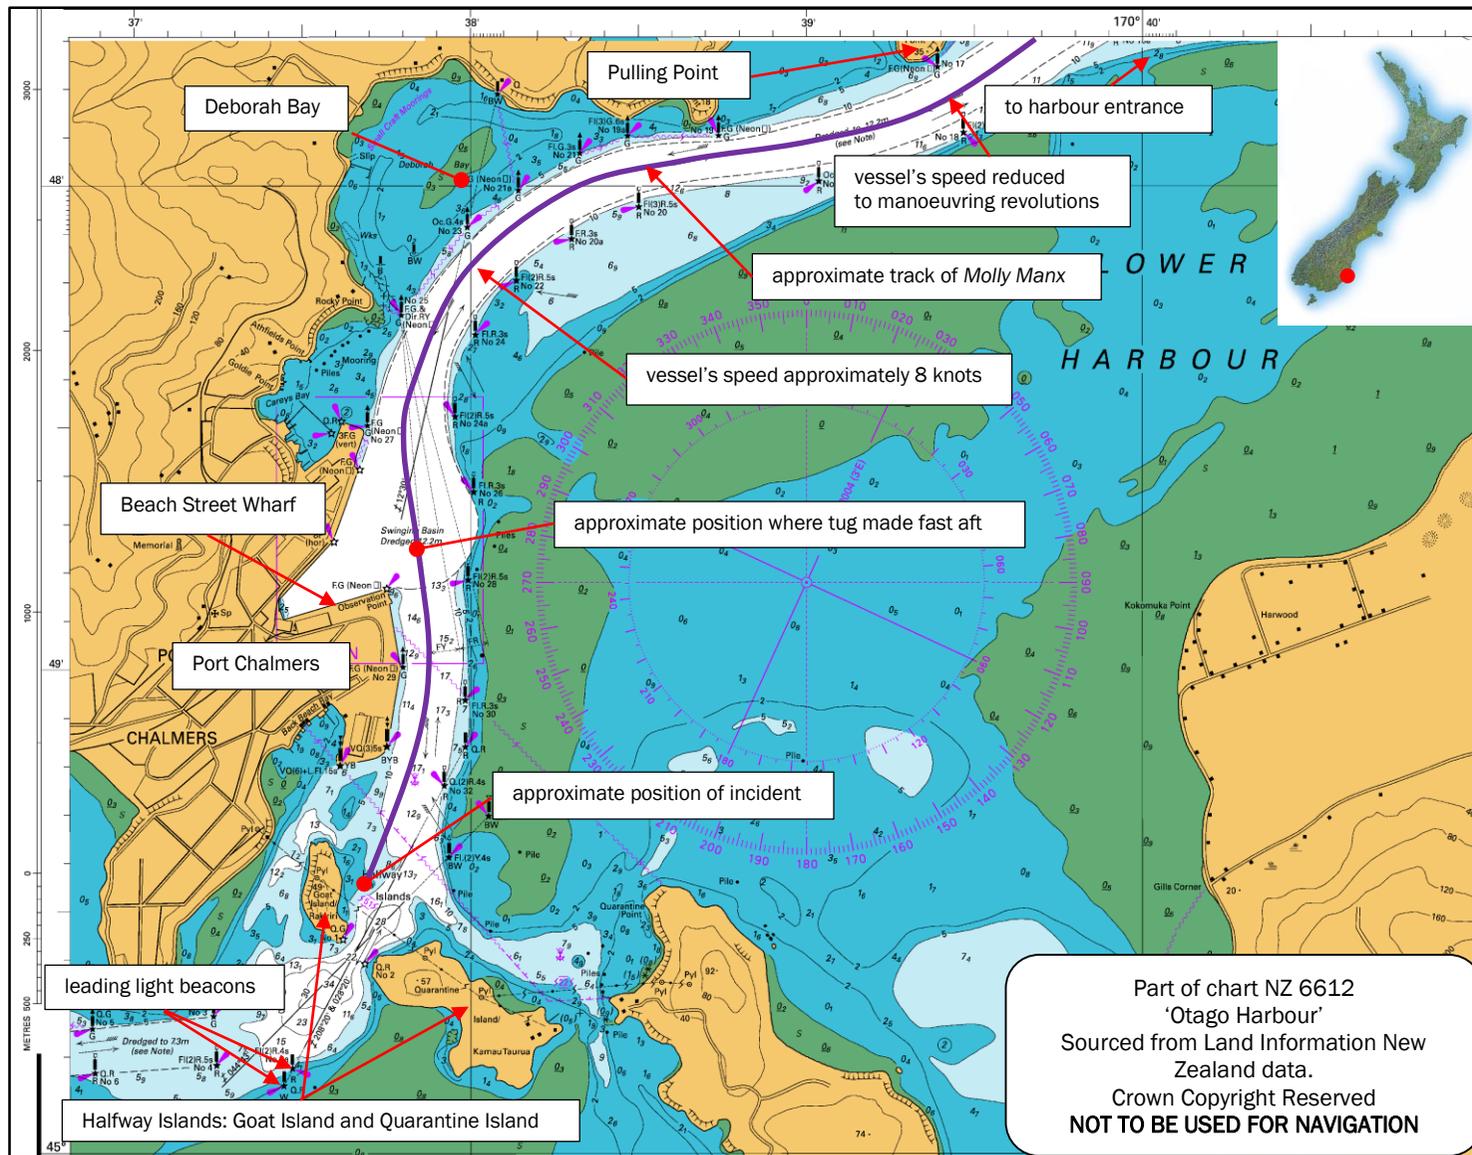
Figure 1  
General area of the incident

- 3.1.4. At 0719 when the *Molly Manx* was passing Pulling Point (see Figure 1), the pilot requested a reduction in speed from full sea speed to manoeuvring speed, and by the time the vessel reached Deborah Bay (see Figure 1) it was making about 8 knots over the ground.

- 3.1.6. As the *Molly Manx* passed Port Chalmers, the pilot pointed out to the master the leading line beacons<sup>6</sup> he intended to use to guide the vessel through the narrow gap between Quarantine and Goat Islands (referred to as Halfway Islands on the chart – see Figure 1). At that time the leading marks showed that the vessel was to starboard of the intended track, which the pilot was aware of and where he planned the vessel to be once he had commenced the turn to starboard.
